North Maple Avenue (CR 607) Road Safety Audit

Evesham Township, NJ

March, 2015

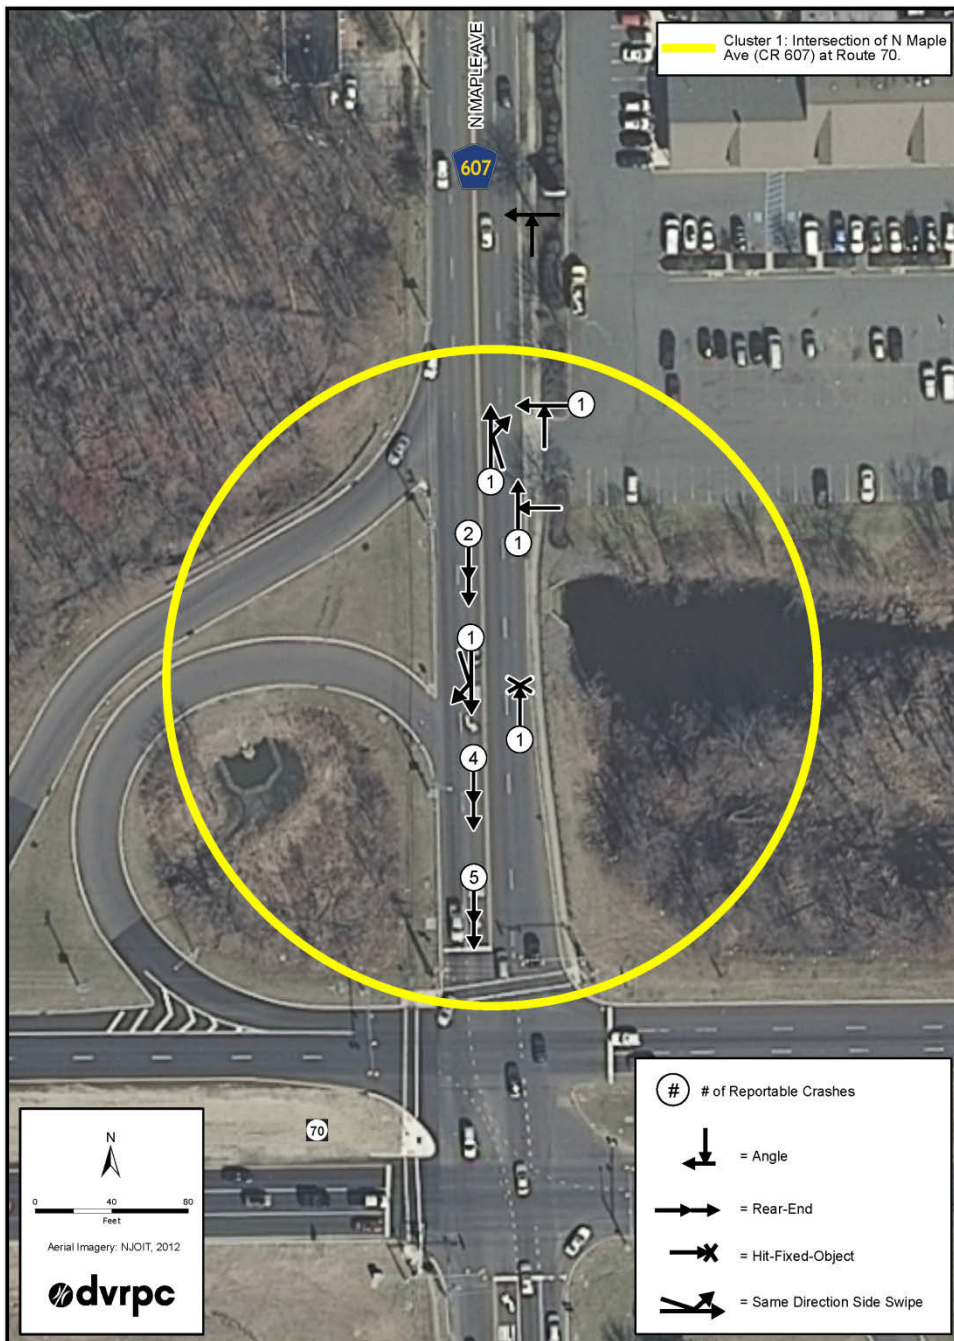
Figure 7: Cluster #1 Crash Diagram

- ▶ There were 16 total crashes, 25 percent of the corridor total
- ▶ Predominant collision types: rear-end (69%), same-direction sideswipe, and right angle (13% each)
- ▶ Predominant pre-crash actions were “stopped in traffic” and “going straight ahead”
- ▶ 12 crashes involved drivers traveling southbound
- ▶ No fatalities, five minor injury crashes, nine property damage only crashes

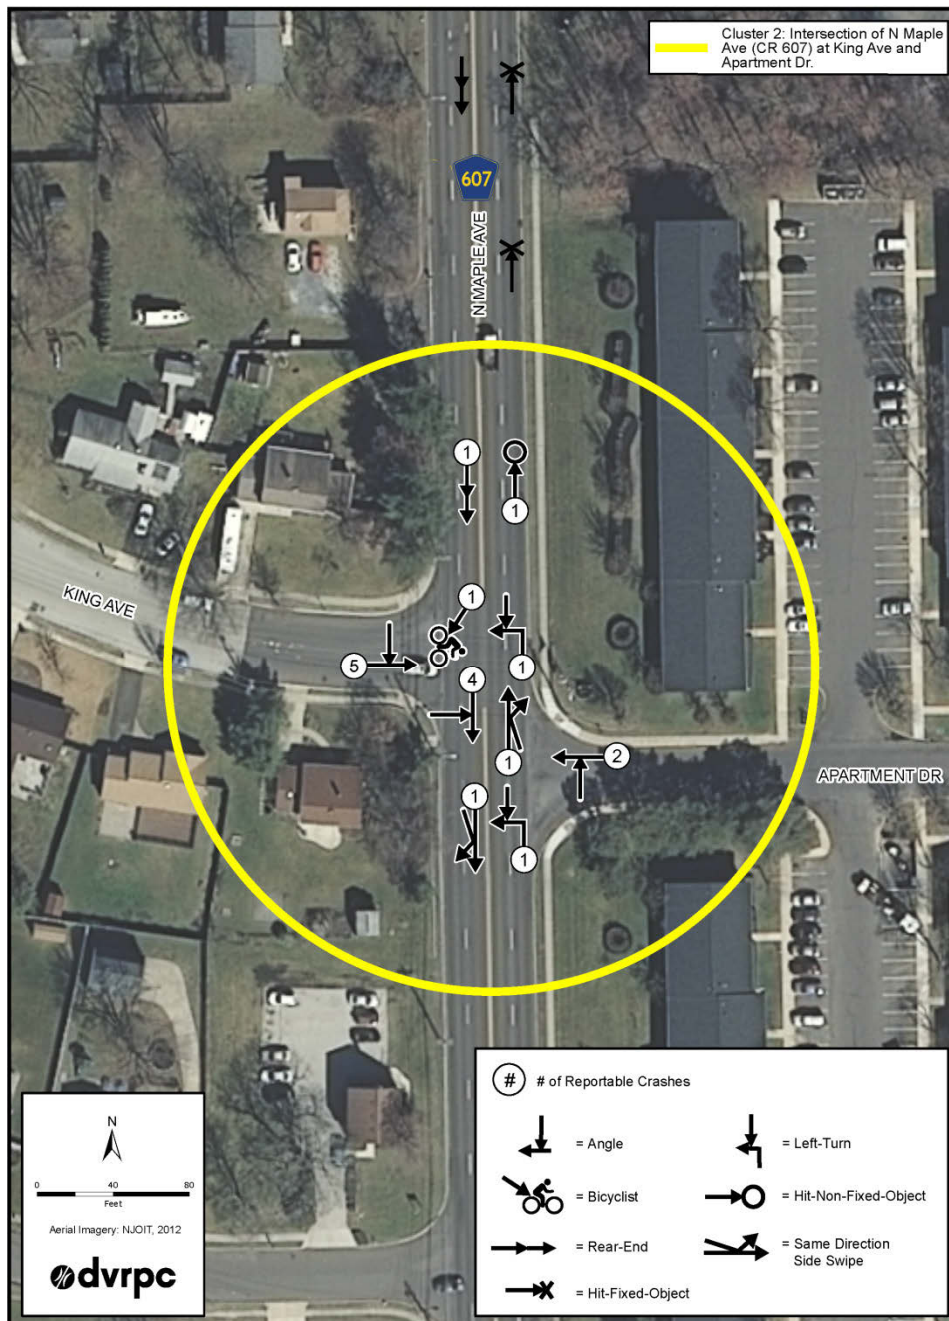
Figure 8: Cluster #2 Crash Diagram

- ▶ There were 18 total crashes, 28 percent of the corridor total
- ▶ Predominant collision type: right angle (61%), same-direction sideswipe, and left/U-turn (11% each)
- ▶ Predominant pre-crash action was “going straight ahead”
- ▶ Nine crashes (50%) involved drivers entering N. Maple Avenue from King Avenue eastbound
- ▶ No fatalities, one major, one moderate, and seven minor injury crashes; nine property damage only

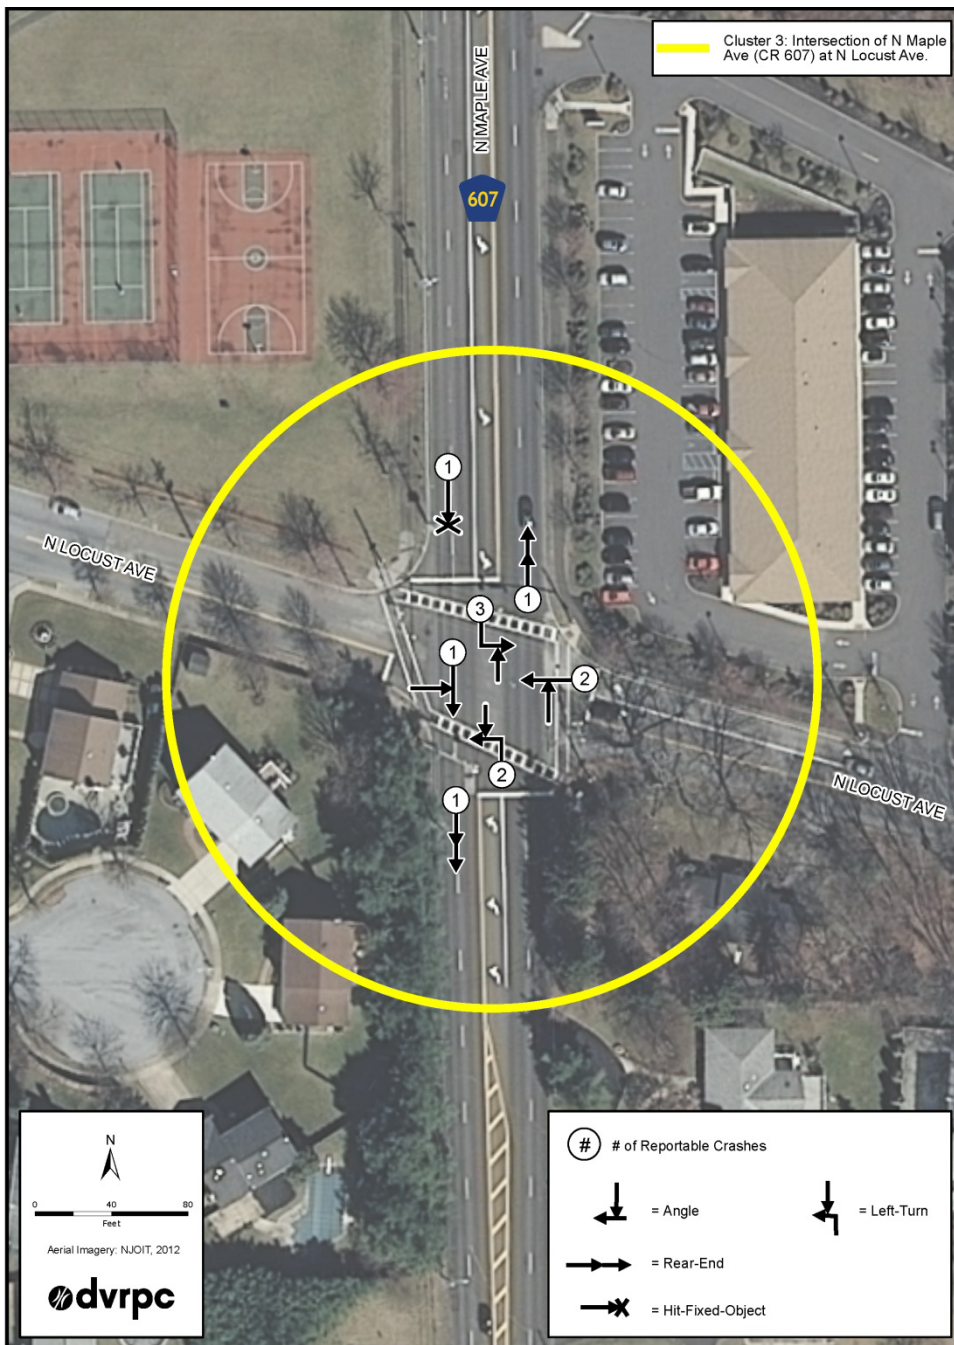
Figure 9: Cluster #3 Crash Diagram

- ▶ There were 11 crashes, 17 percent of the corridor total
- ▶ Predominant collision types: left turn/U-turn (45%), right angle (27%)
- ▶ Predominant pre-crash actions were “going straight ahead” and “making a left turn”
- ▶ Six of the 11 crashes involved southbound vehicles
- ▶ No fatalities, one major, five moderate, and one minor injury crash; four property-damage-only crashes

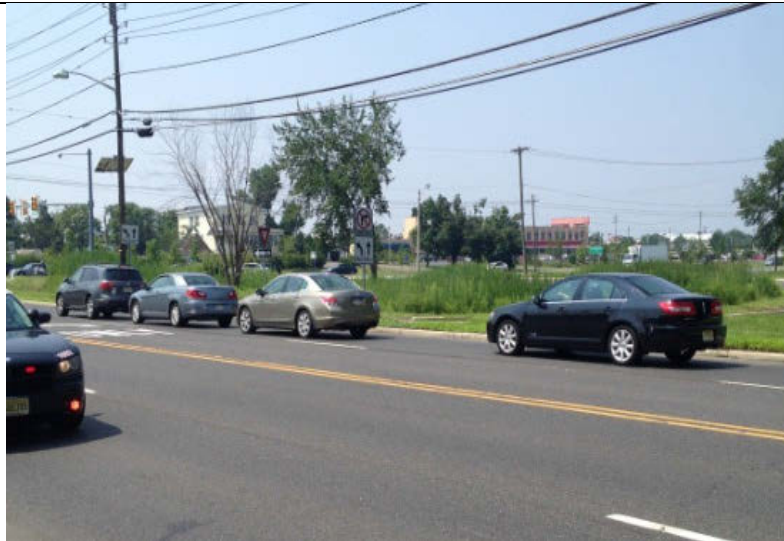
Issue #1: Problematic weave between left-turn lane and through lane approaching the NJ 70 intersection on North Maple Avenue southbound

Vehicles queuing in the southbound through lanes

With 12 southbound crashes (75% cluster total), 11 of which are rear-end collisions, this issue has a notable number of associated crashes making the exposure relatively high.

The severity trend is relatively low at this cluster (eight PDO, four minor injury crashes), possibly related to drivers slowing as they approach the intersection. Also, congestion in the southbound through lane was noted during the audit.

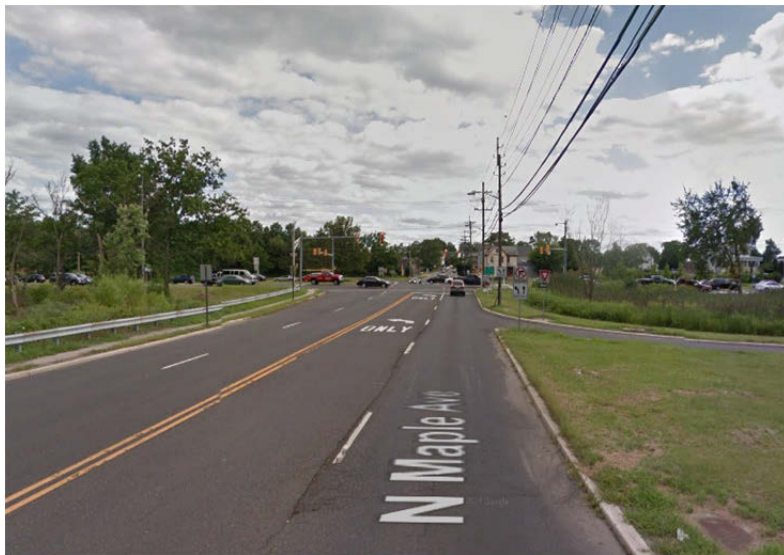
Southbound where the left lane becomes the left-turn-only lane and NJ 70 westbound off-ramp traffic enters North Maple Avenue southbound

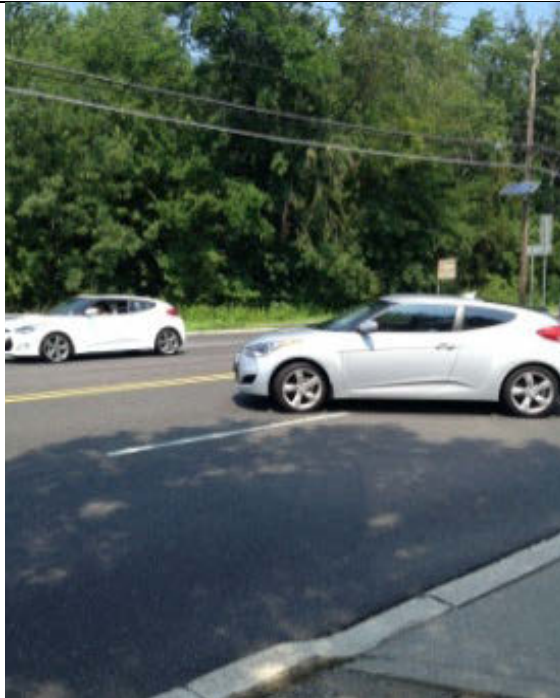
Issue# 2: Left-turns crossing multiple live traffic lanes into and out of the Wawa parking lot

Drivers exiting the southern driveway of the Wawa convenience store

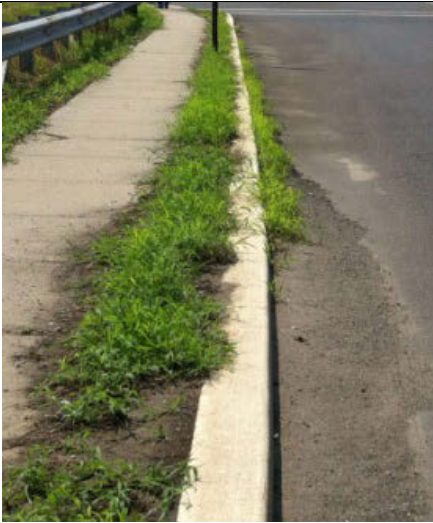
Debris from ponding along the curb in the northbound lane

- Evidence of ponding on North Maple Avenue northbound and southbound between NJ 70 and the westbound NJ 70 on-ramp along curb line. During rain events, ponding can create a potentially hazardous situation as drivers may be forced to swerve out of their lane to avoid the water;
- Most signs lack retro-reflectivity;
- Deteriorating pavement condition and faded striping was noted at select locations within this cluster.

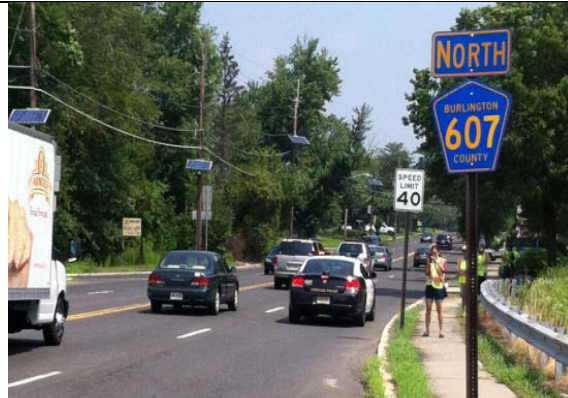
Roadway signs lack retro-reflectivity

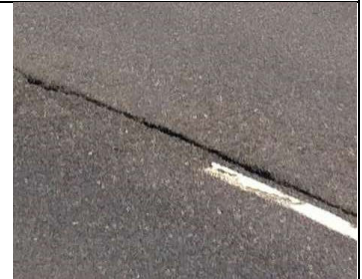
Roadway pavement cracking in several locations

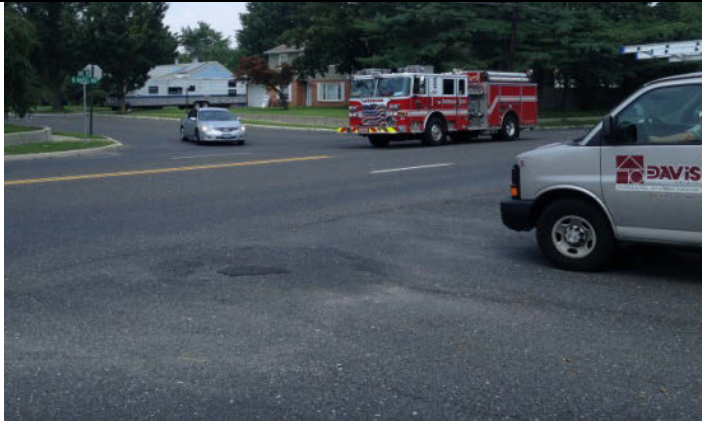
Issue #1: Offset intersection alignment, tight turning radii, missing pedestrian crossings, right-turn crash trend

Confluence of through traffic and traffic entering the corridor

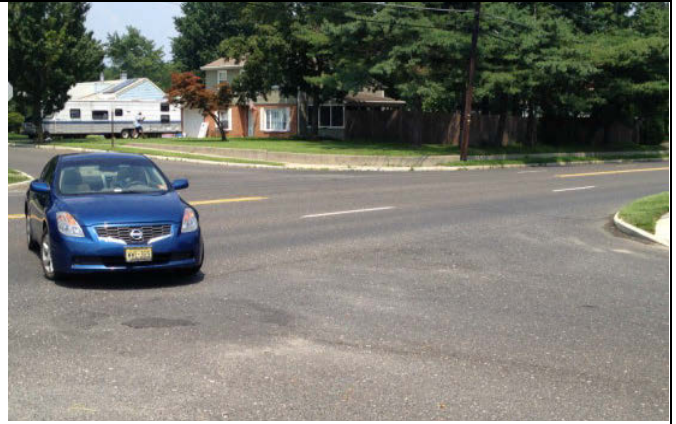
Driver passing between offset side street legs

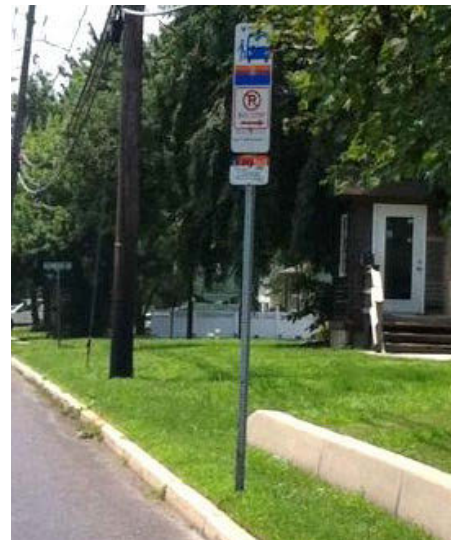
Missing pedestrian accommodations at/to bus stop along corridor northbound

<p>Recommendation:</p> <p>Short Term – Approaches to North Maple Avenue need proper lane markings and signs, including stop bars, lane designation, crosswalk striping, and replacement of the Apartment Drive stop sign with a code-compliant sign. Agreement is needed among the property owner, Evesham Township, and Burlington County to share installation and maintenance responsibilities for the Apartment Drive improvements. A mid-block crosswalk over North Maple Avenue to accommodate pedestrians walking to bus stops should be considered (NJ Transit must be a partner on this item). Long term – Incorporate access management changes as part of a corridor-wide road diet. This would separate turning traffic from through traffic, calm traffic through the intersection, and improve general pedestrian access as well as access to the transit stops.</p> <p>Note: The apartment complex is responsible for maintaining the traffic controls for their access. Burlington County does not have the authority to require them to maintain it.</p>

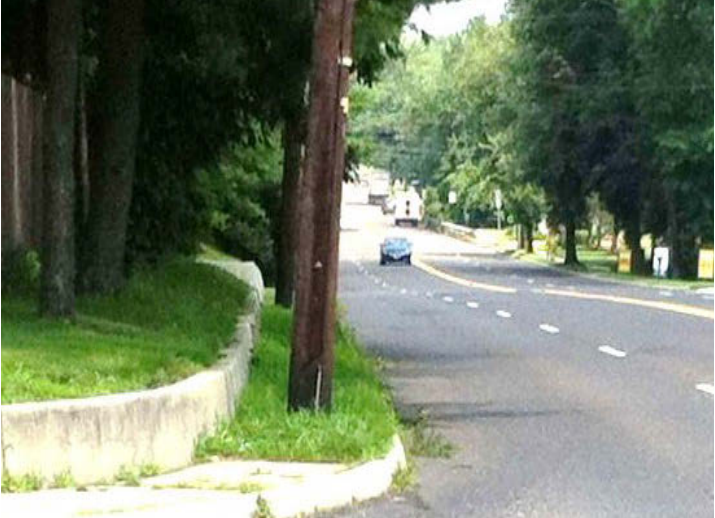
<p>Utility poles obscure view of oncoming traffic for drivers exiting King Avenue onto North Maple Avenue</p>	<p>Issue: Telephone poles obstruct view from King Avenue eastbound, specifically blocking the view of traffic approaching the intersection from North Maple Avenue southbound. Left turns are particularly problematic due to the crossing of multiple live traffic lanes, combined with sight distance obstructions.</p> <p>Exposure: As mentioned in Issue #1, traffic count data shows frequent right turns onto North Maple Avenue, increasing the chance of right angle crashes, making the exposure relatively high.</p> <p>Severity: This location reflects the overall severity of the cluster.</p>
<p>Recommendation:</p> <p>Conduct further study into mitigation of visual obstructions.</p> <p>Short Term - Burlington County will collect traffic count data to determine if two travel lanes are warranted in each direction on North Maple Avenue (road diet feasibility analysis). A cross-section of three lanes and shoulders (i.e., road diet) will address the drainage along the gutter line and improve the visibility from the driveways and side streets. Long Term - Relocation of the utility poles would be a costly, long-term project and would require the county to purchase right of way from each parcel before the utility companies would agree to relocate. No action regarding this option was planned at the time of publication.</p>

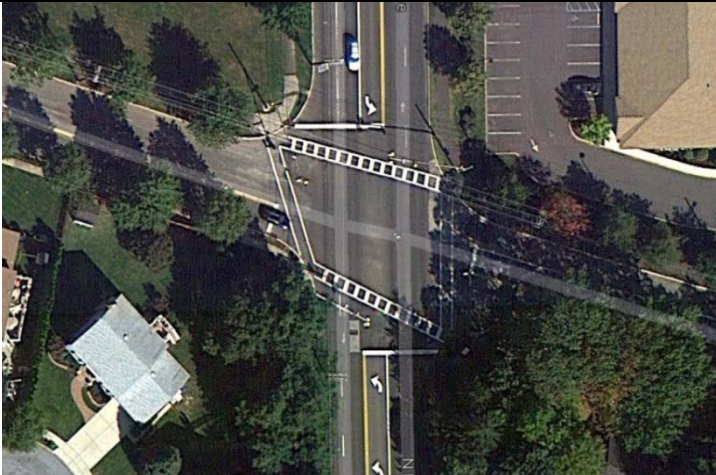
Issue #1: Left-turn crash trend, signal head misalignment

Aerial view of intersection illustrating skewed alignment

Five of the 11 crashes resulted in moderate injury, plus one major and one minor injury crash. Regarding overall severity and the property damage only to injury crash ratio, this location has the most severe crash experience on the corridor, despite the lowest number of total crashes.

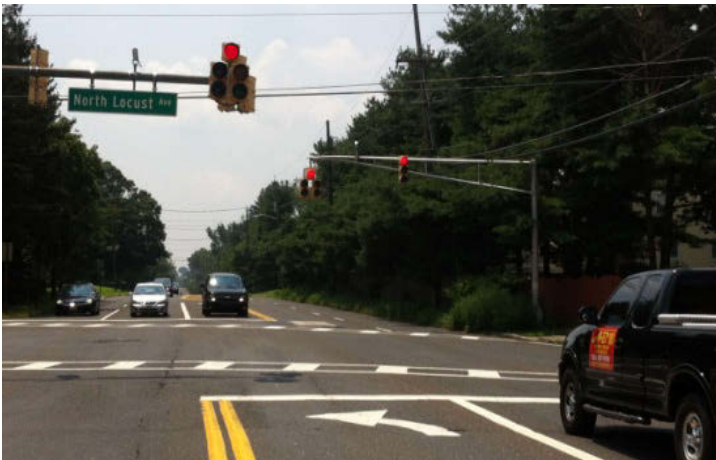
Looking southbound on North Maple Avenue from north side of the intersection; signal head not centered over left-turn lane

In addition, a work order has been submitted to the county maintenance division to rotate the 30-foot traffic signal mast arm on the southwest corner of the intersection to align the five-section signal head above the left-turn lane as per audit recommendation. The work order will also include installing five-section signal heads on the traffic signal standards to the far left of North Maple Avenue's left-turn lanes.

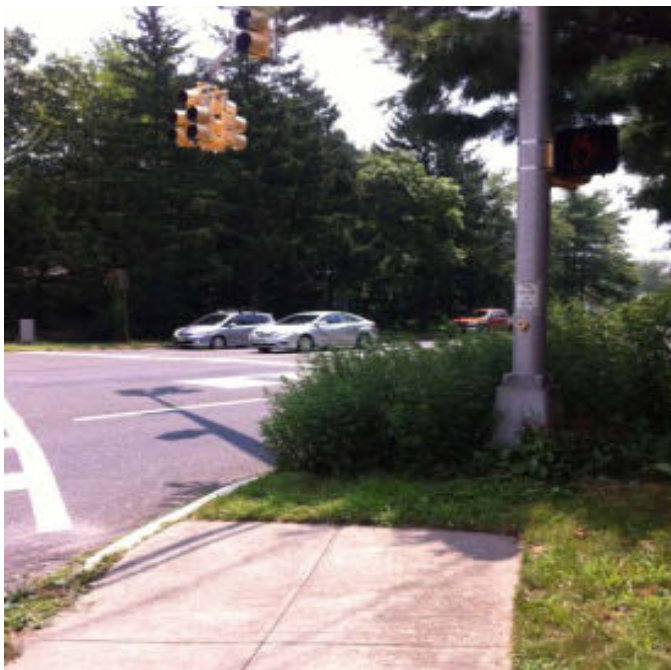
- Crosswalk striping is beginning to fade; ADA ramps are missing on southeast quadrant, and crossing time is reportedly insufficient, especially when crossing North Maple Avenue due to the skewed intersection alignment;
- Sidewalks are nonexistent along northbound and southbound North Maple Avenue on the south side of the intersection;
- Overgrown vegetation blocking pedestrian connection.

Missing pedestrian connection, overgrown goat path.

Upgrade or add needed pedestrian accommodations at each intersection approach: curb ramps, push buttons, striping, and sidewalk sections. Shorten the crossing distance by restriping crosswalks to a more perpendicular alignment. Revisit signal timing to check time for pedestrian crossing phase; upgrade to standard if needed. Trim vegetation at corners where needed to clear path for pedestrians. Add missing sidewalk along North Maple Avenue to connect to existing network.

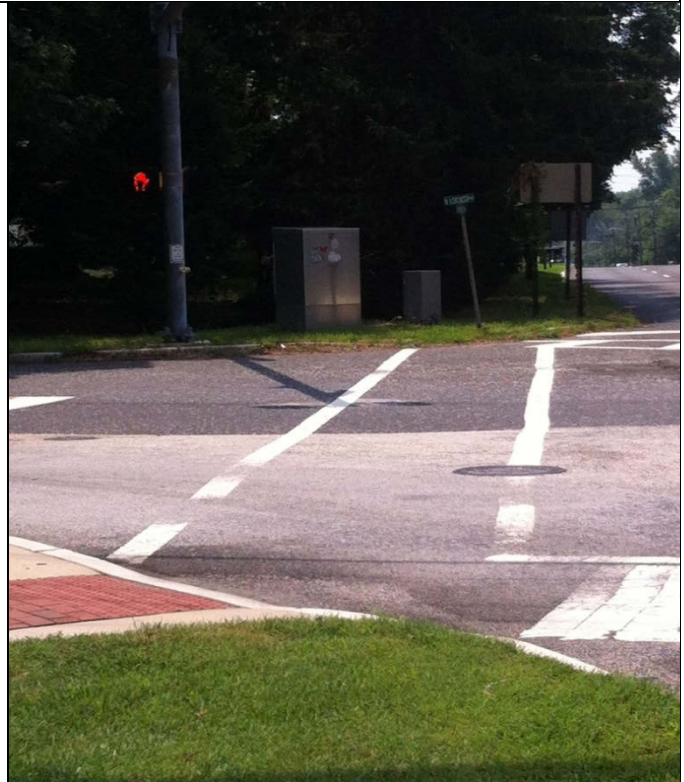
Faded crosswalk and missing curb ramp (far side)

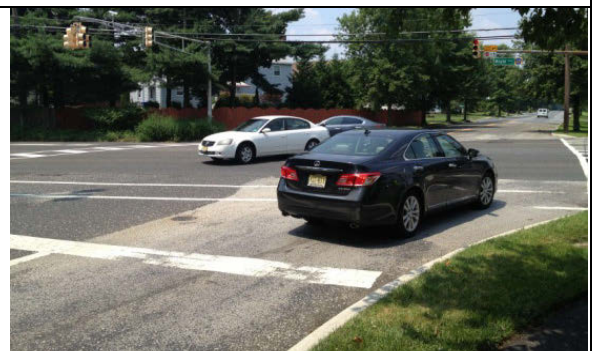
Faded striping
