# Cheltenham Township Energy Assessment

## Township Administration Building

8230 Old York Road, Elkins Park, PA 19027

APRIL 2016

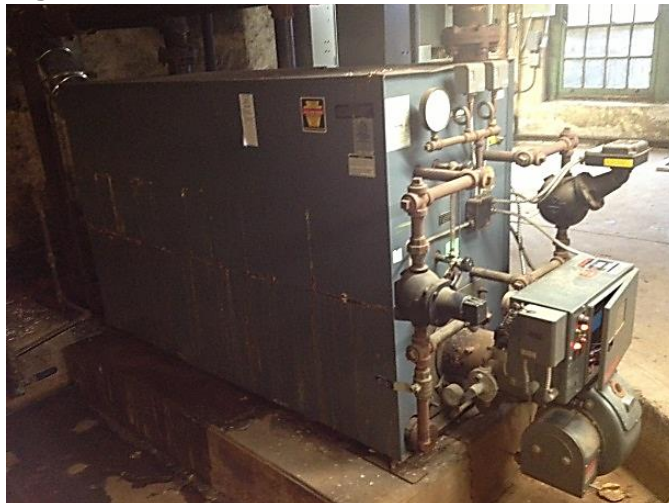
**Figure 1:** Boiler

At the time of the site visit, the boiler was damaged and leaking steam from the pressure vessel, substantially reducing steam pressure throughout the system. As a result, steam is unable to reach all of the radiators, causing significant temperature fluctuations and occupant discomfort throughout the building. The boiler is not expected to function through another winter season. An image of this boiler, captured during PES's site visit, is shown as Figure 1 below.

- *Lack of water treatment.* While steam systems in other Cheltenham Township facilities have water treatment components, this system does not. Without proper chemical treatment, solid deposits are left behind as steam evaporates. These deposits cause corrosion and insulate heat exchange surfaces, reducing efficiency and ultimately causing metal failure. The deposits can also clog the steam piping system components (i.e., steam valves and traps) and greatly reduce the longevity of any system repairs. The lack of water treatment has likely contributed to the boiler failure and caused piping, radiator, and steam trap damage.

PES recommends against any further repairs to the steam system, because this capital is better invested in a more efficient, more effective, and more serviceable HVAC system. Specifically, PES recommends retiring the steam system and installing a high-efficiency distributed heat pump system with VSD compressor.

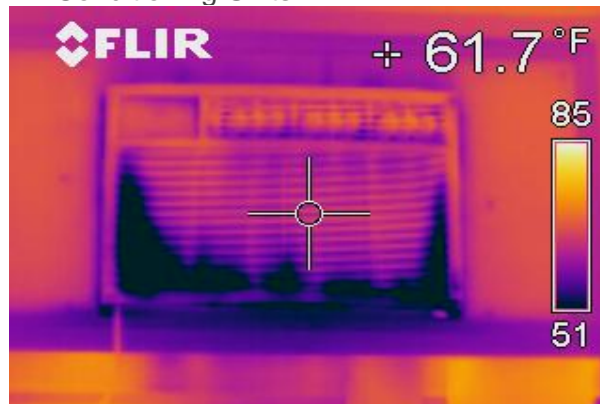
**Figure 2:** Cold Air Infiltrating Through Window Air-Conditioning Units

2. *Efficiency.* VRF systems are highly efficient, as the variable capacity feature precisely matches compressor output to actual demand. The system also has individual zones, so occupants can manage and schedule their demands for heating and cooling energy. The VRF system will also allow the township to remove the window air-conditioning units, and either seal the cavities or replace them with glazing. This will significantly reduce unwanted air infiltration and further lower HVAC energy use, thereby reducing the lifetime operational costs and environmental impacts of the HVAC system. Figure 2 below shows an infrared image captured during PES' site visit. The temperature measured by PES' infrared camera in the circle centered in the photo is 61.7°F, and the temperature toward the bottom of the AC units is closer to 50°F, indicating air infiltration through the unit.

As shown earlier, the various window and through-wall air conditioners present a far greater source of cold air infiltration than the window frames. The previously described HVAC renovation plan will allow for these units to be removed and the penetrations properly sealed. The added expense of this portion of the HVAC upgrade project should be considered and prioritized above the window replacement.

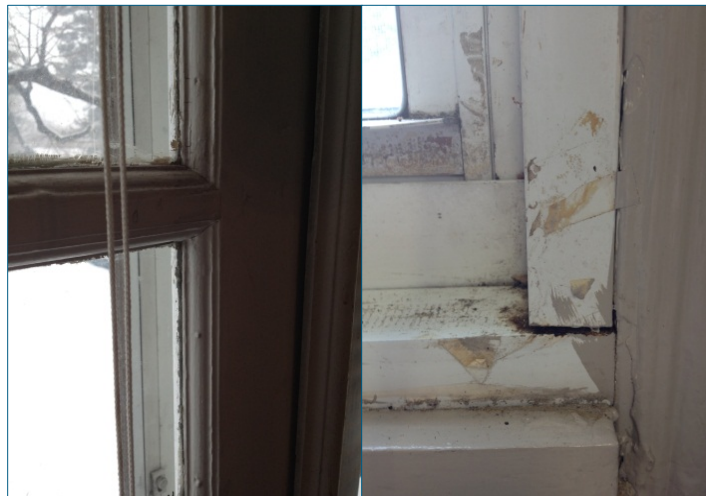
**Figure 3:** Window Frame Damage

Windows throughout the facility are operable, double-paned units with wood frames. Windows in the council meeting room have metal frames. Employee interviews indicate that the windows are somewhat drafty; examination of the window frames confirmed this. Many have cracked sealant and signs of damage or poor installation. Figure 3 below presents two images showing window frame damage captured during PES’s site visit.

Conversations with maintenance staff revealed that a design firm is currently designing window upgrades for the facility. However, PES recommends placing the window upgrade on hold until the HVAC system is addressed or, at the minimum, performing both projects simultaneously if budget permits. Simply air sealing around the window frames as an interim measure will yield a better return on investment, while freeing funds

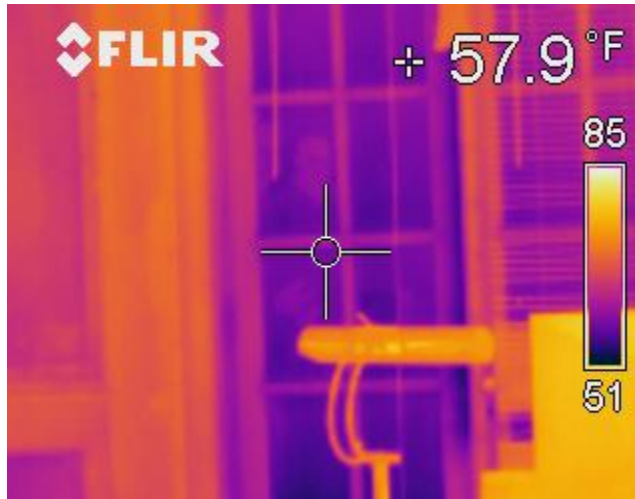
**Figure 4:** Window Glazing Thermal Performance

Figure 4 below shows an infrared image captured during PES’ site visit. The temperature measured by PES’ infrared camera in the circle centered in the photo is 57.9°F, indicating that the thermal performance of the glazing is relatively good.
