Intersection Road Safety Audit

NJ 47 Delsea Drive & Cooper Street

Deptford Township,
Gloucester County

July 2008

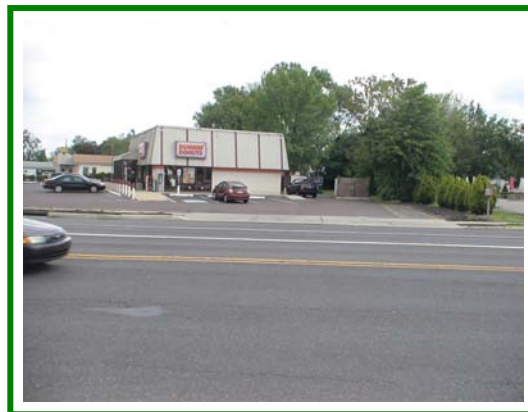
Dunkin' Donuts

- The high volume of traffic generated by this business warrants consideration of an access management plan. The drive-through window queue backs up into the Cooper Street access during the morning hours.

- Quantify the access movements to determine turn volumes. Coordinate with adjacent land owners to consider shared access driveways (where possible). Apply a no-left-turn restriction (where appropriate).

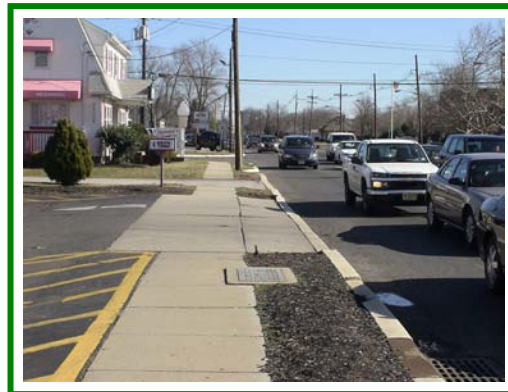
- Left turns onto Cooper Street eastbound are problematic due to compromised sight distance caused by queuing Cooper Street westbound traffic. Drivers attempting this left turn must often rely on a “wave-on” from waiting motorists, which is an inherently unsafe practice.

- Make Cooper Street access right-in right-out only, and force Cooper Street eastbound access via the NJ 47 southbound left-turn lane. The left turn from this approach has a dedicated signal phase, making it safer than the left turn out of the parking lot onto Cooper Street eastbound, which requires crossing four lanes of traffic.

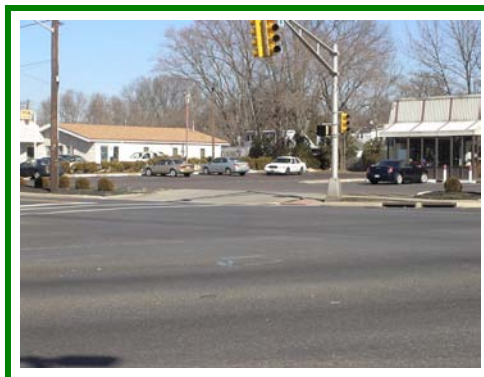
- NJ 47 northbound access located closest to the intersection allows for a potentially unsafe movement—Cooper Street eastbound traffic uses the left-turn lane to NJ 47 northbound and then makes a quick right into this access. This move is especially hazardous to pedestrians and is an unsafe and unnecessary movement since access to NJ 47 can be gained at another point located further away from the intersection.

- Close access from NJ 47 closest to the intersection.

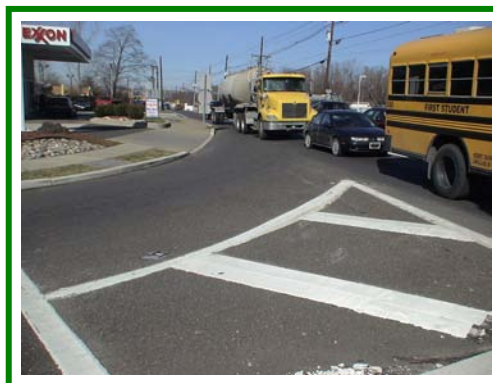
Exxon

- Left turns are problematic out of the driveway onto NJ 47 located closest to the intersection due to poor sight distance. Left turns are further complicated due to the driveway's close proximity to the traffic signal and the channelized right-turn lane.

- Make access closest to intersection right-in right-out only.

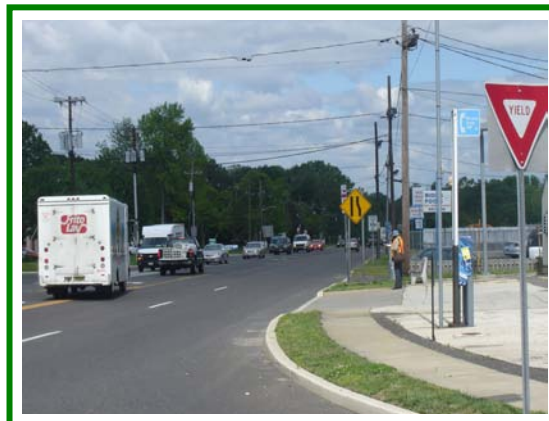
NOTE: There is already sign clutter in this area; additional signs may have a negative effect (too many messages on an approach may confuse motorists). NJDOT TE&I will investigate.

- Add merge-ahead (lane drop) sign with distance to merge point in feet indicated on the sign to better prepare motorists; install before merge point according to MUTCD specification.

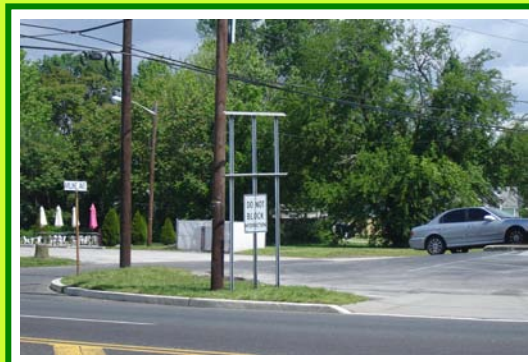
- Guide/route/destination signs missing on Cooper Street westbound approach to intersection.

- Replace signs and mount according to MUTCD guidance.

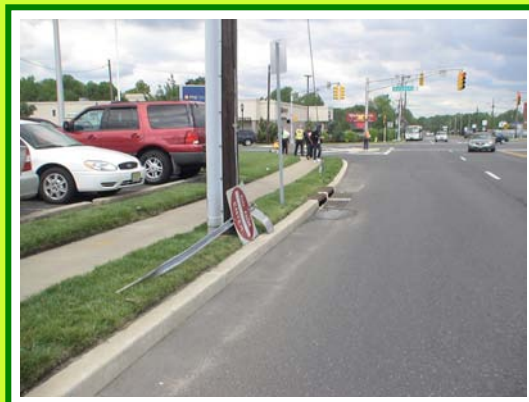
- Missing do-not-enter” sign for opposite direction traffic to remind them not to turn left into the channelized right turn lane.

- Replace sign and mount according to MUTCD.

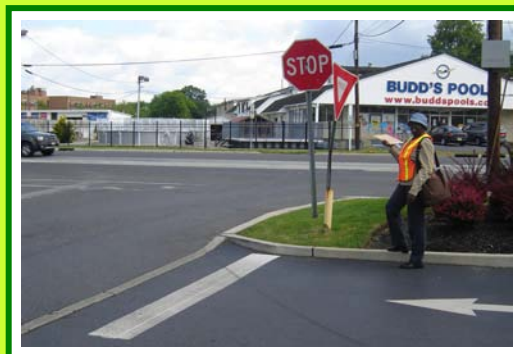
- Stop sign posted on Cape May Avenue at intersection with Cooper Street is damaged.

- Replace sign and mount according to MUTCD.

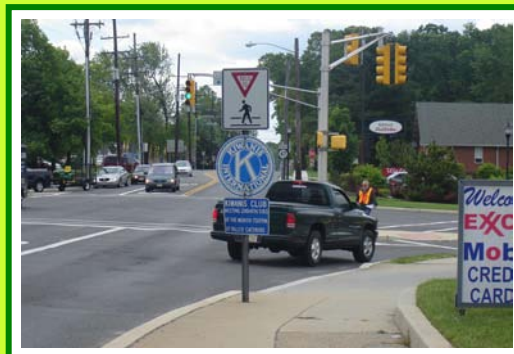
- The pole of the yield-to-pedestrians sign located in the channelized right-turn lane on the NJ 47 southbound approach is being inappropriately used to post other signs. This creates a distraction and minimizes the effects of the yield-to-pedestrians sign.

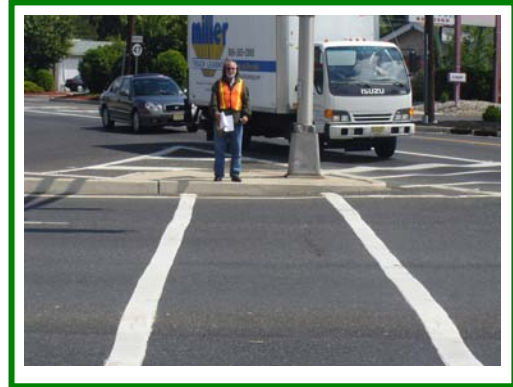
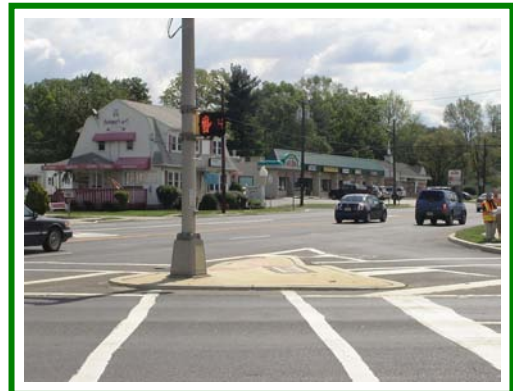
- Missing curb ramps (1. N-S over Cooper Street on west side of intersection; 2. E-W over NJ 47 on south side of intersection). Other curb ramps are not ADA compliant (e.g., SE corner-in front of PNC Bank).

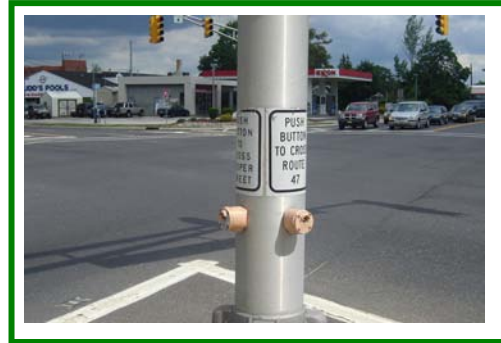
- Pedestrian push button for crossing Cooper Street S-N on east side is misaligned to the east.

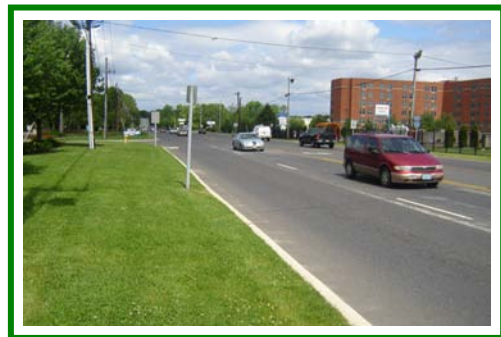
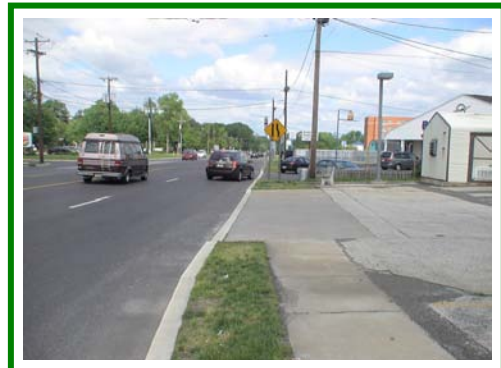
- Missing sidewalk connection between the senior center and the intersection crossings.

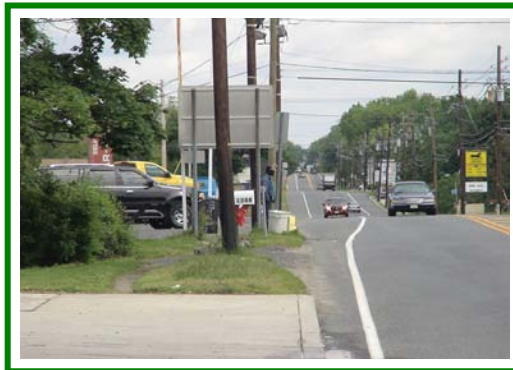
- Missing sidewalks between transit stop and intersection (along NJ 47 SB, north of gas station).

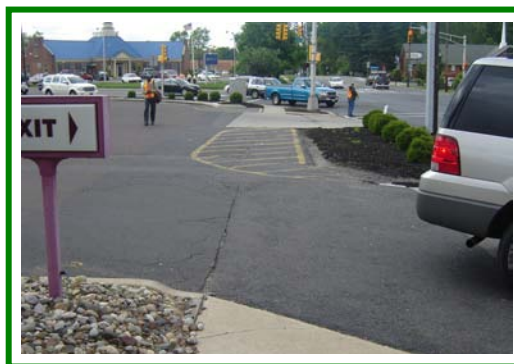
- Missing sidewalk connection between intersection and pizza shop along the Dunkin Donuts frontage.

- Replace missing sidewalk to establish pedestrian right-of-way through donut shop parking lot.

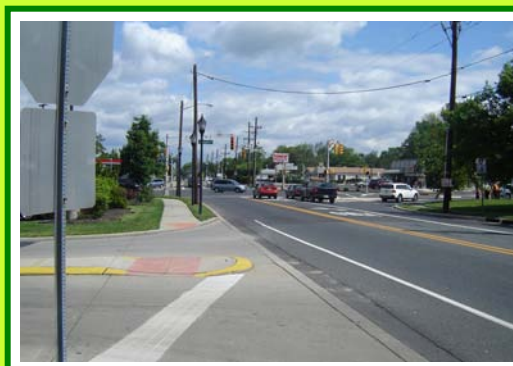
- Tree located on the southeast intersection quadrant (in front of bank) obstructs sight distance of and for pedestrians at the channelized right-turn lane.

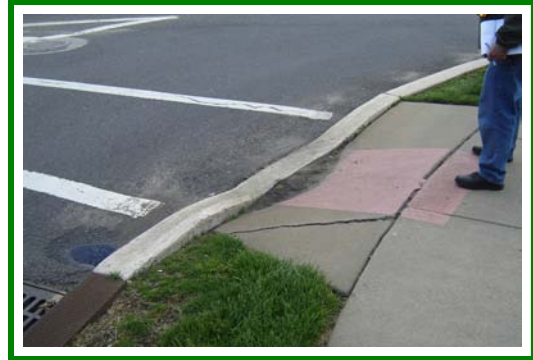
- Some sidewalk blocks are cracked and/or heaving (at various locations including curb ramps), creating a tripping hazard.

- Repair sidewalks where needed.

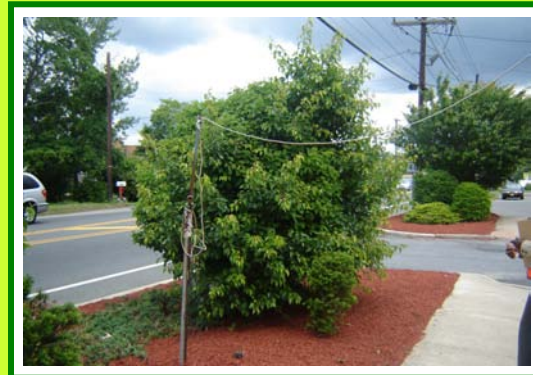
- An electrical wire was discovered hanging low over the sidewalk along NJ 47 NB just north of the Dunkin' Donuts parking lot.

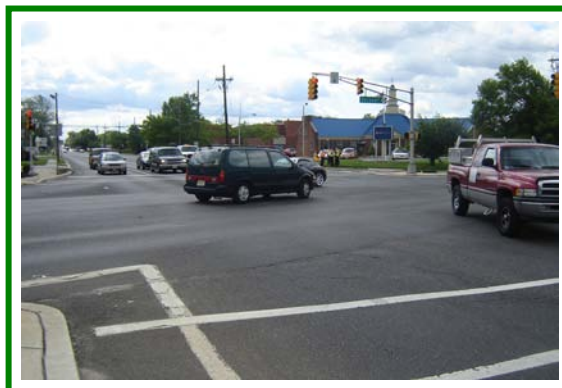
- High left-turn volumes, limited left turn green time along Cooper Street to NJ 47 (both directions), and a lack of gaps in oncoming traffic seem to be factors contributing to the number of left-turning vehicles observed waiting to turn left at the end of the cycle.

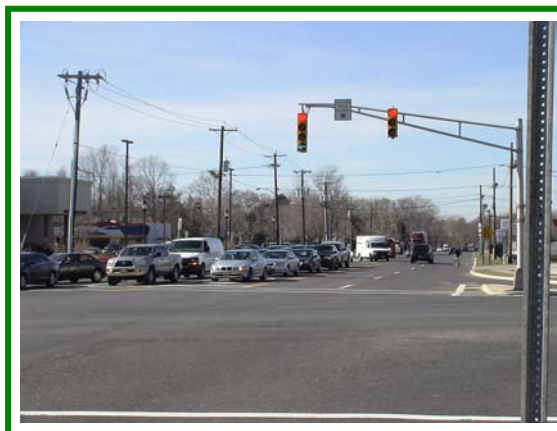
- Peak period congestion delays traffic and may result in rear-end crashes (rear-end crashes represented 38.8% of the total).

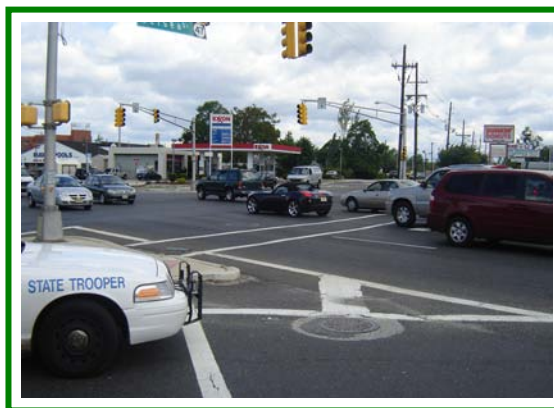
- Intersection clearance time may be inadequate based on field visit and crash data.

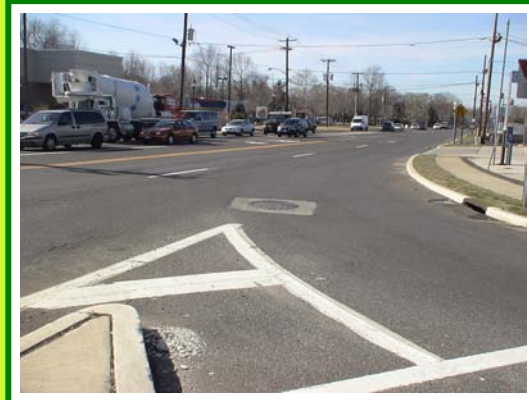
- Uneven pavement at select drainage grates.

- Reset drainage grates to prevent tripping hazards.
