**Regional Roundabout
Analysis**

Phase II

SEPTEMBER 2009

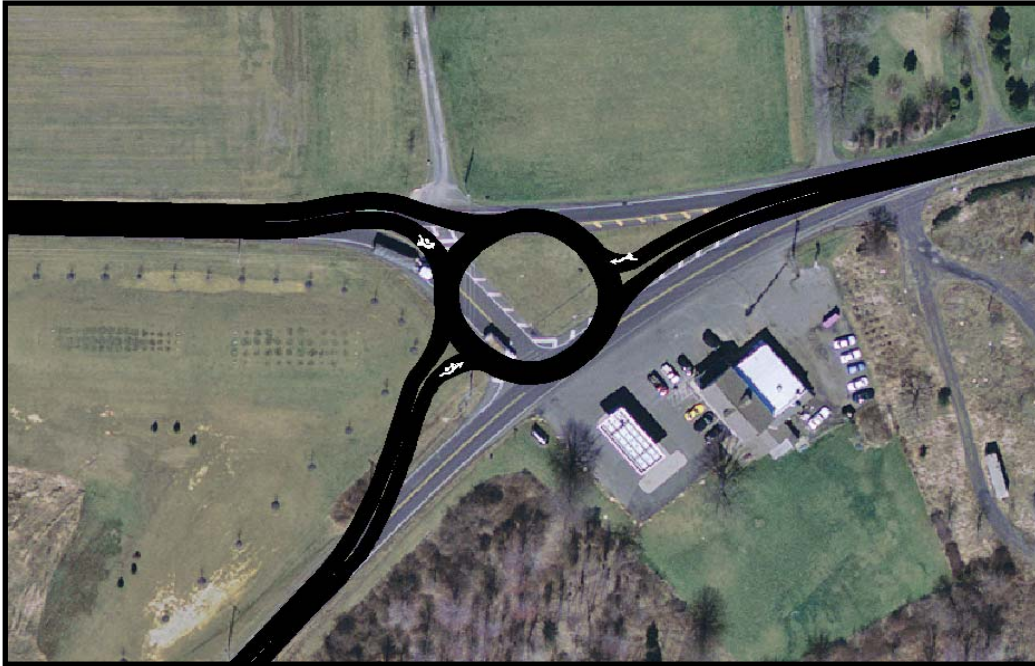
Figure 6: Bucks County Study Location – Roundabout Rendering

A roundabout (as depicted in **Figure 6**) at this location with AM peak hour traffic volumes operates at an overall LOS of C, with 17 seconds of average delay. This represents a 21-second improvement from existing conditions, but a marginal decline from the signalization scenario. The roundabout also achieves a reduction in delay for the eastbound Stoopville Road approach, which performs at a LOS of A, with only eight seconds of average delay. However, delay and queues result on the previously free-flowing Washington Crossing Road approaches. In particular, northbound Washington Crossing Road experiences 42 seconds of delay, for a LOS of E and a 95th percentile queue of 400 feet, or 20 vehicle lengths. During the PM peak hour, the intersection performs at an overall LOS of A, with only six seconds of average delay. This is comparable to existing conditions and ten seconds better than the signalization scenario. All three approaches operate with less than ten seconds of delay for a LOS of A and zero 95th percentile queuing.

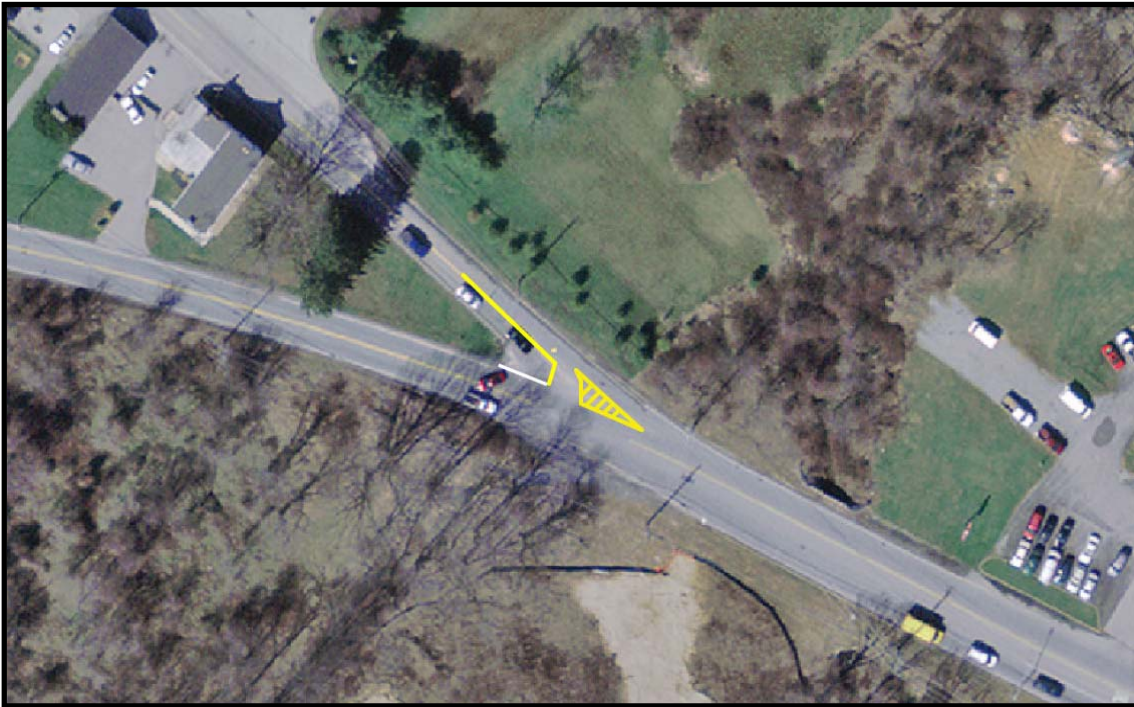
Figure 12: Chester County Study Location – Short-term Improvement

- Originally, Chester County officials were concerned about the close proximity of the Phoenixville Pike intersection and thus sought to utilize VISSIM in order to explore various means to alter the signalized intersection to accommodate a roundabout at the Ship Road intersection;
- After examination of the refined scenarios, Chester County officials do not endorse a roundabout at the study location; and
- As shown in **Figure 12**, Chester County desires to have short-term safety and operational improvements implemented at this location. This improvement includes a stop bar and painted median along Ship Road that meets Boot Road at a 90 degree angle, and a painted gore area that may serve as a splitter island to differentiate westbound Boot Road through movements from right-turns.

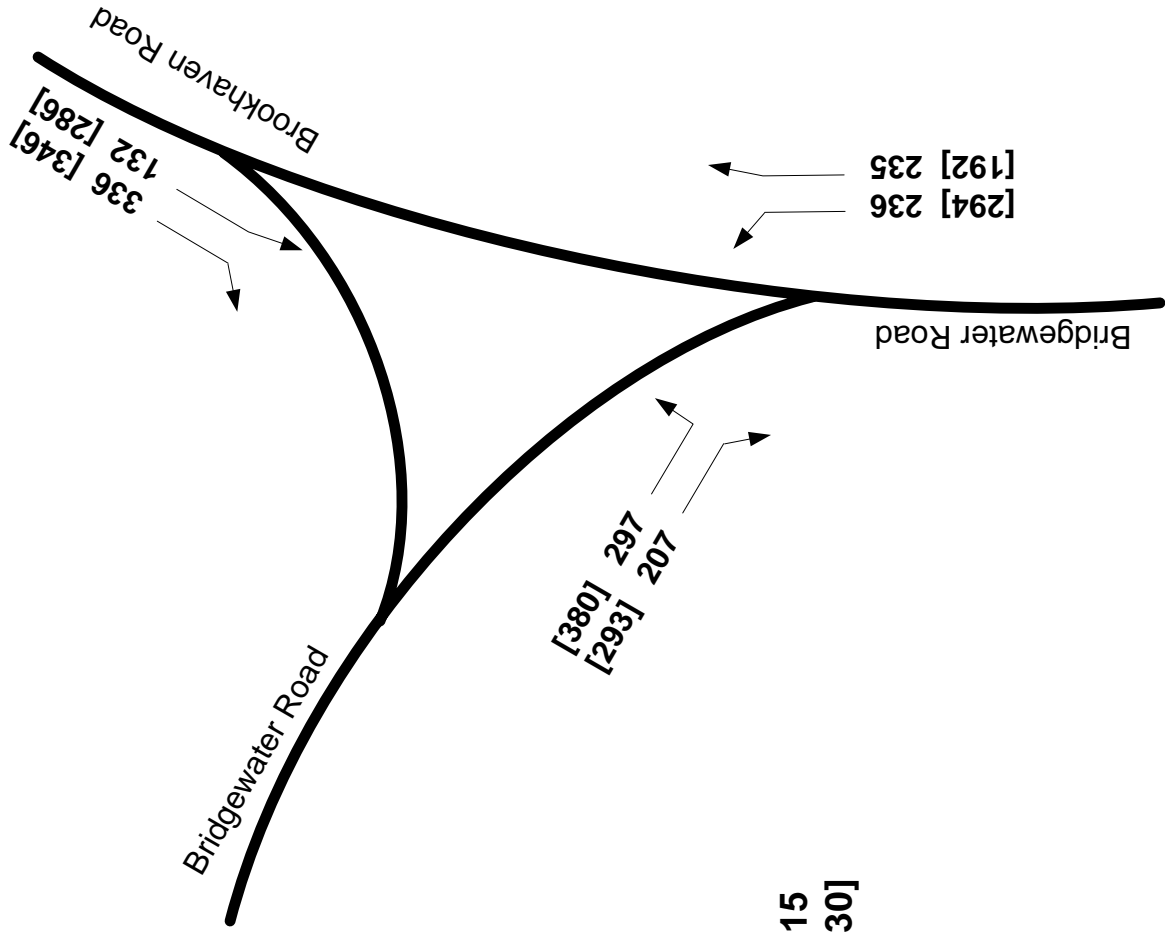
Delaware County Study Location Turning Movements
EXISTING Peak Hour Turning Movement Counts AM & [PM]

Peak Hours
AM: 7:15 - 8:15
PM: [4:30 - 5:30]

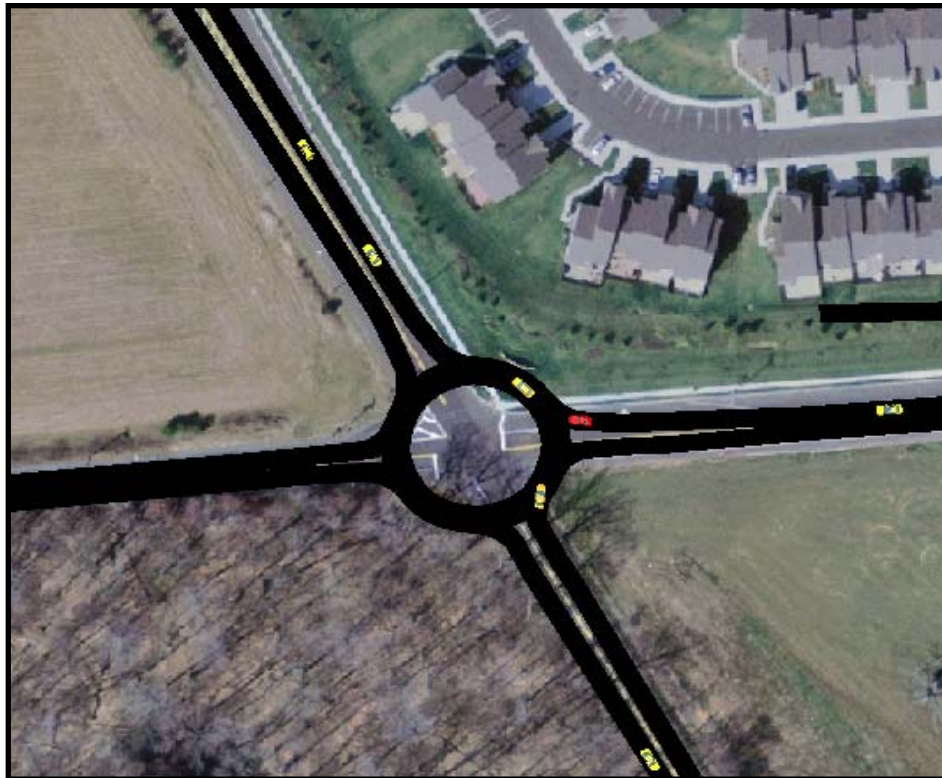
Figure 30: Burlington County Study Location – Roundabout Rendering #2

Roundabout Scenario – 110' Diameter
