US 130 Brooklawn Circles Concept Development Report

# **US 130**

# **BROOKLAWN CIRCLES**

# **CONCEPT DEVELOPMENT**

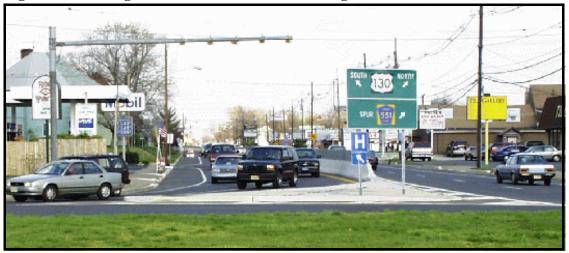
Figure 4: Looking at southbound US 130 entering the East Circle

lights that warn motorists of the circle. At the point where US 130 merges into the circle, a concrete island helps to channel the vehicles into the circle. US 130 northbound has two departure lanes that exit the circle. A jersey barrier separates the northbound lanes from the southbound lanes.

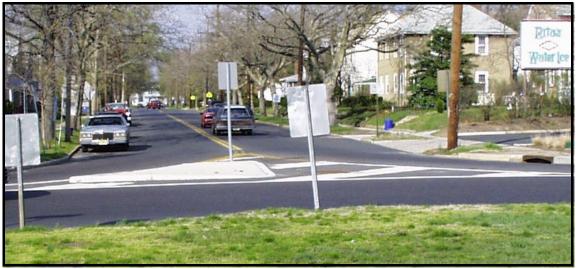
Figure 5: Looking North at Hannevig Ave. from the East Circle

Once a vehicle enters the circle, the next entrance/exit to the circle is Hannevig Avenue. This is a local street that leads into a residential neighborhood. It contains one lane of traffic in each direction (Figure 5). On street parking is also permitted along Hannevig Avenue. At the egress of the circle, there also is a concrete island that directs the traffic into the circle.

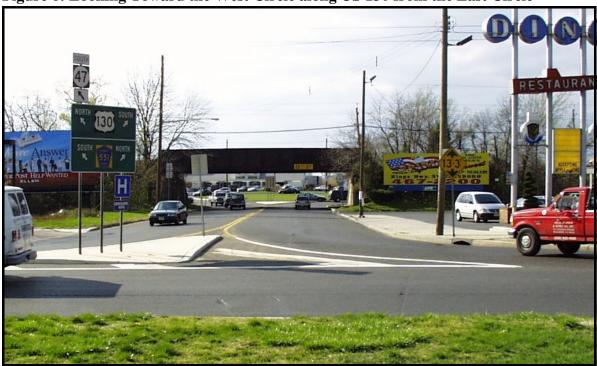
Figure 6: Looking Toward the West Circle along US 130 from the East Circle

US 130 exits the East Traffic Circle and connects to the West Circle by means of a two-lane road, with one lane of travel in each direction (Figure 6). Again, a concrete island is channeling traffic into the circle. This section of US 130 is bridged by the Conrail Railroad. Approximately halfway between the east and the west circles, a Conrail Railroad overpass bisects the roadway. When this study initiated, New Jersey Department of Transportation had the height of the overpass signed at 13' 3", however it has recently been posted to 13' 0".

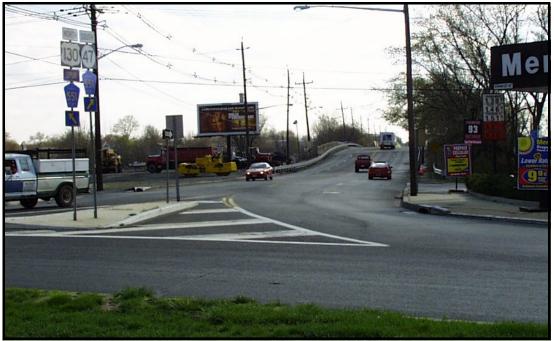
Figure 7: Looking South at NJ 47 from the East Circle

Another leg entering the east circle is NJ 47. This route heads south from the circle and carries two lanes of traffic in each direction. As with the other legs of the circle, a concrete island is placed at the entrance of the circle. As NJ 47 heads south, the road heads up a slight incline toward a bridge over Timber Creek (Figure 7). This section of NJ 47 is impacted by Creek Road, which contains only one travel lane in each direction. Although Creek Road does not directly enter the east traffic circle, it does intersect with NJ 47 just east of the circle (Figure 8). Access to NJ 47 from Creek Road is controlled by a stop sign. Vehicles exiting Creek Road are only able to make right turns as a concrete island prevents any left turns onto NJ 47. The result of making a right turn off of a Creek Road places them in the direction of the circle.

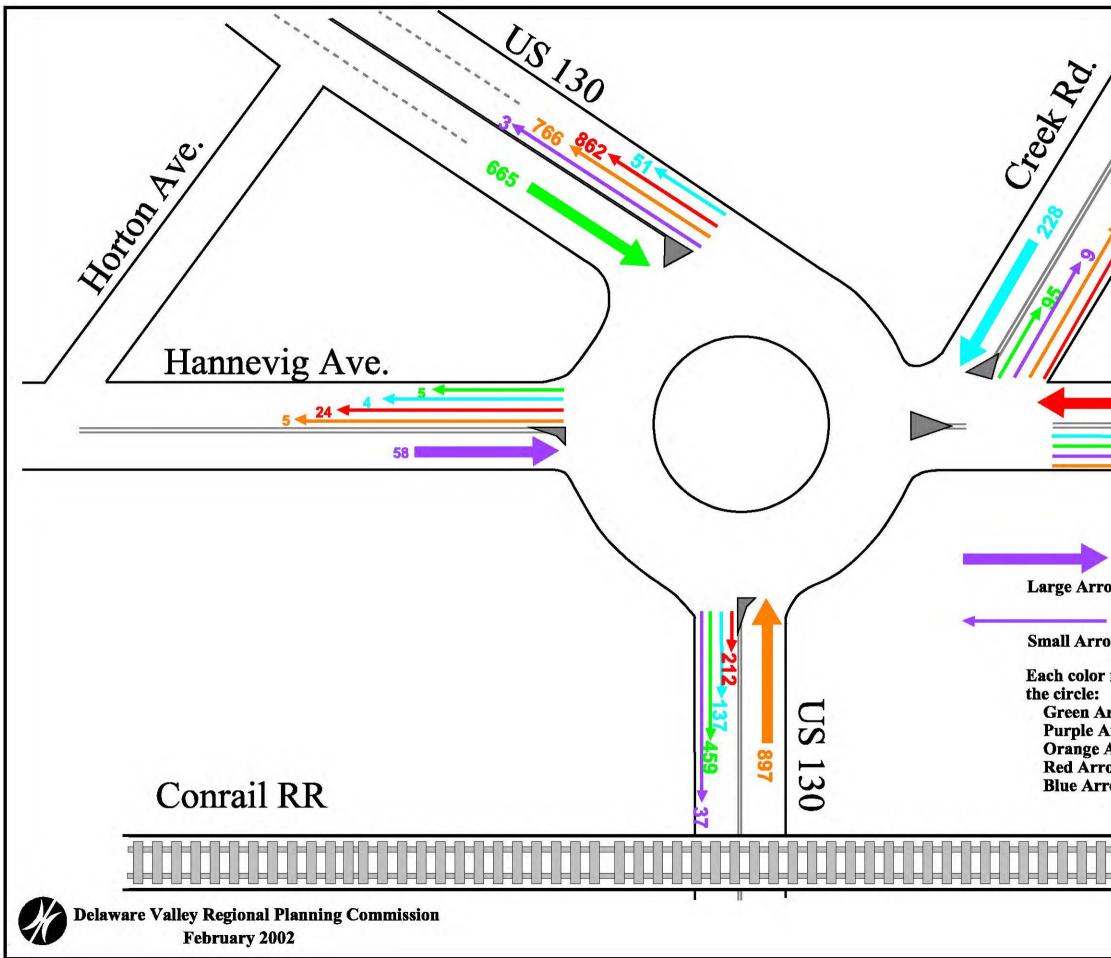
FIGURE	10
Brooklaw	n East Traffic Circle
AM Peak	Turning Movements
(7:00 AM	to 8:00 AM)
2	
211	
11	
/	
NIT 47	
NJ 47	
1,128	
→ 36	▶96
	→ 9 → 63
ow Represents V	olume Into the Circle
•	
ow Represents V	olume Out of the Circle
relates back to t	he original entry point into
rrows - From rrows - From	US 130 SB Hannevig Avenue
Arows - From	US 130 NB
ows - From ows - From	
	SCHEMATIC
	NOT TO SCALE

Turning movement counts for the AM and PM peak period were also collected at the East Traffic Circle in March 2000 and are presented in Figures 10 and 11. Vehicle classification counts were also taken at two locations at the same time as the traffic counts. Along Creek Road between the East Traffic Circle and Old Salem Road, 89% of the vehicles were automobiles while the remaining 11% were trucks. Similar results occurred along New Broadway between the West Traffic Circle and Towne Center Square where 93% of the vehicles were automobiles and the remaining 7% were trucks.

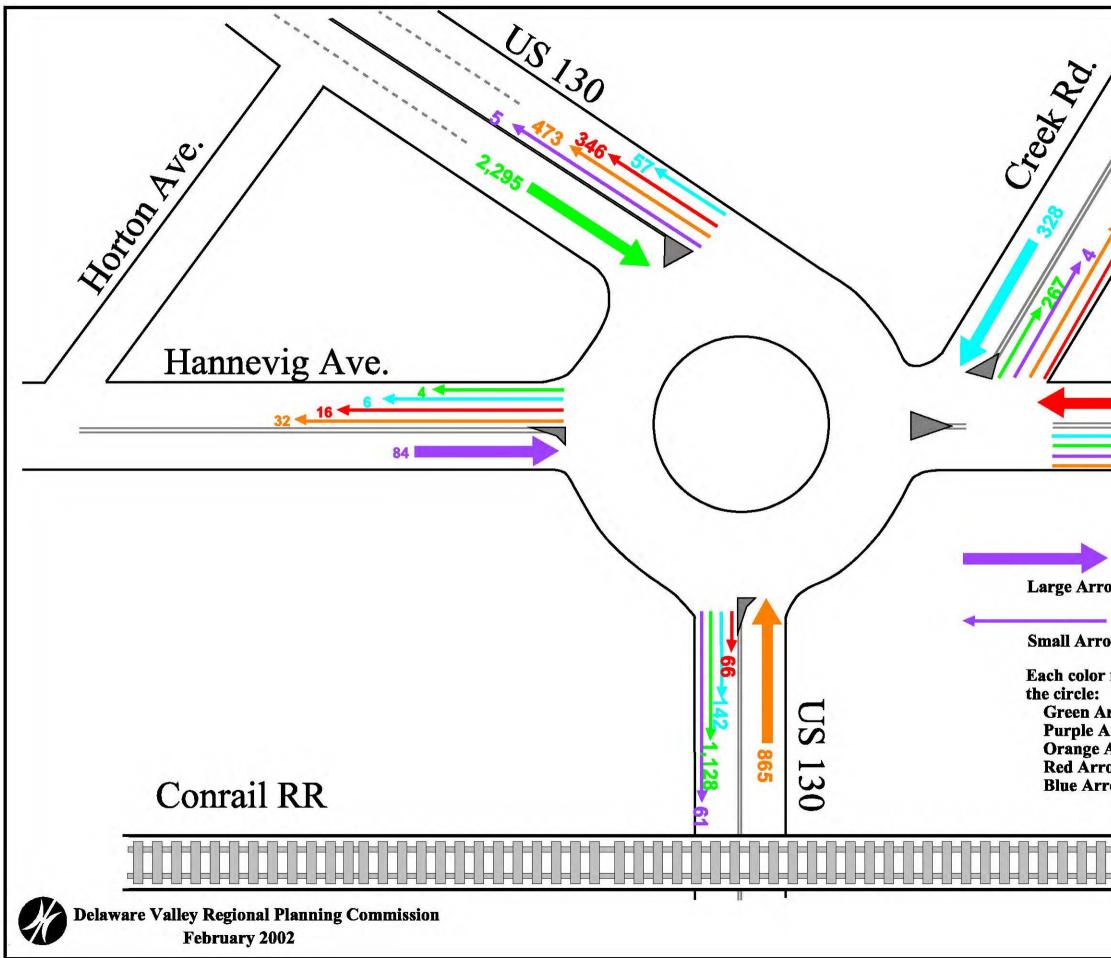
FIGURE 11
Brooklawn East Traffic Circle
PM Peak Turning Movements
(5:00 PM to 6:00 PM)
2
1
<b>%</b>
NJ 47
510
510
123 ▶896 ▶14 ▶070
ow Represents Volume Into the Circle
w Represents Volume Out of the Circle
relates back to the original entry point into
rrows - From US 130 SB
rrows - From Hannevig Avenue
Arows - From US 130 NB ows - From NJ 47
ows - From Creek Road
SCHEMATIC NOT TO SCAL

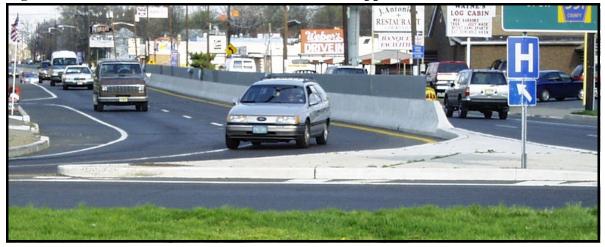
Figure 15: Concrete Island at Southbound US 130 Approach to the East Circle

The third type of accident is a vehicle striking a concrete island that channels the vehicles into the circle. The location for these accidents occurs along southbound on US 130 entering the East Circle (Figure 15). As vehicles approach the circle, they may be moving at a high rate of speed and are unable to make the right turn into the circle. During this three-year period 73 accidents (21.9%) are related to striking this island. It should be noted that of these 73 accidents, 62 (84.9%) of them occurred while the road conditions were wet.

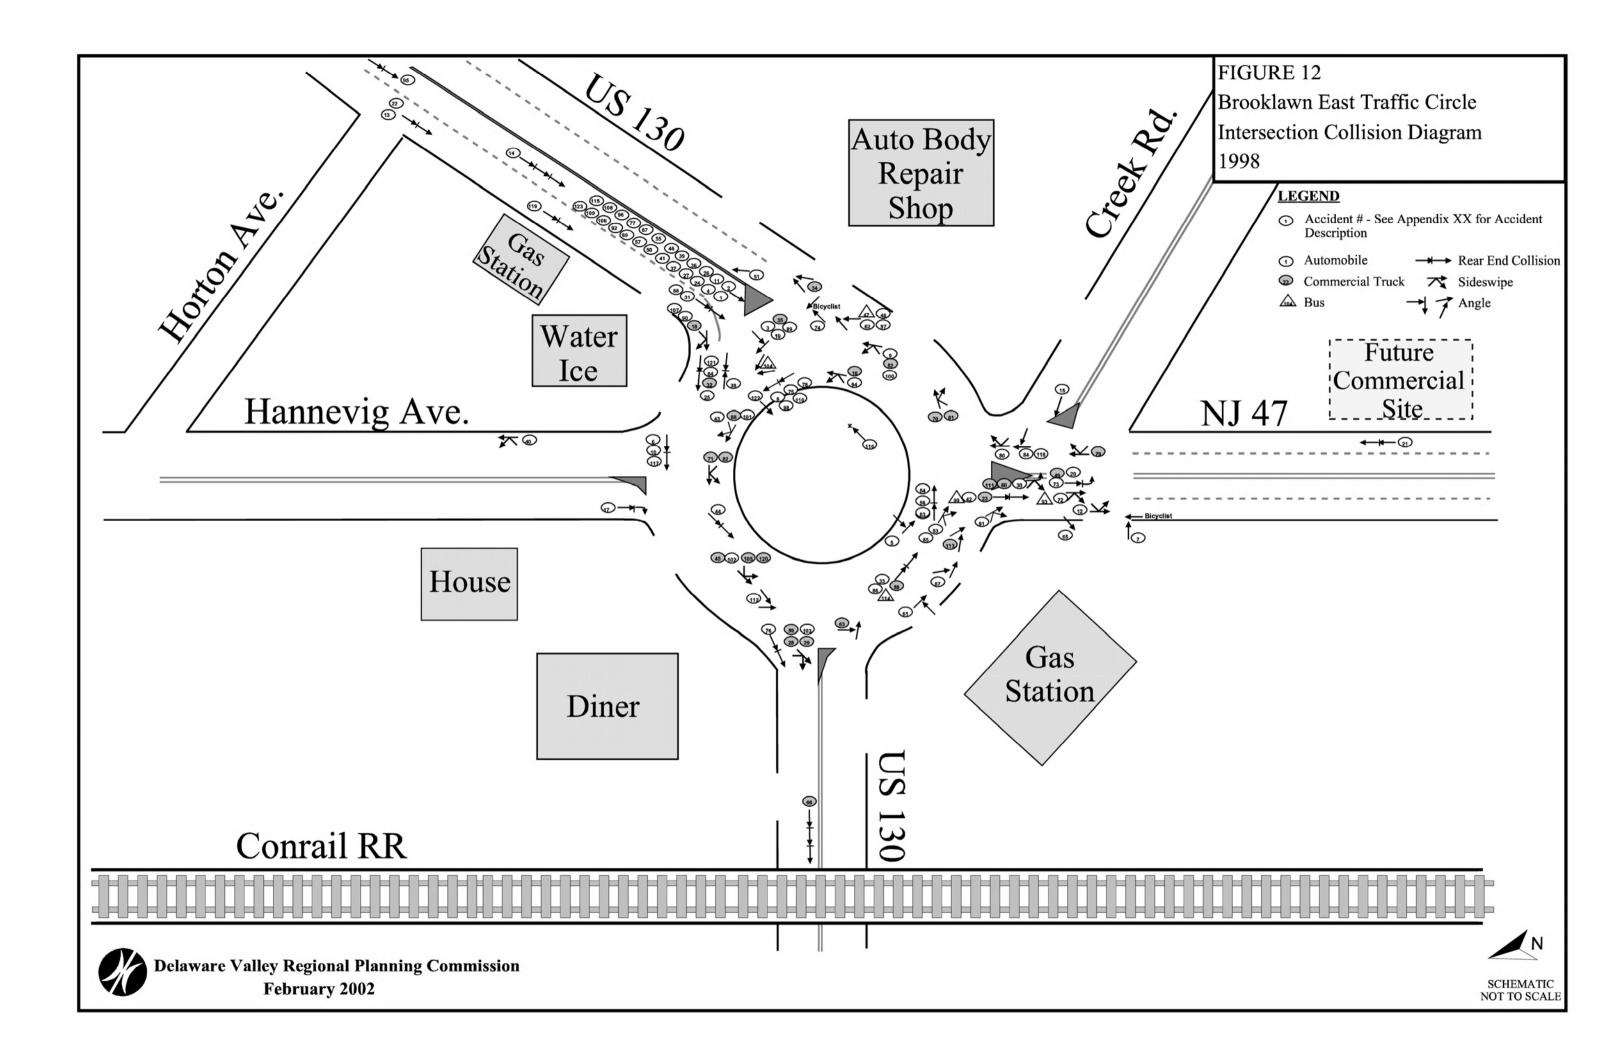
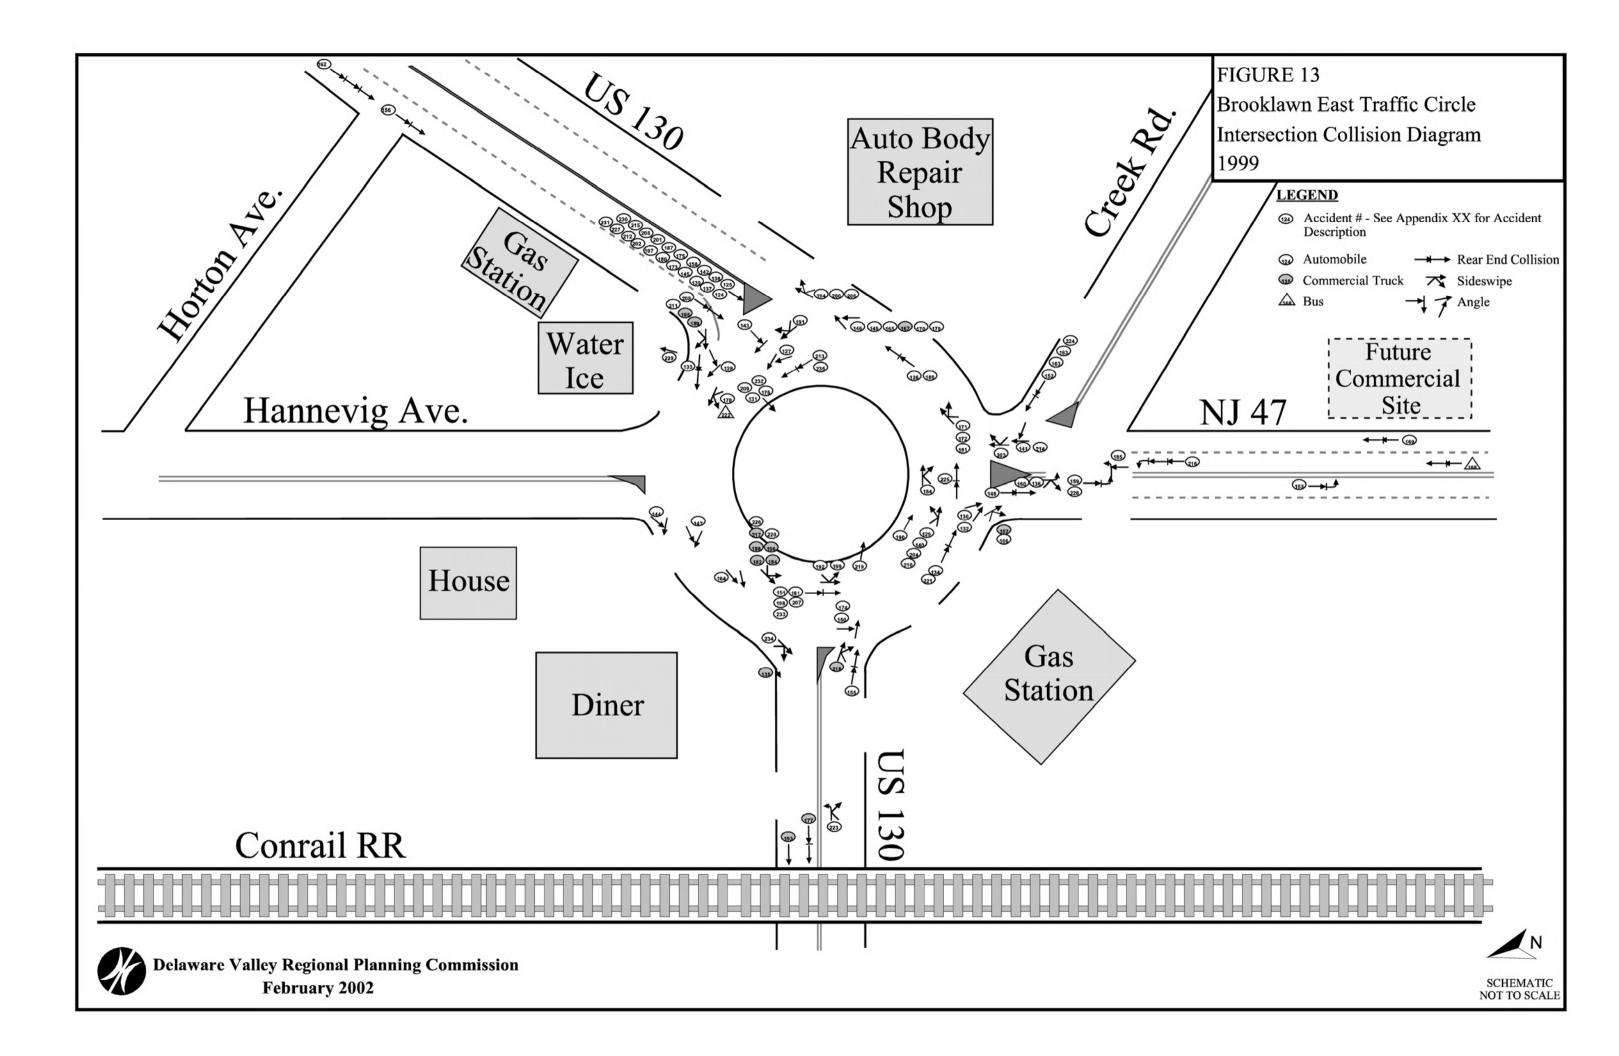
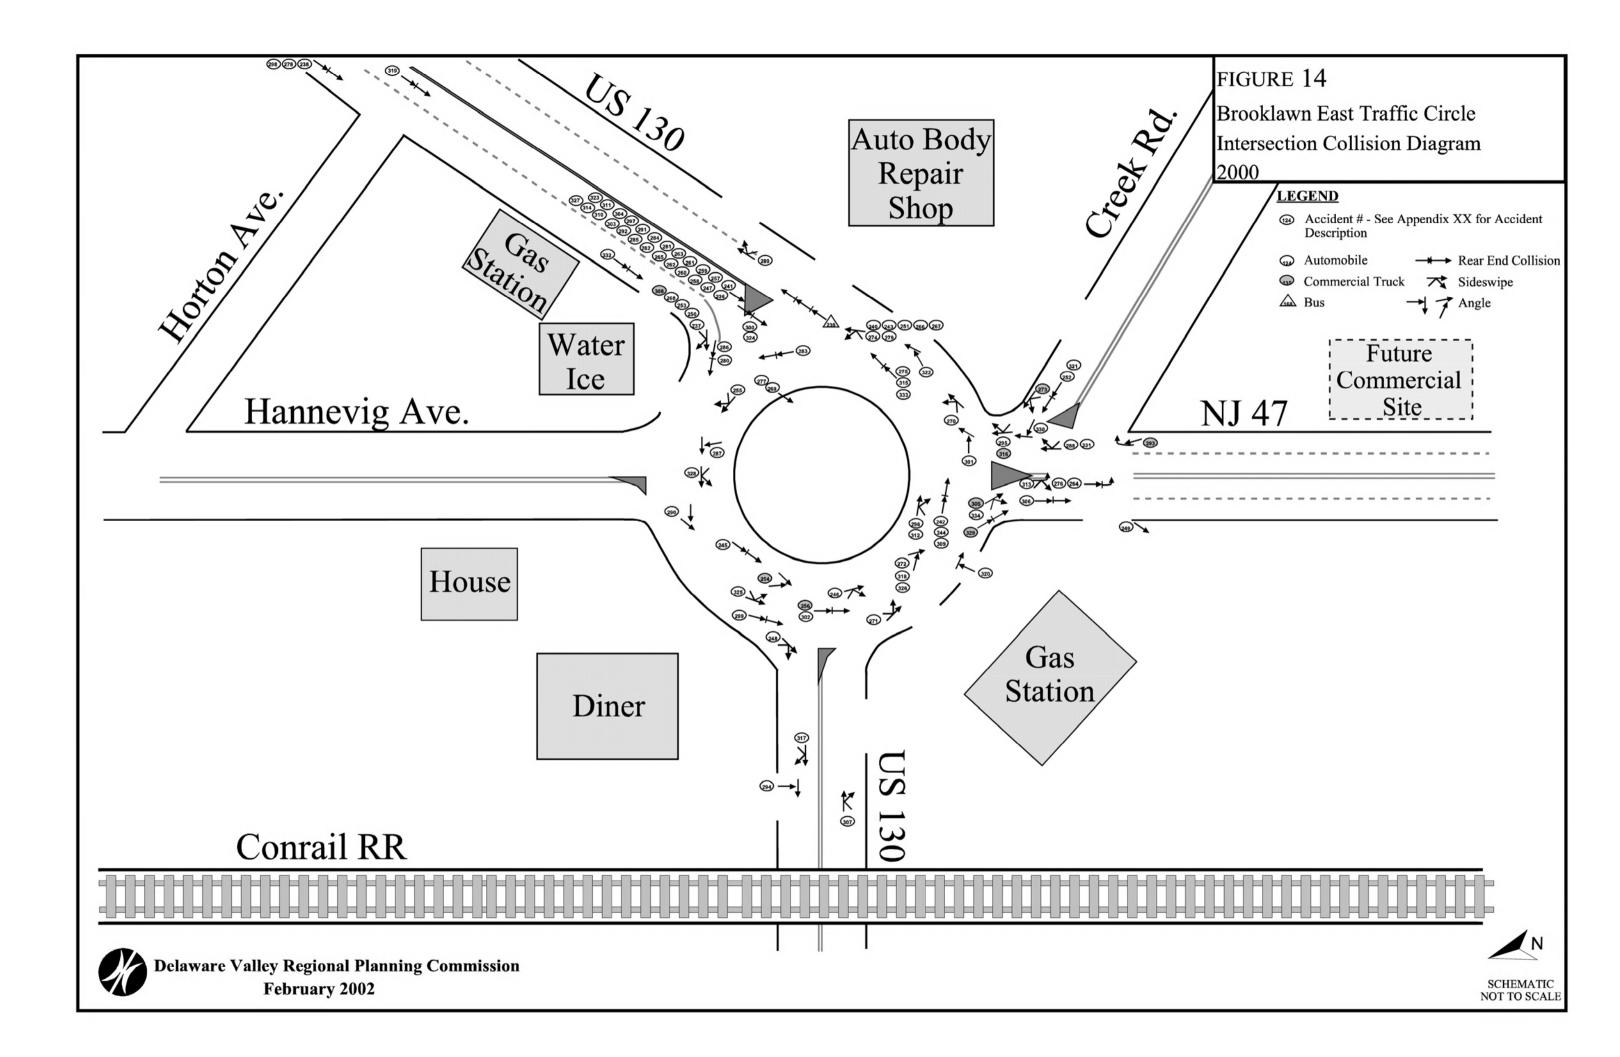
At the East Traffic Circle, 334 accidents occurred during this period. Figures 12, 13, and 14 display each of the accidents on a collision diagrams for the years 1998, 1999, and 2000 respectively. (Refer to APPENDIX B for a description of each individual accident). Most of the accidents occurred during daylight hours. Approximately 47% of the accidents are associated with wet or icy road conditions. Automobiles were the most common vehicles involved in accidents within the East Circle with 81% of all accidents. Approximately 15% of the incidents involved commercial trucks, while the remaining 4% of the incidents involved either buses, motorcycles or bicycles.

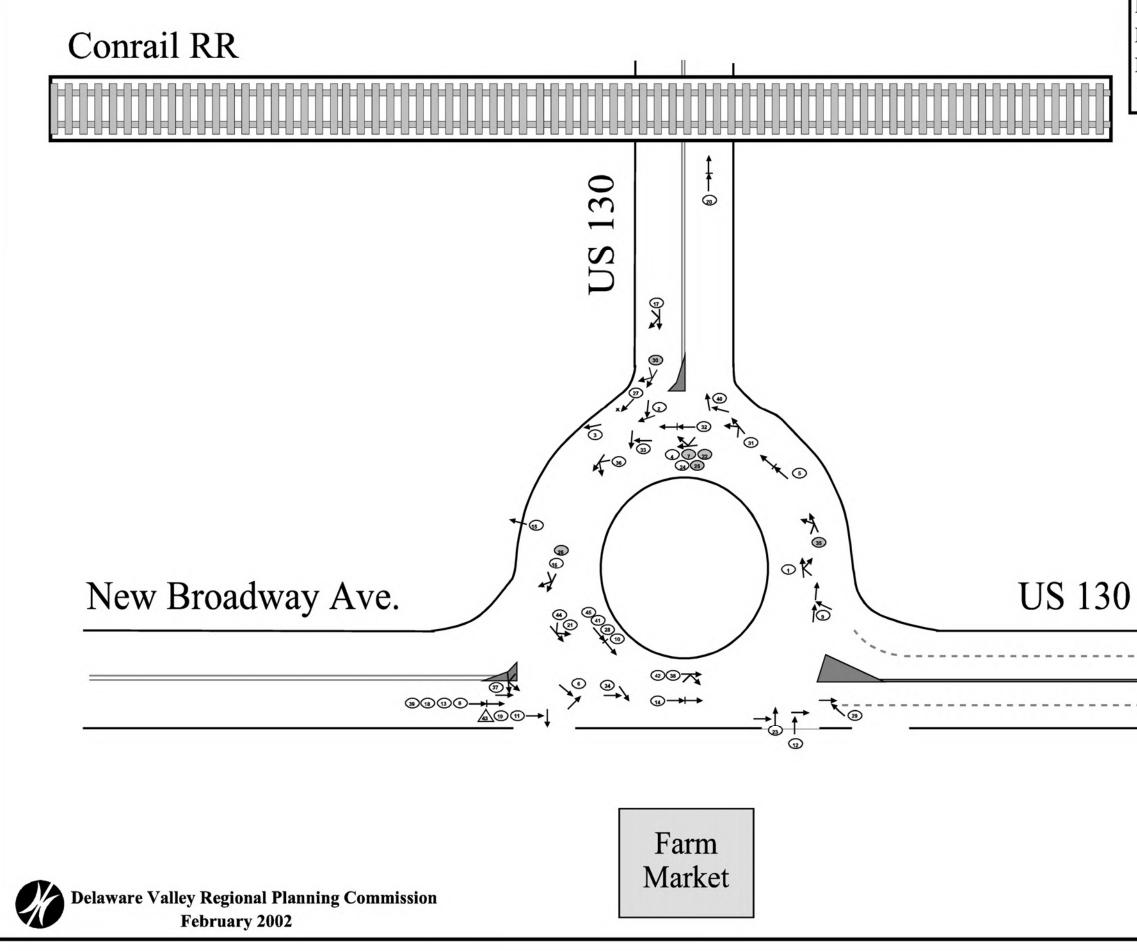
# FIGURE 16 Brooklawn West Traffic Circle Intersection Collision Diagram 1998 - 1999 - 2000 LEGEND Accident # - See Appendix XX for Accident Description Automobile → Rear End Collision Commercial Truck Sideswipe A Bus → 7 Angle N SCHEMATIC NOT TO SCALE

Accidents along the West Traffic Circle mostly happen during the day with more than 38% of the accidents occurred in the evening peak hours of 4 - 7 p.m., and approximately 13% of the accidents happened in the morning peak hours of 6 - 9 a.m. Nineteen of the forty-five accidents occurred when the road conditions were wet or icy.

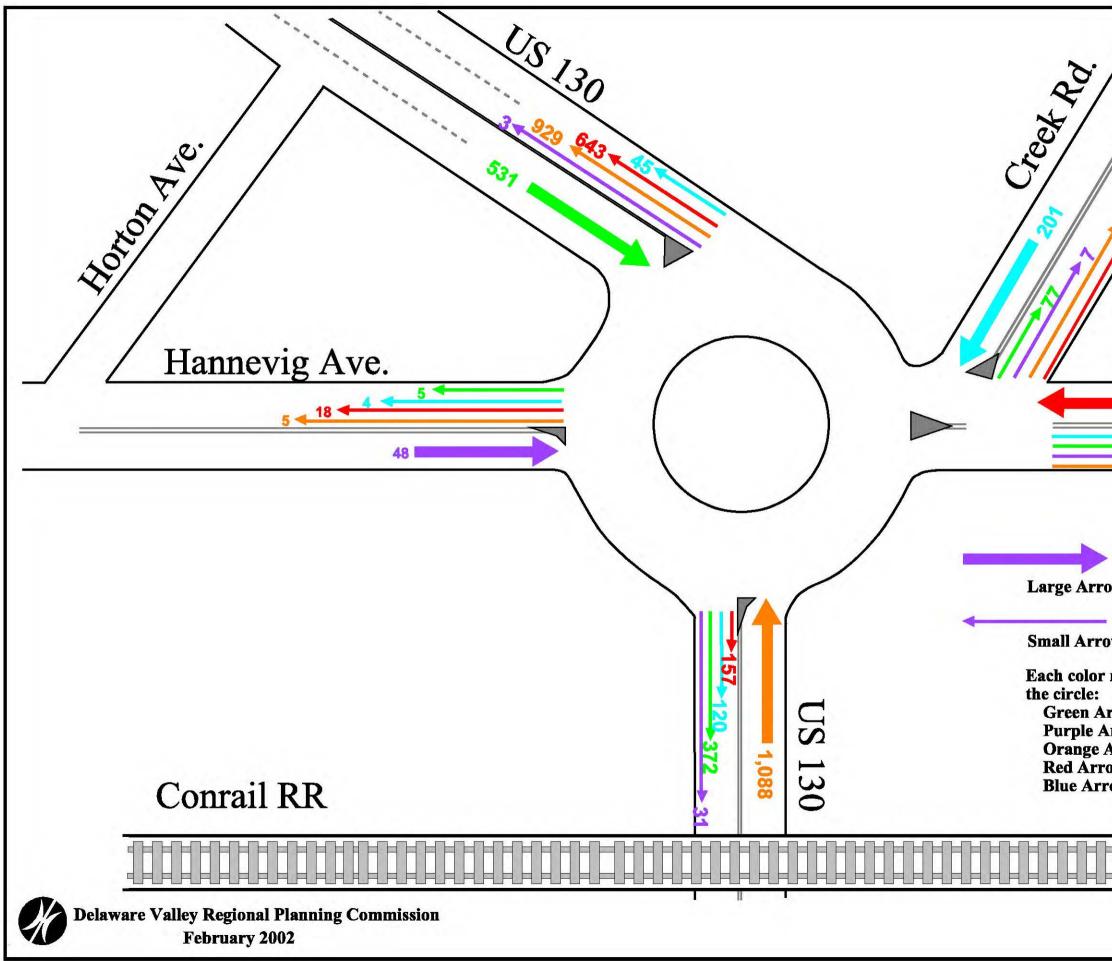
FIGURE 17	
Brooklawn East Traffic Cir	cle
2025 AM Peak Turning Mo	ovements
(7:00 AM to 8:00 AM)	
N	
11	
NJ 47	
INJ 47	
915	
32 77 . 7	
ow Represents Volume Into the Circ	le
ow Represents Volume Out of the Cir	rcle
relates back to the original entry po	int into
rrows - From US 130 SB	
rrows - From Hannevig Avenue	
Arows - From US 130 NB ows - From NJ 47	
ows - From Creek Road	
	SCHEMATIC NOT TO SCALE

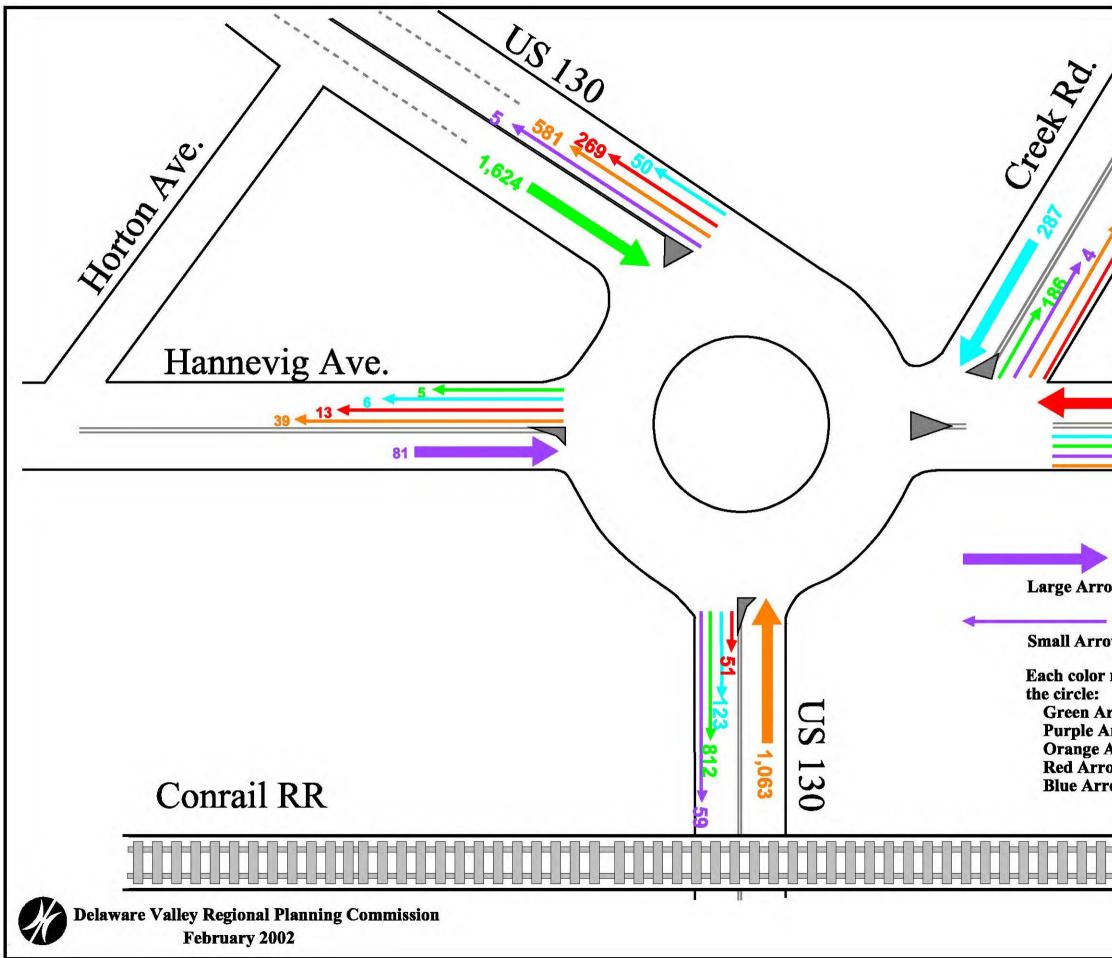
FIGURE 18
/	Brooklawn East Traffic Circle
/	2025 PM Peak Turning Movements
	(5:00 PM to 6:00 PM)
/	2
6	<b>/</b> /
11	
/	
N	JJ 47
1	NJ 4 /
	397
	108 621 12
	341
8	
ow I	Represents Volume Into the Circle
w F	Represents Volume Out of the Circle
rela	ates back to the original entry point into
rrov	ws - From US 130 SB
	ws - From Hannevig Avenue ws - From US 130 NB
	- From NJ 47
ows	- From Creek Road
	SCHEMATIC NOT TO SCALE

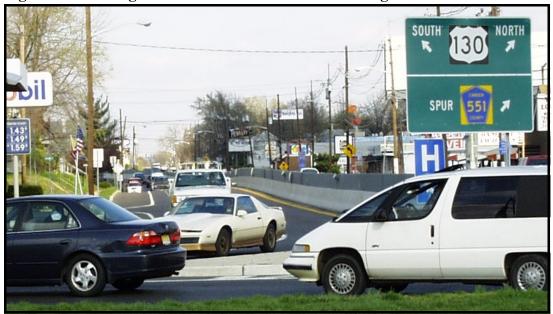
# Figure 20: Looking at US 130 Southbound Traffic Merge into the East Circle

Traffic accidents in the Circles, primarily in the East Circle, were a significant concern of the borough representatives. The accident analyses presented in an earlier section of this report support that concern as they document the reoccurrence of specific accident patterns. Severe peak period congestion, especially in the PM peak, was also identified as a problem. This congestion has an impact on the accidents at this location since a significant number of accidents are rear-end type accidents. This type of accident is frequently associated with congested conditions. Some of the congestion in this vicinity (Figure 20) can be linked to a decrease in speeds which results from several factors such as; the reduction in capacity from three travel lanes to two on the southbound US 130 approach to the East Circle, the merging and weaving movements through the circles and the availability of only one lane in each direction between the two circles.

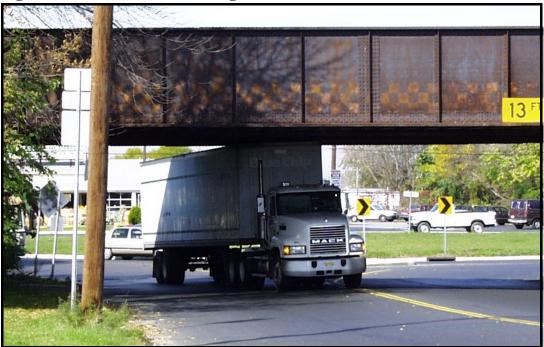
Figure 21: Conrail Railroad Bridge Between the East and West Circles

trucks that pass through the circles (Figure 21). It is not uncommon for trucks to get stuck under or hit the overpass. Some trucks, although eventually able to pass under the railroad bridge, stop

as they approach. The drivers get out of their vehicles, step into the roadway and visually observe how much clearance the truck has under the bridge. This backs-up traffic behind the truck and creates a safety problem as the driver walks around in the roadway.

While undertaking this project, mention should also be made of the Conrail railroad bridge which spans across Route 130 between the circles. Its present condition is a detriment to the truck traffic patterns in the area. The height restriction is 13 ft. 3 in., which is 3 inches short of the minimum 13 ft. 6 in. required for safe clearance. The Gloucester City Master Plan points out this deficiency, and observes that addressing it will benefit the truck routes through the area. If this inadequacy could also be addressed, it would be a major improvement.

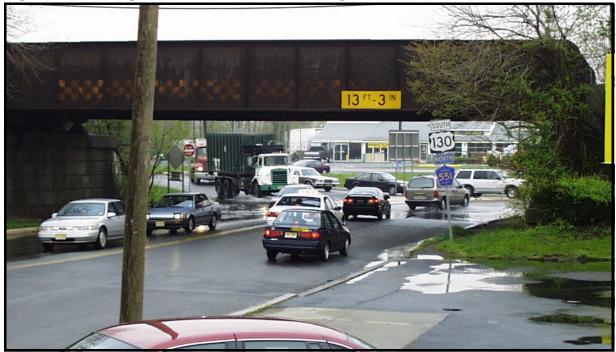
Figure 22: Looking Toward the West Circle along US 130 from the East Circle

Chronic flooding problems under the railroad overpass were also mentioned as an important concern (Figure 22). However the representatives of the borough felt that the frequency and severity of flooding in the vicinity of the circles has decreased since the installation of a tide flex valve in the drainage system.

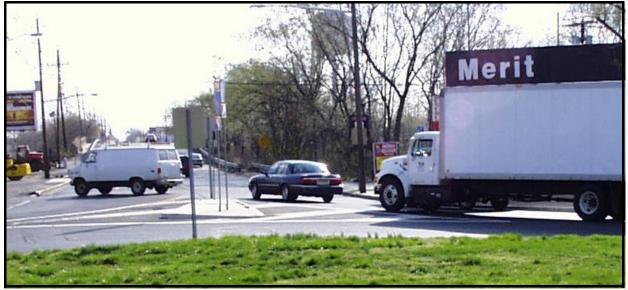
Figure 23: Vehicles Turning from the East Circle onto Creek Road

The primary issue effecting the Borough of Bellmawr is the access to Creek Road from the East Circle (Figures 23 and 24). This is a particularly difficult and dangerous movement. Traffic must exit the circle by bearing right onto RT 47 and make an immediate left turn onto Creek Road. What makes this movement so difficult is the weaving movement from the circle onto RT 47 and then to Creek Road compounded by the fact that there is no dedicated left turn lane and there is no stacking room for vehicles to queue up for the left turn. As indicated by the accident analysis, a number of rear end and sideswipe accidents took place at this location.

Congestion is the other primary problem identified for the East Circle. There are two key locations where geometrics and traffic flow create critical conflict points and result in congested conditions. The most problematic location is in the vicinity of Creek Road. The problems stem from the movement which takes traffic from the circle across NJ 47 and onto Creek Road. This movement requires vehicles to exit the circle by making a right turn into the left lane of southbound NJ 47 and an immediate left turn onto Creek Road. NJ 47 carries two travel lanes in each direction at this location. There is no left turn stacking lane to accommodate movements to Creek Road.

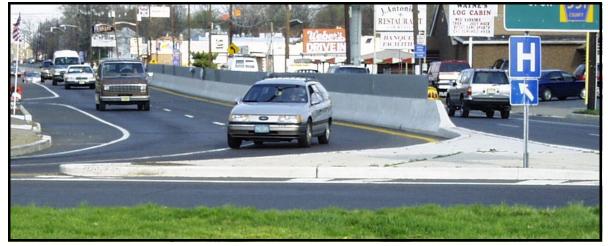
# Figure 25: Looking at Concrete Island at US 130 at the East Circle

A short term recommendation that is expected to improve safety in the circles and vicinity is the installation of additional signing and markings. The most common accident pattern is vehicles striking the concrete island on the southbound US 130 approach to the East Circle (Figure 25). It is recommended that flexible object markers called flexiposts be installed on the approach to the circle and the concrete island to increase its visibility and direct traffic into the circle. These are four inch wide flexible strips approximately four feet high. They should be placed approximately 10 feet apart from the end of the island to the Jersey barrier. This spacing will not obstruct any views of on- coming traffic in the circle.

with flashers should be installed on US 130 near Haakon Avenue. This should be a cantilever sign over the roadway with 8 inch flashers that reads "Circle Ahead 1200 ft". This structure should be supplemented with a sign over the right lane that reads "Lane Ends Merge Right 300 Feet". In addition to these signs, epoxy rumble strips should be installed laterally across the roadway on southbound US 130. These advance warning signs and rumble strips will alert motorists of the changing conditions ahead and prepare them to take appropriate actions.

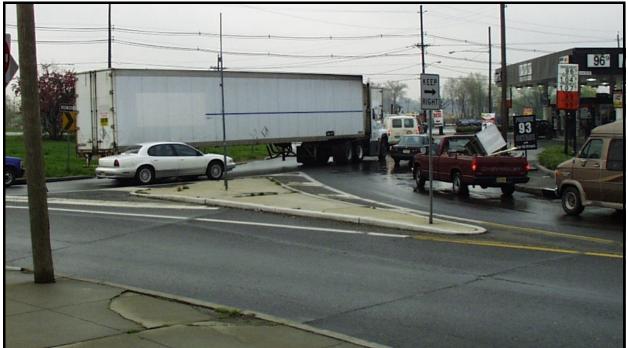
Figure 28: Looking at US 130 Northbound Traffic Merge into the East Circle

A significant contributing factor to accidents in the East Circle is related to the weaving movements and positioning of vehicles as they proceed around the circle (Figure 28). This is evidenced by the number of side swipe, angle and rear end accidents documented in the circle. Observations of traffic operations within the circle makes it clear that motorists are unsure about where to position their vehicles within the circle. NJ DOT should investigate the possibility of providing dashed lane lines around the circle to assist in designating the proper positioning for vehicles in the circle.

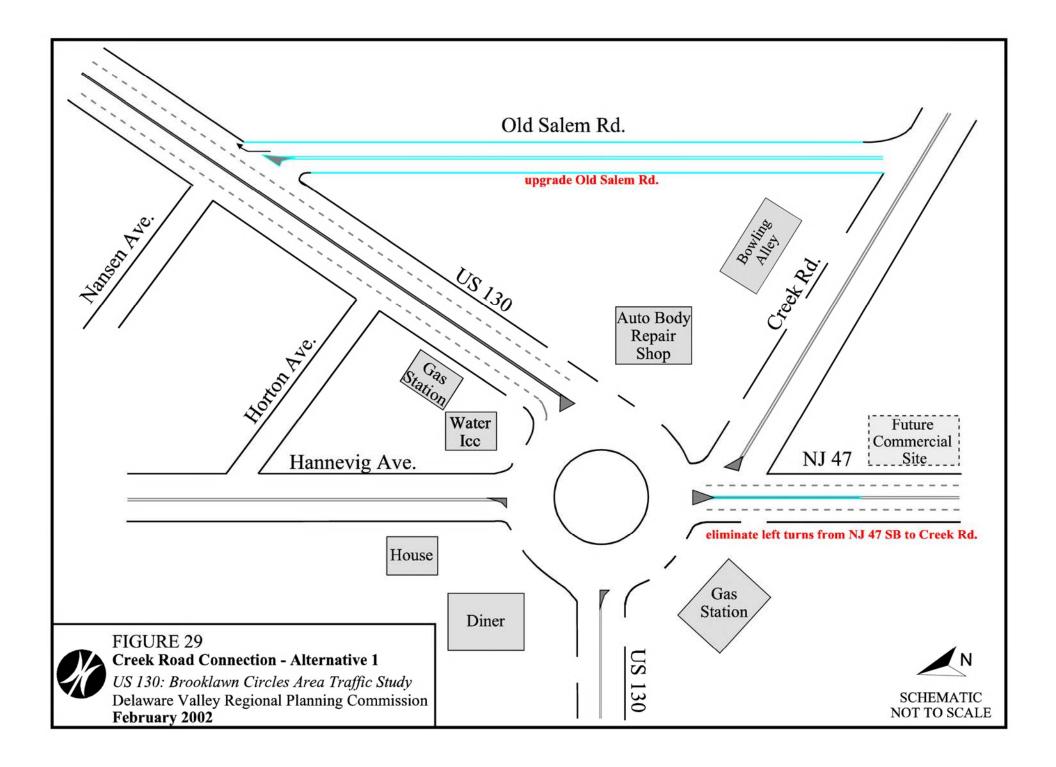
**Alternative 1** - Under this alternative, (Figure 29) left turns from southbound NJ 47 to Creek Road (167 existing AM Peak vehicles, 351 existing PM Peak vehicles) would be eliminated by installing a median barrier along NJ 47 from the East Circle to a point south of Creek Road. Traffic from the East Circle destined to Creek Road would proceed around the circle to US 130 northbound and turn right onto an improved Old Salem Road (Figure 30). This alternative proposes to upgrade Old Salem Road. Parts of the Old Salem Road right of way currently function as a roadway while other sections appear to have been incorporated into a parking lot (Figures 31 and 32). However, this potential connection should be looked at in more depth. This roadway intersects Creek Road approximately 700 feet south of its current intersection with NJ 47/East Circle. It also currently provides access to US 130 northbound approximately 700 feet north of the East Circle next to the miniature golf course. This movement would require additional signing to

direct motorists through the maneuvers. Traffic from Creek Road to US 130 northbound would not be required to go through the circle (51 existing AM Peak vehicles, 57 existing PM Peak vehicles). Right turn traffic from Creek Road into the circle and destined to Hannevig Avenue, US 130 southbound or NJ 47 would continue to be permitted.

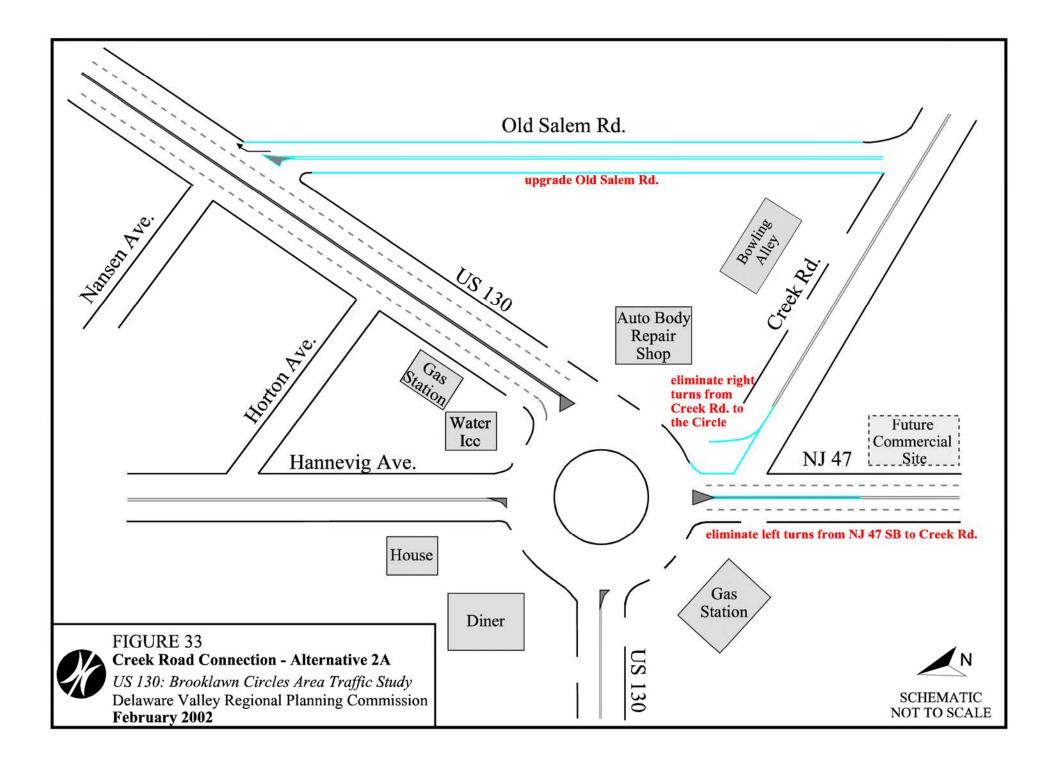
**Alternative 2A** - Under this alternative, (Figure 33) left turns from southbound NJ 47 to Creek Road would continue to be eliminated by a new median barrier along NJ 47. Right turns from Creek Road into the circle would also be eliminated by closing off the Creek Road approach to the circle. Right turns from northbound NJ 47 to Creek Road would continue to be permitted. Traffic from the East Circle destined to Creek Road would proceed around the circle to US 130 northbound and turn right onto an improved Old Salem Road. Traffic from Creek Road destined to Hannevig Avenue, US 130 southbound or NJ 47 would be required to use the upgraded Salem Road to US 130 northbound then make a U-turn at the Kings Highway jughandle to proceed southbound on US 130. This accounts for 77% of the AM Peak westbound Creek Road traffic (177 vehicles) and 83% of the PM Peak westbound Creek Road traffic (271 vehicles).

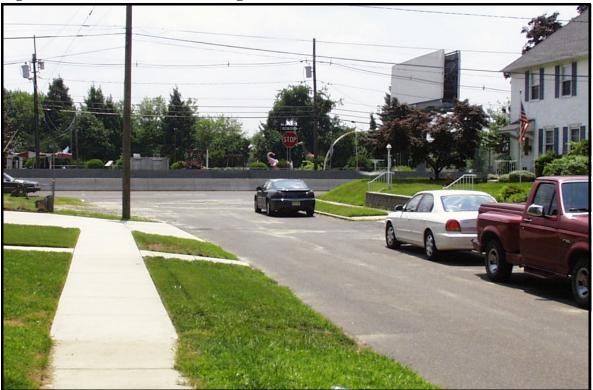
Figure 35: Nansen Avenue Looking South Toward US 130

**Alternative 2B** - As in the previous alternative, left turns from southbound NJ 47 to Creek Road would continue to be eliminated by a new median barrier along NJ 47, right turns from Creek Road into the circle would also be eliminated by closing off the Creek Road approach to the circle and right turns from northbound NJ 47 to Creek Road would continue to be permitted (Figure 34). Traffic between Creek Road and US 130 would use an improved Old Salem Road. However, a median break and traffic signal on US 130 at Old Salem Road/Nansen Avenue would permit access from Creek Road/Old Salem Road to US 130 southbound. A concrete island on Nansen Avenue would permit right turns in and right turns out from/to US 130 southbound while preventing through traffic from Old Salem Road into Nansen Avenue (Figure 35).

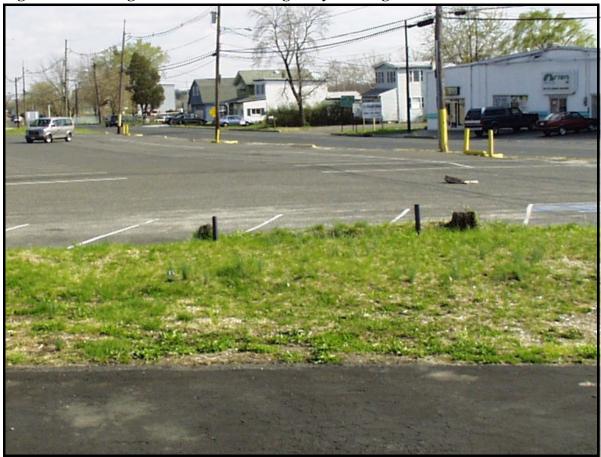
Figure 39: Looking South Across Bowling Alley Parking Lot Toward Creek Road

**Alternative 3** - proposes to relocate the Creek Road intersection to the north so that it intersects directly into the East Circle and not onto NJ 47 (Figure 38). This would eliminate the left turns from the East Circle onto Creek Road by converting that movement into a right turn. The area that would be needed for the approach road and a newly created intersection between Creek Road and the East Circle is currently used as a parking area for a bowling alley (Figures 39 and 40)

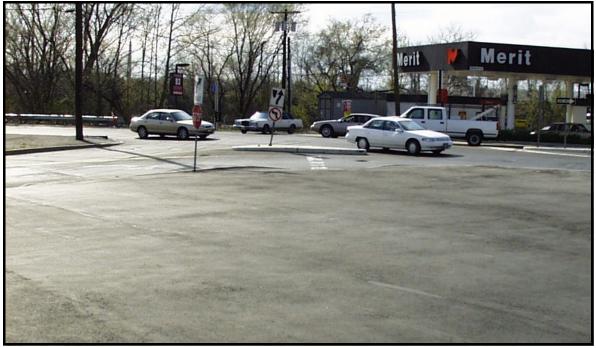
# Figure 41: Looking at the Creek Road / NJ 47 Intersection with the Body Shop Parking Lot in the Foreground

and a parking area for the auto body repair shop (Figures 41 and 42) located along the circle. A potential problem for this alternative is that it creates a new access point onto the circle and could create a weaving problem because of its proximity to NJ 47. However, metering of the NJ 47 northbound traffic into the circle may reduce much of these weaving movements. Under this alternative, Old Salem Road would not be improved. This alternative would provide the shortest access from the circle to the potential future commercial site.
