Trolley Crashes in Philadelphia and Delaware County

February 2013

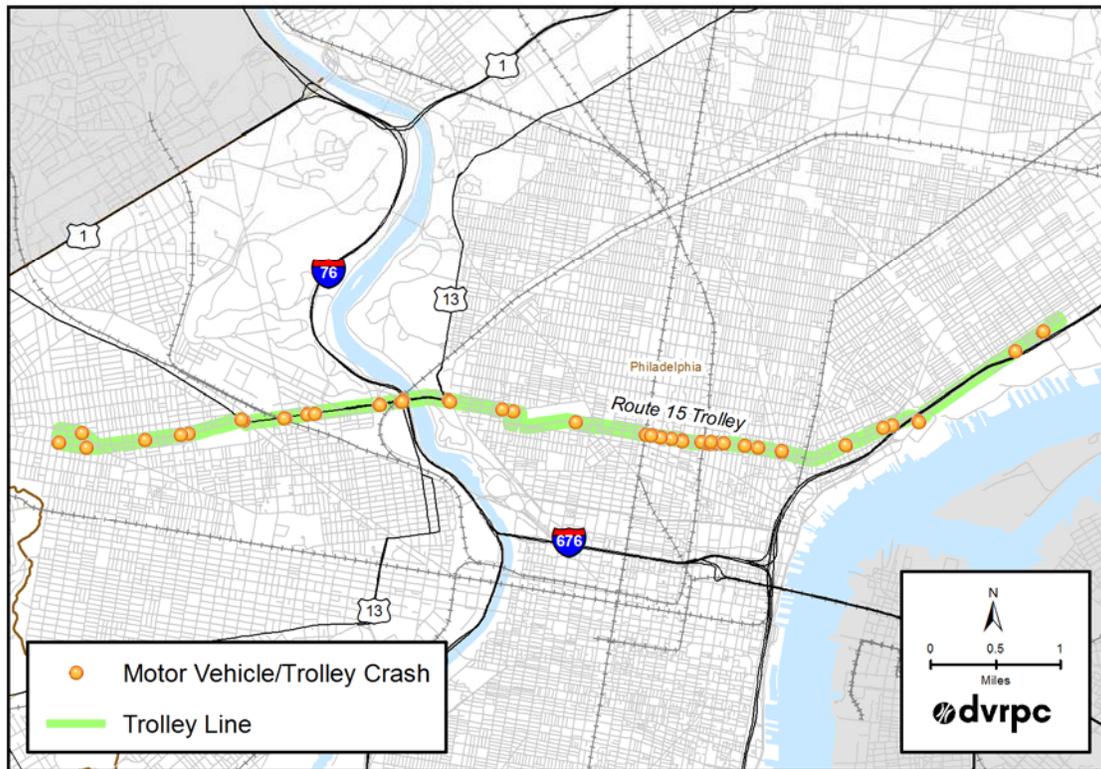
Figure 2: Route 15 Trolley Crashes

During the study period, 39 crashes occurred involving the Route 15 Trolley, the highest number of crashes of the routes studied (**Figure 2**). This is the only line operating in North Philadelphia and the only urban trolley not using the underground main line under Center City. The line runs primarily on Girard Avenue, a major east–west thoroughfare, and is widely known as the Girard Avenue Trolley.

This trolley connects North and West Philadelphia over the Schuylkill River between 33rd and 34th streets. Girard Avenue cycles between two- and four-lane configurations along the route. West of the Schuylkill River, the road is either two lanes (both shared with trolleys) with bike lanes, or two or four lanes with trolleys in a dedicated median that may be exclusive or may be used for left turns or through traffic, depending on location. On-street parking is prevalent throughout. Girard Avenue is two-ways for its entire length, and where there is a median, the left turn lane is shared with the trolley right-of-way. The Route 15 Trolley operates 24 hours a day at 10–15-minute headways during the

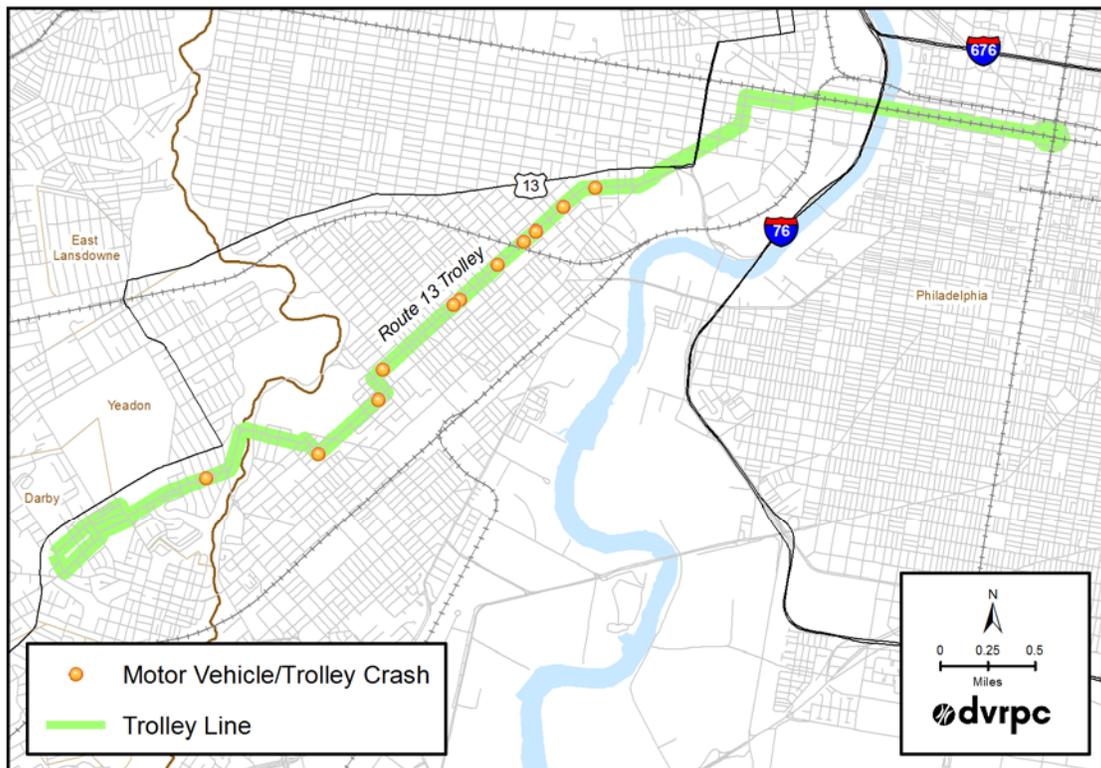
Figure 5: Route 13 Trolley Crashes

During the study period, the Route 13 Trolley was involved in 15 crashes (**Figure 5**). It begins underground in Center City, runs above ground in Southwest Philadelphia, and terminates in Darby, Delaware County. Roads used include Chester Avenue, Kingsessing Avenue, and 65th Street. The route runs primarily through residential areas, with on-street parking available intermittently throughout. All roads traversed are two lanes with the exception of a brief portion in Darby, where the line splits in order to use one-way roads. Along with the other trolley lines that run underground through Center City, the Route 13 Trolley makes connections with numerous buses, the MFL, the BSL, SEPTA Regional Rail, and other trolley lines. Ridership on the Route 13 Trolley is the highest among the trolley lines, with 16,700 passengers daily and about five million passengers annually, running 24 hours a day with 3–10-minute headways and up to 36 minutes overnight.

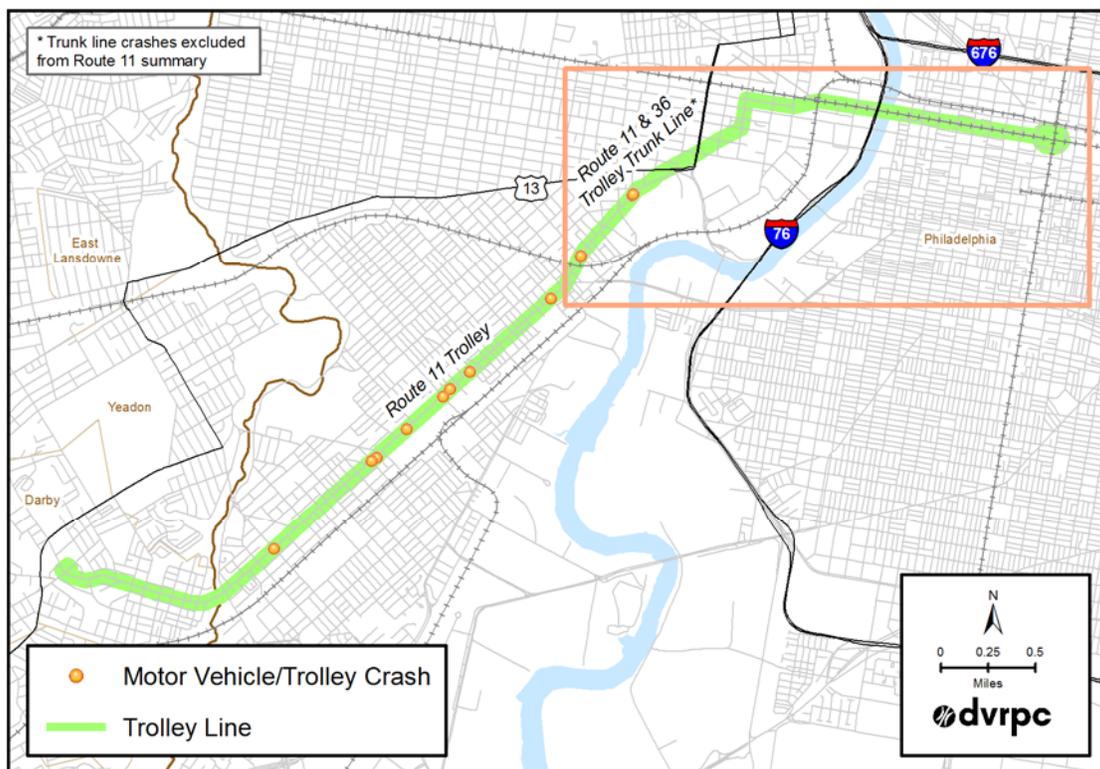
Figure 6: Route 11 Trolley Crashes

The Route 11 Trolley was involved in eight crashes during the study period (**Figure 6**). The line follows Woodland Avenue in Southwest Philadelphia to Darby, in Delaware County. Woodland Avenue is an important corridor in Southwest Philadelphia, with one lane per direction, on-street parking along its entire length, and a bike lane on either side. Easy connections can be made from the line's leg in Center City to many transit lines, including buses, the MFL, the BSL, SEPTA Regional Rail, and other trolley lines. The Route 11 Trolley also meets with the Route 13 Trolley at the Darby Terminal in Delaware County. It operates from 5:00 AM to 2:00 AM, with headways of 5–10 minutes during the day and 15–20 minutes at night.

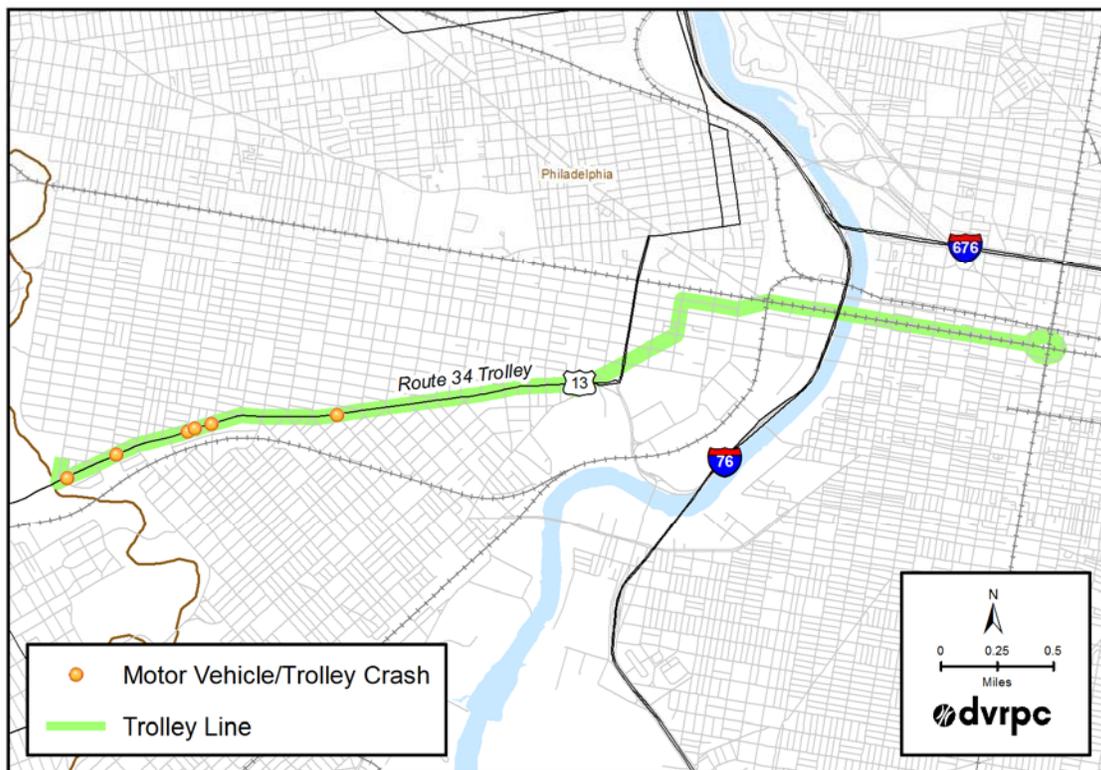
Figure 7: Route 34 Trolley Crashes

Trolleys on Route 34 were involved in six crashes during the study period (**Figure 7**). This line stretches from Center City, where it runs underground, and along Baltimore Avenue to the neighborhood of Angora, where it terminates just before Philadelphia's border with Delaware County. For the entire length of the trolley line, Baltimore Avenue is a two-lane, two-way street with frequent lights and on-street parking. Along with the other trolley lines that run underground through Center City, the Route 34 Trolley makes connections with numerous buses, the MFL, the BSL, SEPTA Regional Rail, and other trolley lines. Nineteen vehicles operate on the Route 34 Trolley, carrying upwards of 15,000 passengers a day and about four million passengers annually. The service runs from 5:30 AM to 1:45 AM and operates at headways of 3–10 minutes during the day and up to 30 minutes at night.

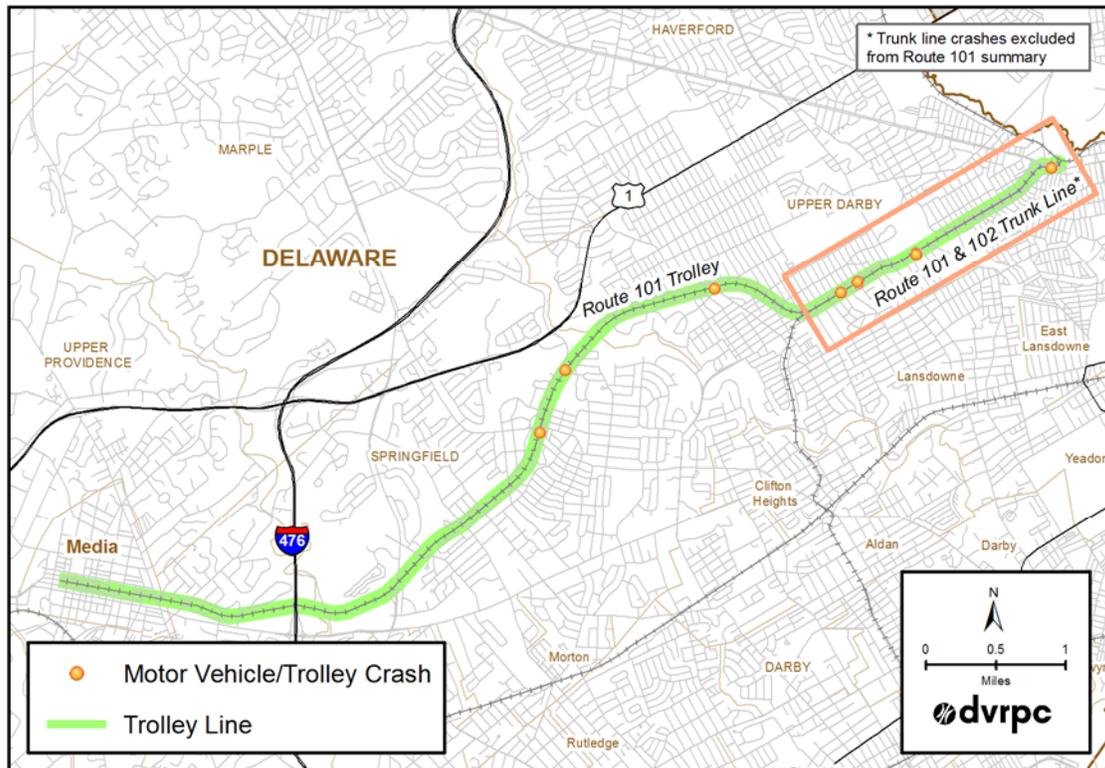
Figure 9: Route 101 Trolley Crashes

The Route 101 Trolley was involved in four crashes (**Figure 9**). The line connects the 69th Street Terminal in Upper Darby to Media, the seat of Delaware County. The entire line runs on the surface; there are no underground portions. Being in a more suburban setting than the other trolleys studied, it largely runs on its own right-of-way. Beginning at 69th Street, it parallels Garrett Avenue until Drexel Hill, while sharing tracks with the similar Route 102 Trolley. After Drexel Hill, the lines split and the Route 101 Trolley makes stops in Springfield, including at the Springfield Mall, before reaching Media. The right-of-way ends when entering Media, where the trolleys run on the local street grid. At 69th Street Terminal, there are connections available to the MFL to Center City and bus connection to the Norristown High Speed Line. Hours of operation are 5:00 AM to 1:30 AM, with headways of 10–20 minutes during the day, and up to 30 minutes at night. Ridership is lower than the more urban trolley lines, with just over 4,000 people daily and over one million annually.
