Delaware Valley
Regional Planning
Commission

JANUARY 2007

PA 896

Road Safety Audit

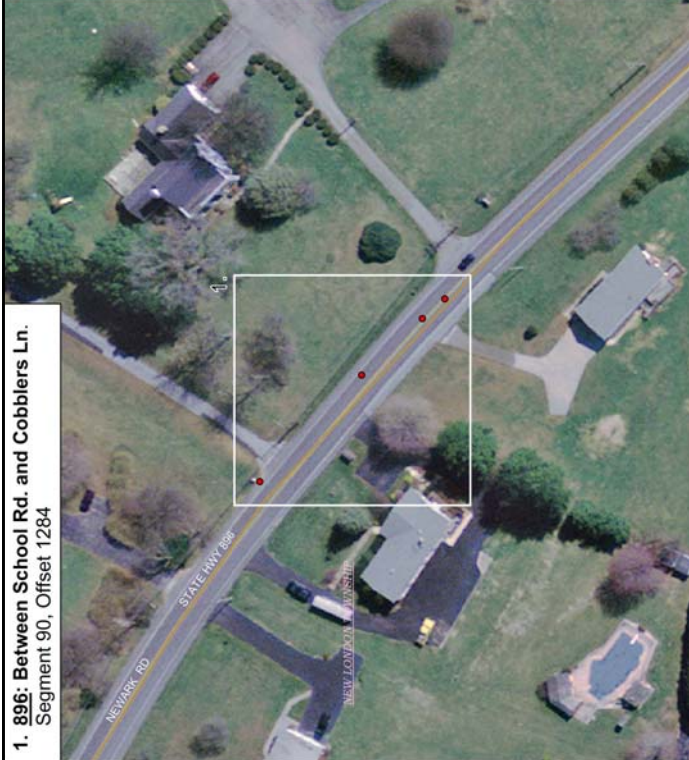
1. 896: Between School Rd. and Cobblers Ln.
Segment 90, Offset 1284

TOTAL CRASHES 4

COLLISION TYPE	
Hit Fix Obj	2
Rear End	1
Unknown	1
ILLUMINATION	
Daylight	2
Dark	1
Other	1
WEATHER	
Clear	3
Unknown	1
SEVERITY COUNT	
Fatalities	0
Injuries	1

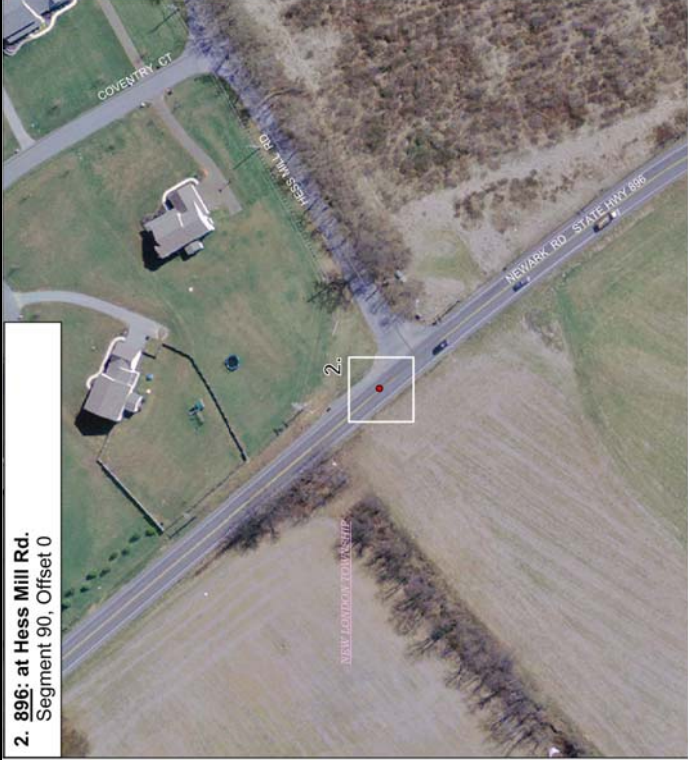
2. 896: at Hess Mill Rd.
Segment 90, Offset 0

TOTAL CRASHES 4

COLLISION TYPE	
Rear End	3
Hit Fix Obj	1
ILLUMINATION	
Daylight	4
WEATHER	
Clear	4
SEVERITY COUNT	
Fatalities	0
Injuries	4

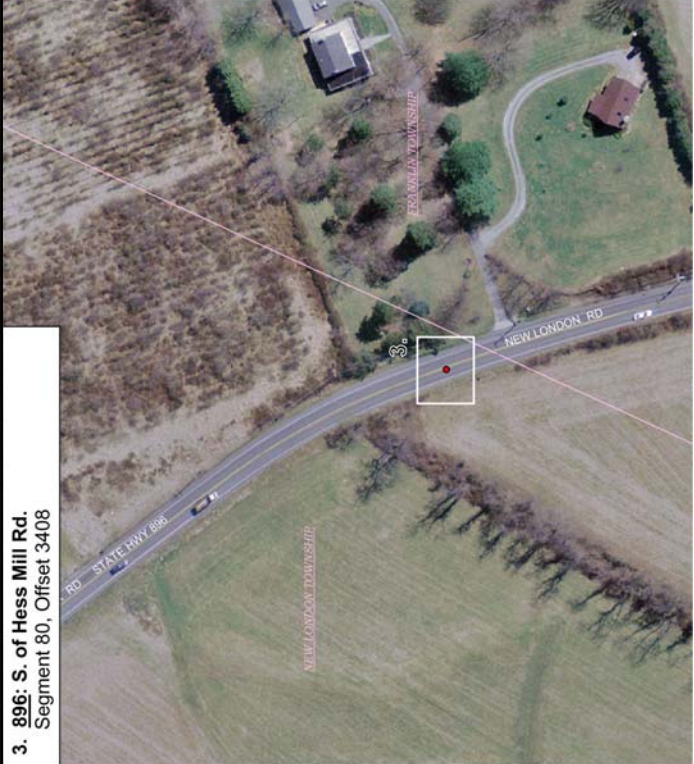
3. 896: S. of Hess Mill Rd.
Segment 80, Offset 3408

TOTAL CRASHES 3	
COLLISION TYPE	
Hit Fix Obj	3
ILLUMINATION	
Dark	2
Daylight	1
WEATHER	
Clear	1
Rain	1
Snow	1
SEVERITY COUNT	
Fatalities	0
Injuries	3

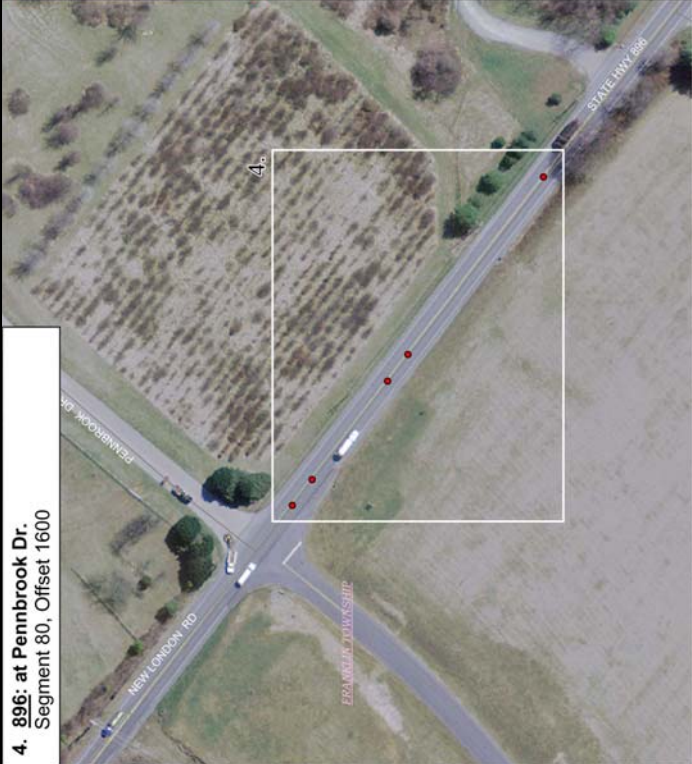
4. 896: at Pennbrook Dr.
Segment 80, Offset 1600

TOTAL CRASHES 5	
COLLISION TYPE	
Hit Fix Obj	4
Angle	1
ILLUMINATION	
Dark	3
Street Lights	2
WEATHER	
Clear	3
Rain	2
SEVERITY COUNT	
Fatalities	0
Injuries	3

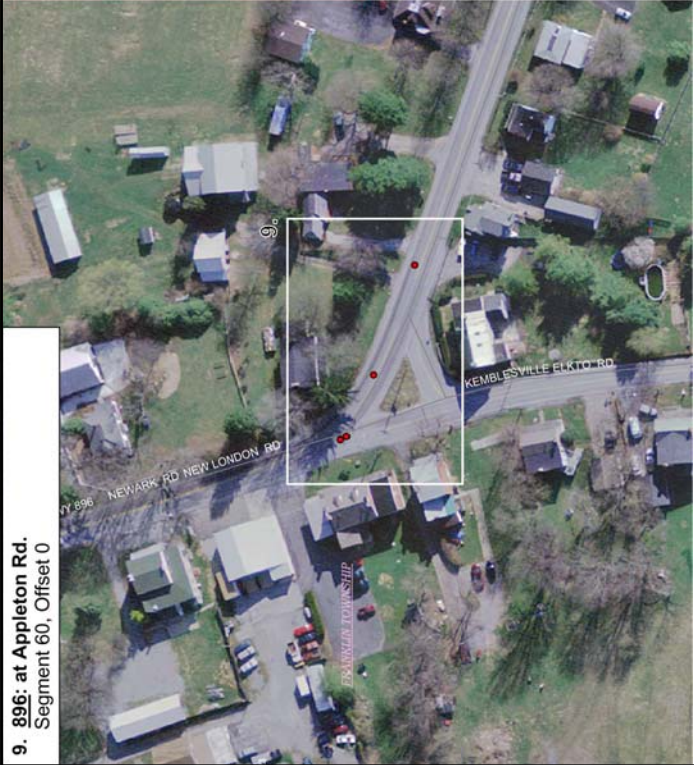
9. 896: at Appleton Rd.
Segment 60, Offset 0

TOTAL CRASHES	16
COLLISION TYPE	
Angle	7
Hit Fixed Obj	4
Head On	3
Opposite Dir Sideswipe	1
Rear End	1
ILLUMINATION	
Daylight	9
Street Lights	5
Dark	1
Dawn	1
WEATHER	
Rain	9
Clear	4
Snow	3
SEVERITY COUNT	
Fatalities	0
Injuries	12

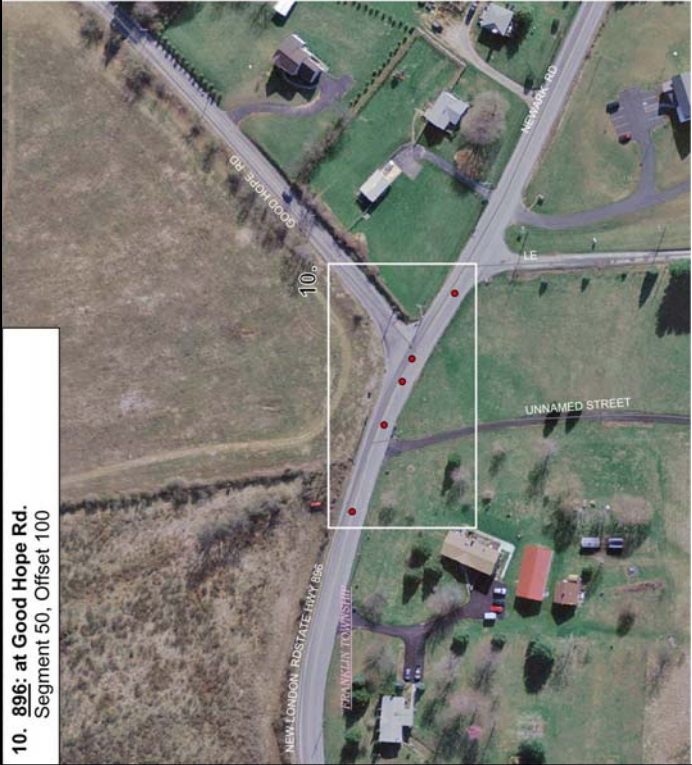
10. 896: at Good Hope Rd.
Segment 50, Offset 100

TOTAL CRASHES	8
COLLISION TYPE	
Hit Fixed Obj	5
Angle	1
Head On	1
Opposite Dir Sideswipe	1
ILLUMINATION	
Daylight	5
Dark	3
WEATHER	
Clear	7
Rain	1
SEVERITY COUNT	
Fatalities	3
Injuries	8

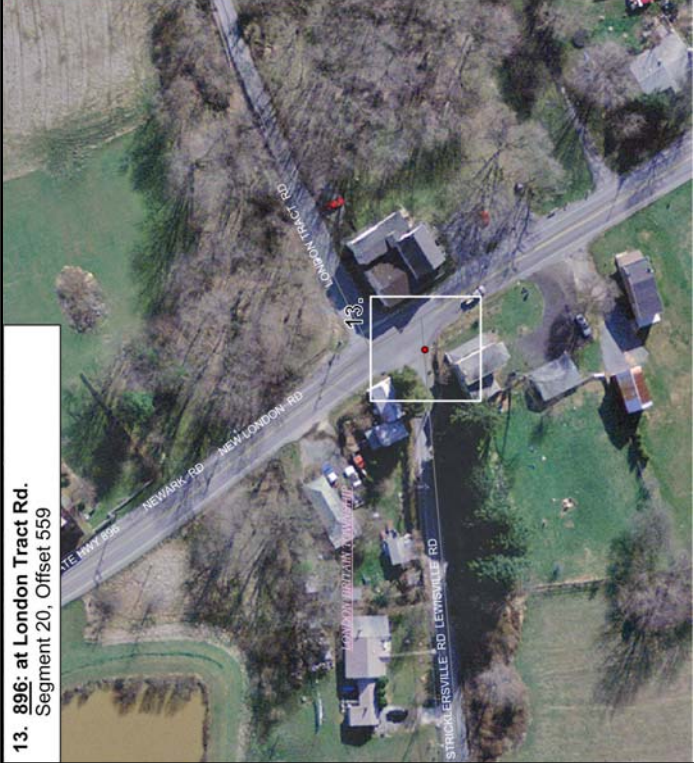
13. 896: at London Tract Rd.
Segment 20, Offset 559

TOTAL CRASHES 5	
COLLISION TYPE	
Angle	2
Hit Fixed Obj	2
Rear End	1
ILLUMINATION	
Dark	2
Daylight	2
Street Lights	1
WEATHER	
Clear	4
Rain	1
SEVERITY COUNT	
Fatalities	0
Injuries	6

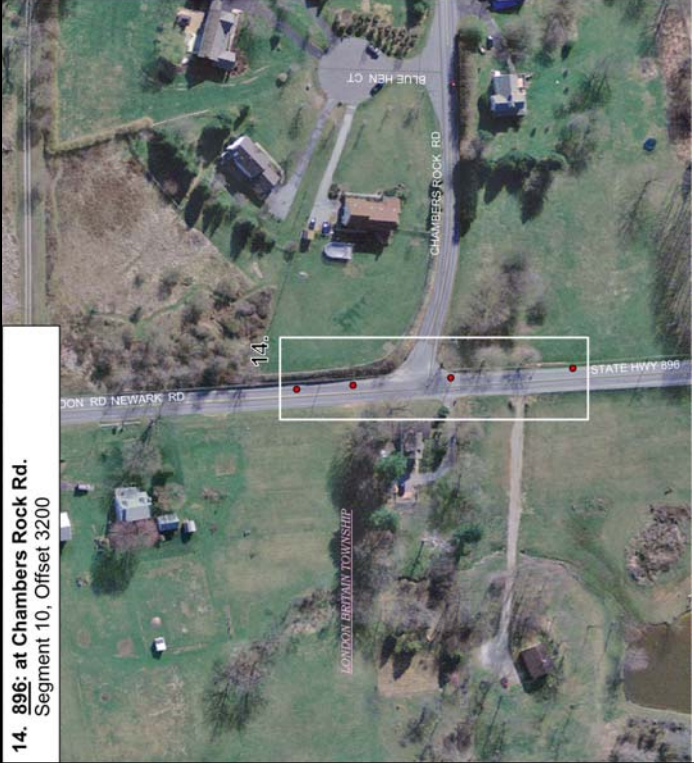
14. 896: at Chambers Rock Rd.
Segment 10, Offset 3200

TOTAL CRASHES 10	
COLLISION TYPE	
Rear End	6
Angle	1
Head On	1
Hit Fixed Obj	1
Opposite Dir Sideswipe	1
ILLUMINATION	
Daylight	6
Dark	4
WEATHER	
Clear	8
Rain	2
SEVERITY COUNT	
Fatalities	0
Injuries	8

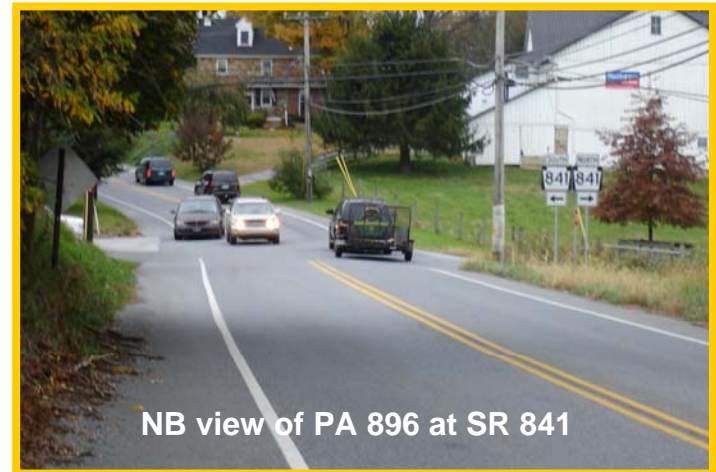
NB view of PA 896 at SR 841

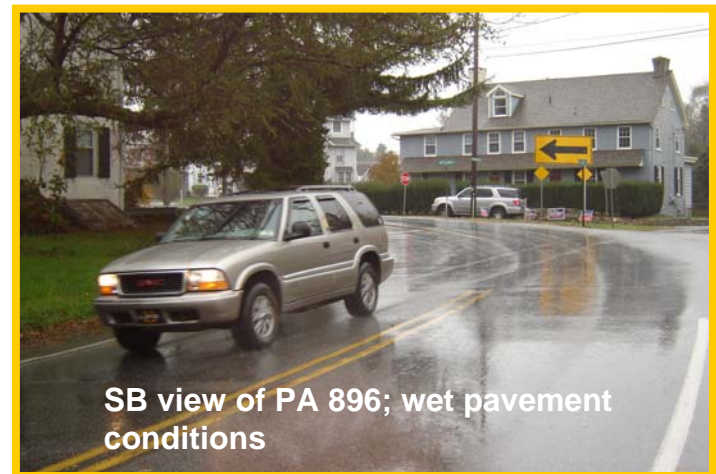
SB view of PA 896; wet pavement
conditions

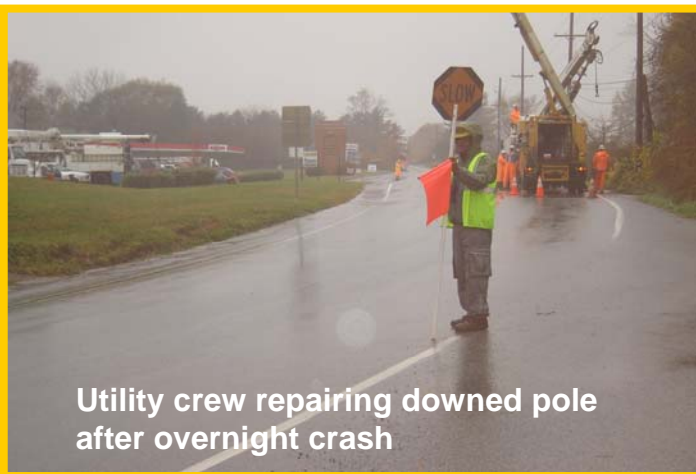
Utility crew repairing downed pole
after overnight crash

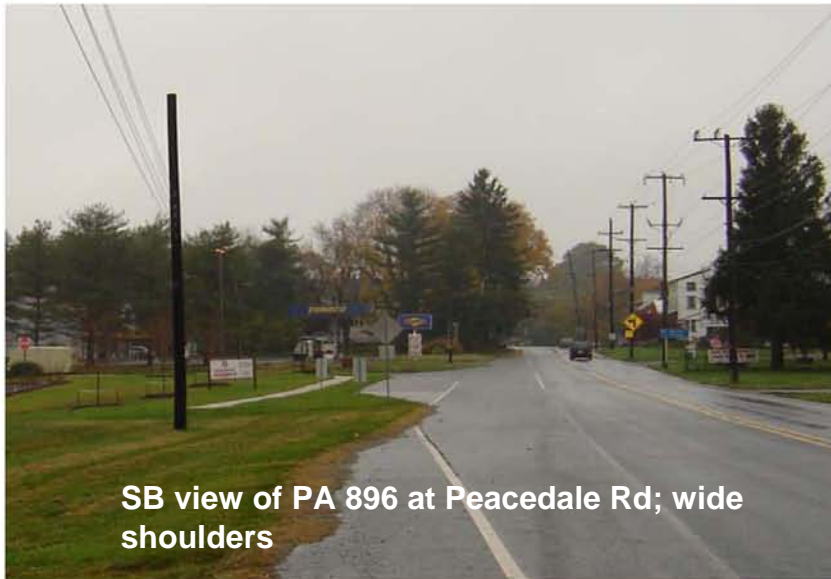
SB view of PA 896 at Peacedale Rd; wide shoulders
