# I-95 Road Safety and Operations Audit (RSOA)

## DELAWARE COUNTY

DECEMBER 2011

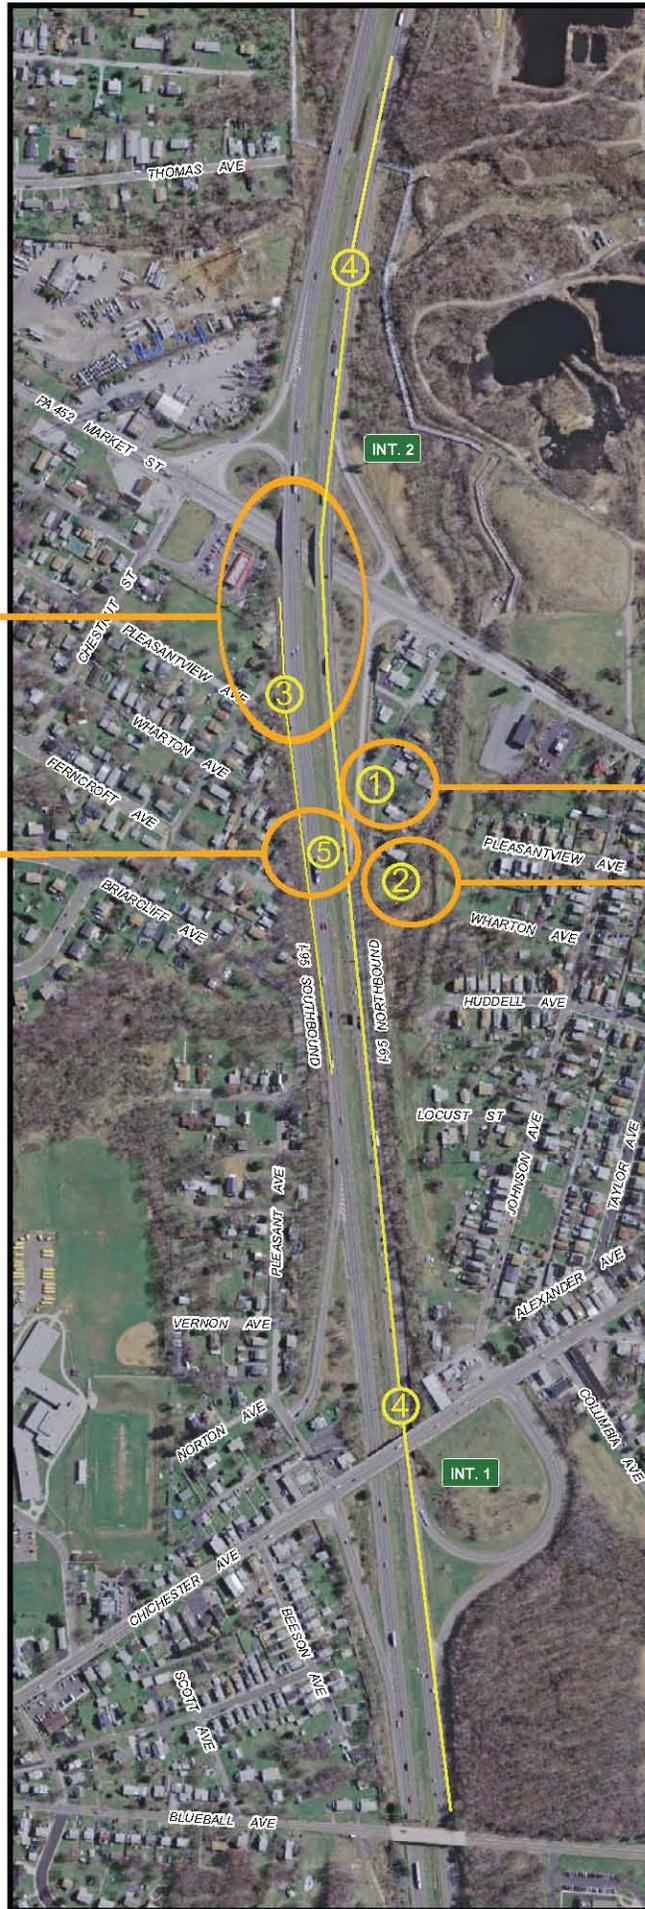
**Table 2: Panel 2 (interchanges 1 and 2)**

Cable barrier repaired  
 Completed Post-Audit 2010

Exit 2 sign replaced  
 Completed Post-Audit 2010

Site-Specific Issue	Potential Strategy	Difficulty to Implement	Estimated Safety Benefit	Estimated Operational Benefit	Road Owner Response
<p><b>Panel 2</b></p> <ol style="list-style-type: none"> <li>1. Missing exit sign in gore area at Exit 2;</li> <li>2. Vegetation blocking signs on off-ramps of Exit 2;</li> <li>3. Low guide rails southbound between Exits 2 and 1;</li> <li>4. Shoulders are narrow in northbound direction;</li> <li>5. Top cable on median barrier is sagging at Exit 2.</li> </ol>	<ol style="list-style-type: none"> <li>1. Replace exit sign;</li> <li>2. Trim vegetation;</li> <li>3. Replace guide rail;</li> <li>4. Increase shoulder width using existing right-of-way;</li> <li>5. Repair cable barrier.</li> </ol>	<p>Low Low Low High Low</p>	<p>Med High Medium High High</p>	<p>Low Low N/A High N/A</p>	<p>Implemented post-audit 2010; Implemented post-audit 2010; Implemented post-audit 2010; Will be investigated as part of a future reconstruction or preservation project; Implemented post-audit 2010.</p>

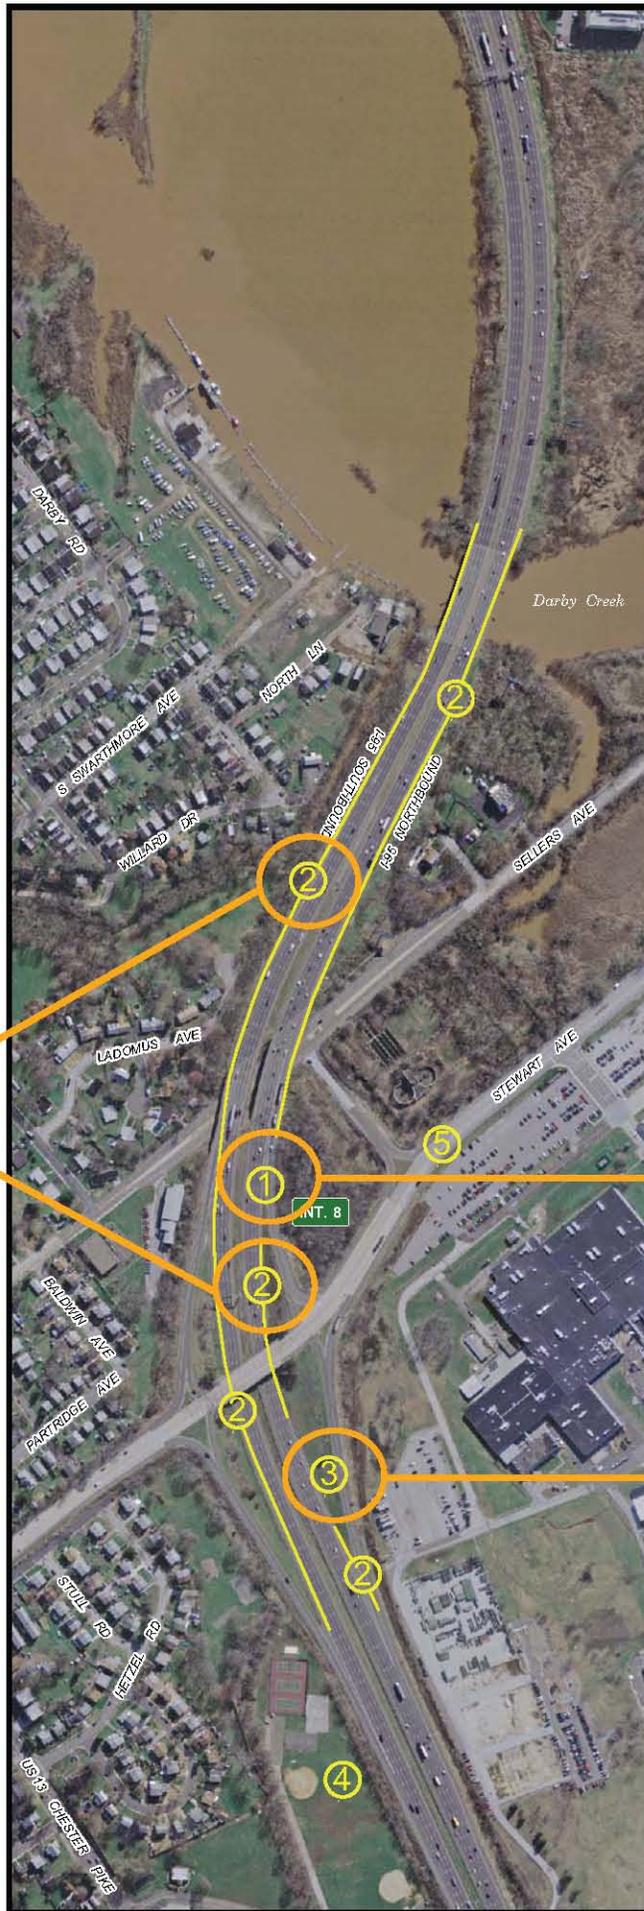
**Table 8: Panel 8 (interchange 8, north over Darby Creek)**

Guide rails repaired, reflectors added  
Completed Post-Audit 2010-2011

Guide rail addressed  
Completed Post-Audit 2010

Exit 8 sign replaced  
Completed Post-Audit 2010

Site-Specific Issue	Potential Strategy	Difficulty to Implement	Estimated Safety Benefit	Estimated Operational Benefit	Road Owner Response
<p><b>Panel 8</b></p> <ol style="list-style-type: none"> <li>Northbound on-ramp from Exit 8 Stewart Ave. has guide rail, but I-95 northbound traffic faces back of guide rail;</li> <li>Missing reflectors on damaged guide rails;</li> <li>Exit signage on I-95 northbound at Exit 8 on-ramp is damaged;</li> <li>Signs for Chester waterfront along I-95 northbound approaching Exit 8 may be unnecessary;</li> <li>Connector road between Stewart Avenue and Sellers Avenue near the I-95 on-ramp could easily be mistaken for the on-ramp.</li> </ol>	<ol style="list-style-type: none"> <li>Add backside to guide rail for I-95 through traffic;</li> <li>Add missing reflectors and repair guide rail;</li> <li>Repair exit sign;</li> <li>Remove existing signs for Chester waterfront and add to Exit 4 US 322/Commodore Barry Bridge signs when new ramps are completed. Determine need for Exit 8 signs for Eddystone/Ridley waterfront;</li> <li>Add street signs to the connector road between Sellers Avenue and Stewart Avenue.</li> </ol>	<p>Low</p> <p>Low</p> <p>Low</p> <p>Low</p> <p>Low</p>	<p>Medium</p> <p>Medium</p> <p>Medium</p> <p>Low</p> <p>Low</p>	<p>N/A</p> <p>Low</p> <p>Low</p> <p>Low</p> <p>Low</p>	<p>Implemented post-audit 2010-2011;</p> <p>Implemented post-audit 2010-2011;</p> <p>Implemented post-audit 2010;</p> <p>Issue will be revisited upon completion of the US 322/I-95 Realignment Project;</p> <p>Will be implemented in 2011.</p>

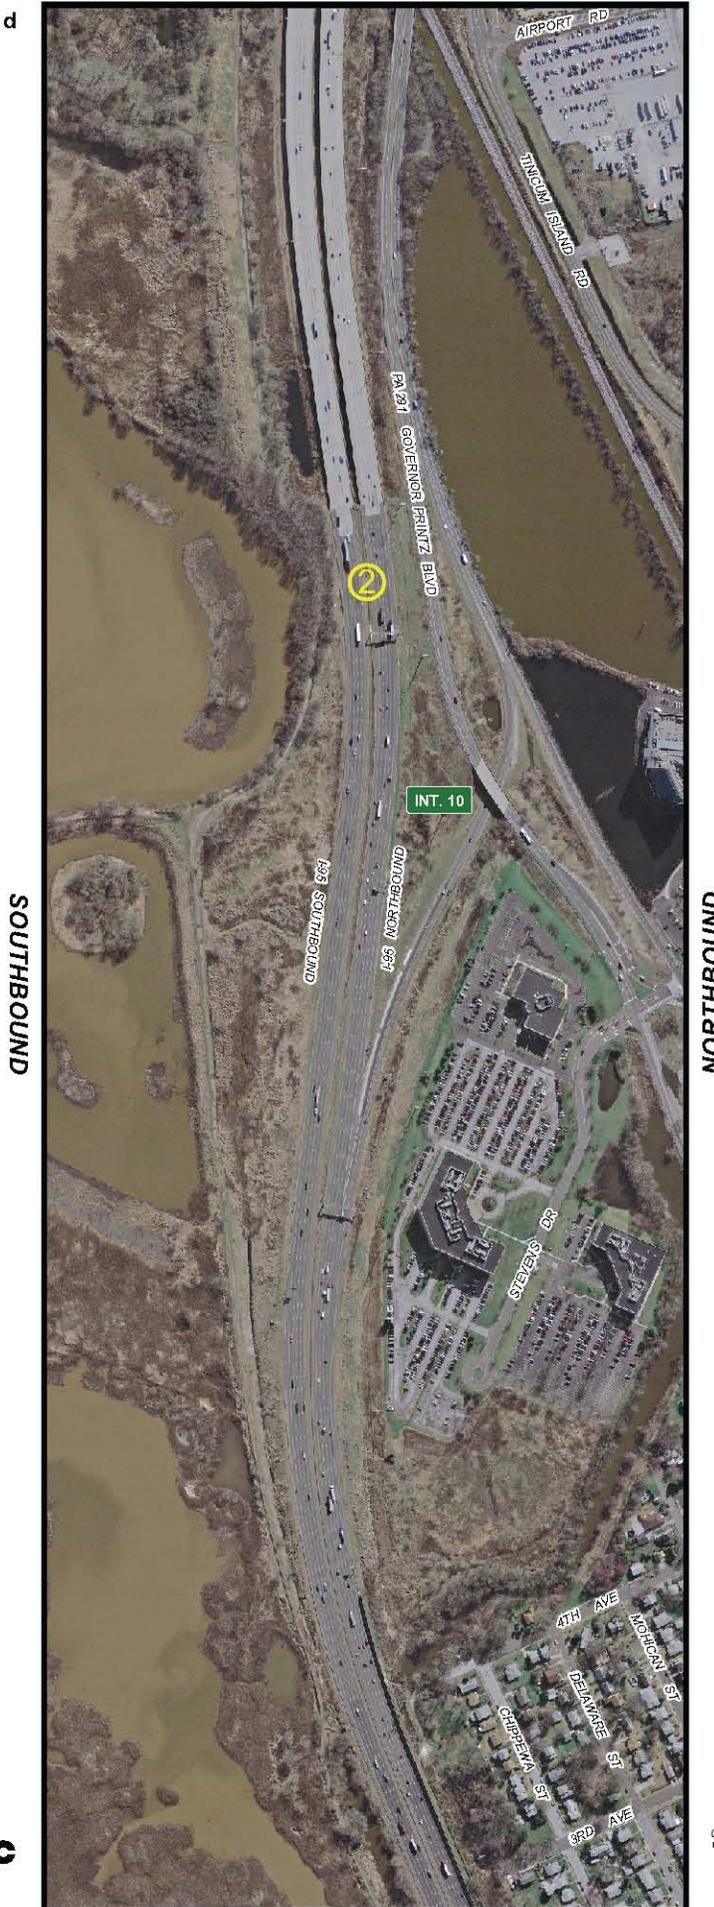
Figure 10

Panel 10  
(vicinity of Interchange 10)
