G STREET and KENSINGTON AVENUE ROAD SAFETY AUDITS

City of Philadelphia, Pennsylvania
December 2013

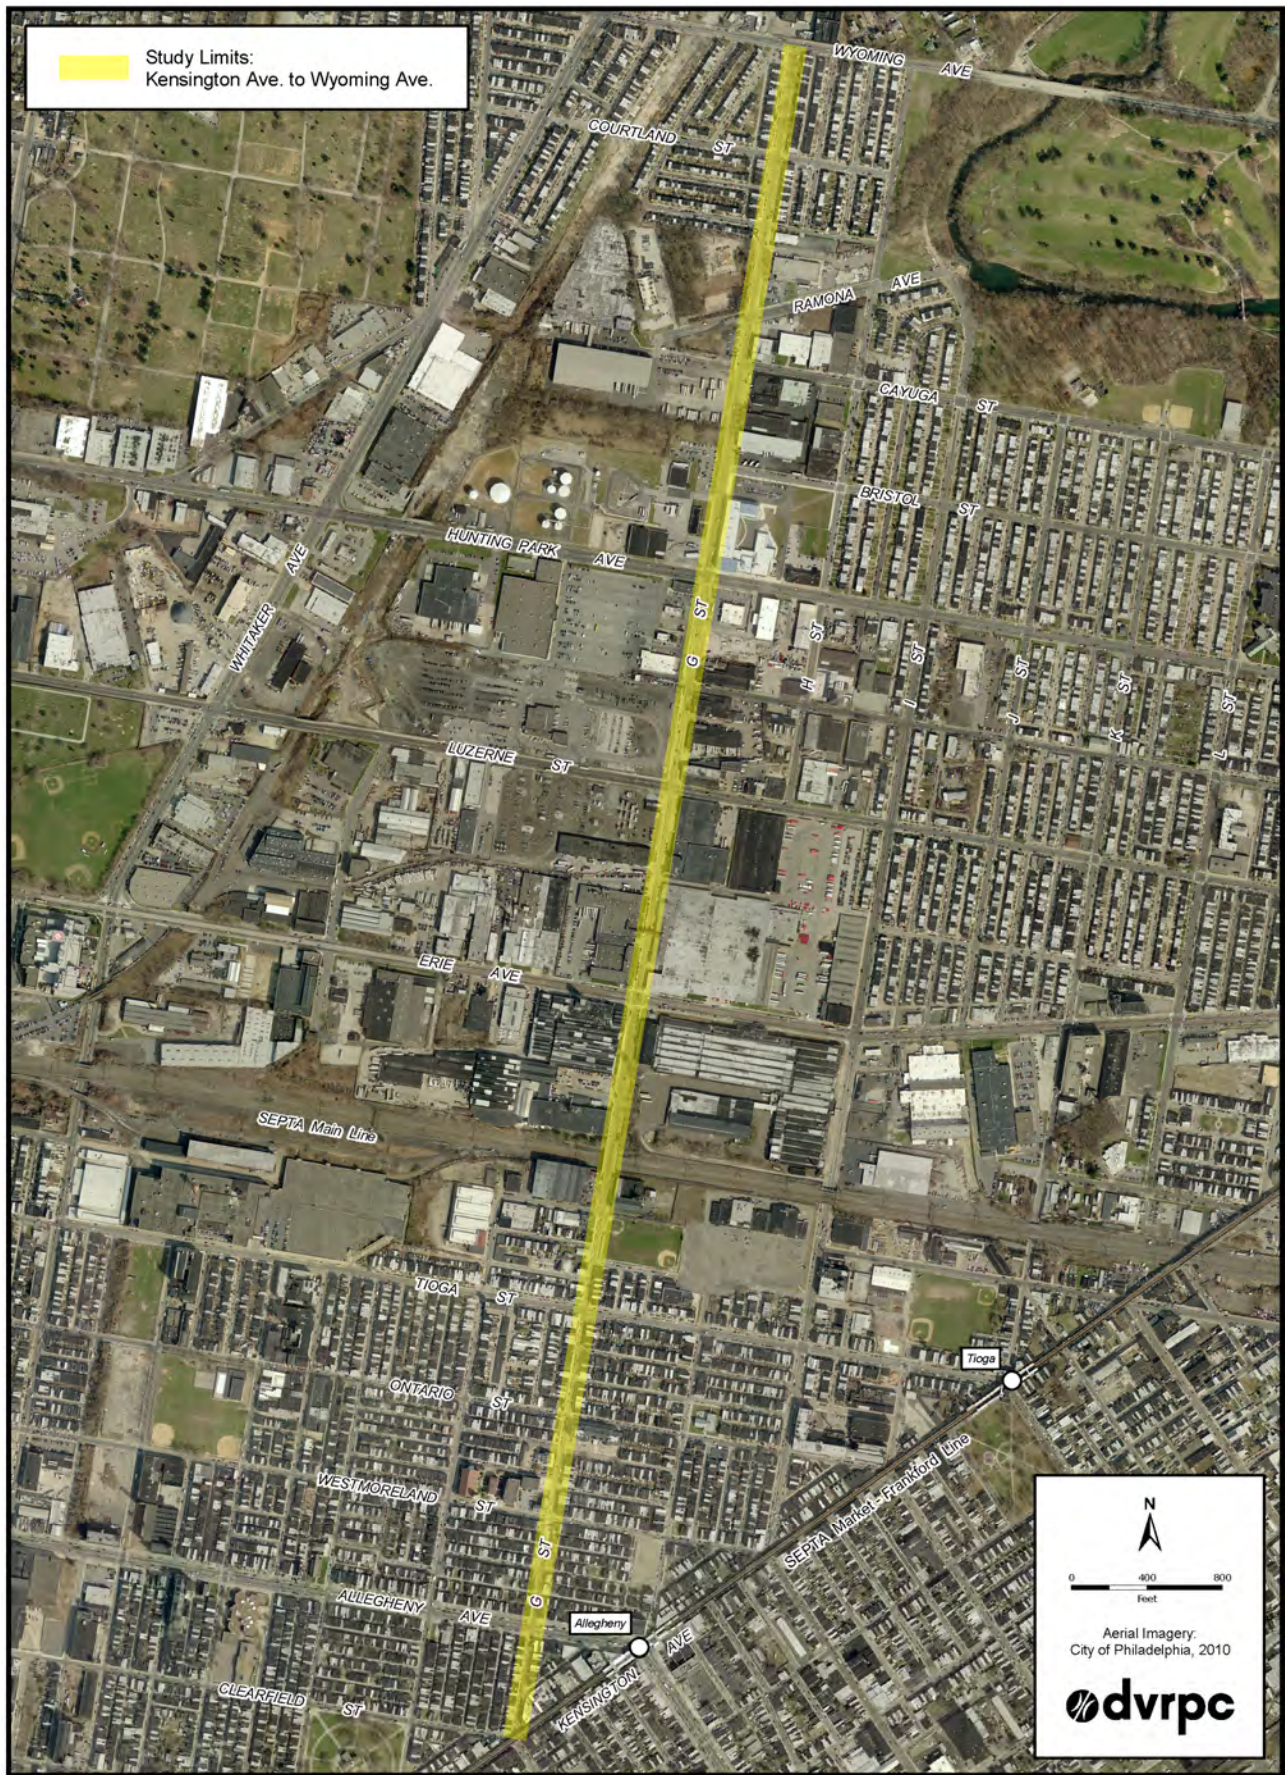
Figure 2: G Street Study Area

The study area consists of approximately 1.72 miles of G Street, from the intersection of Kensington Avenue north to Wyoming Avenue (see Figure 2). The study area is located within North Philadelphia in a predominately dense urban neighborhood with a standard street-grid pattern. The frontage along the corridor is primarily a mix of residential, light industrial and commercial uses. From Kensington Avenue to East Venango Street, land use is residential mixed intermittently with retail. From East Venango Street to East Annsbury Street, land use is predominately commercial and industrial. From East Annsbury Street to East Wyoming Street, land use is residential with one retail shop.

The study area has eight signalized intersections and 20 unsignalized intersections where the side-street is stop-controlled, nine of which are four-leg, and 11 that are three-leg intersections. Sidewalks are consistently available, and bike lanes can be found from East Venango Street to West Wyoming Street.

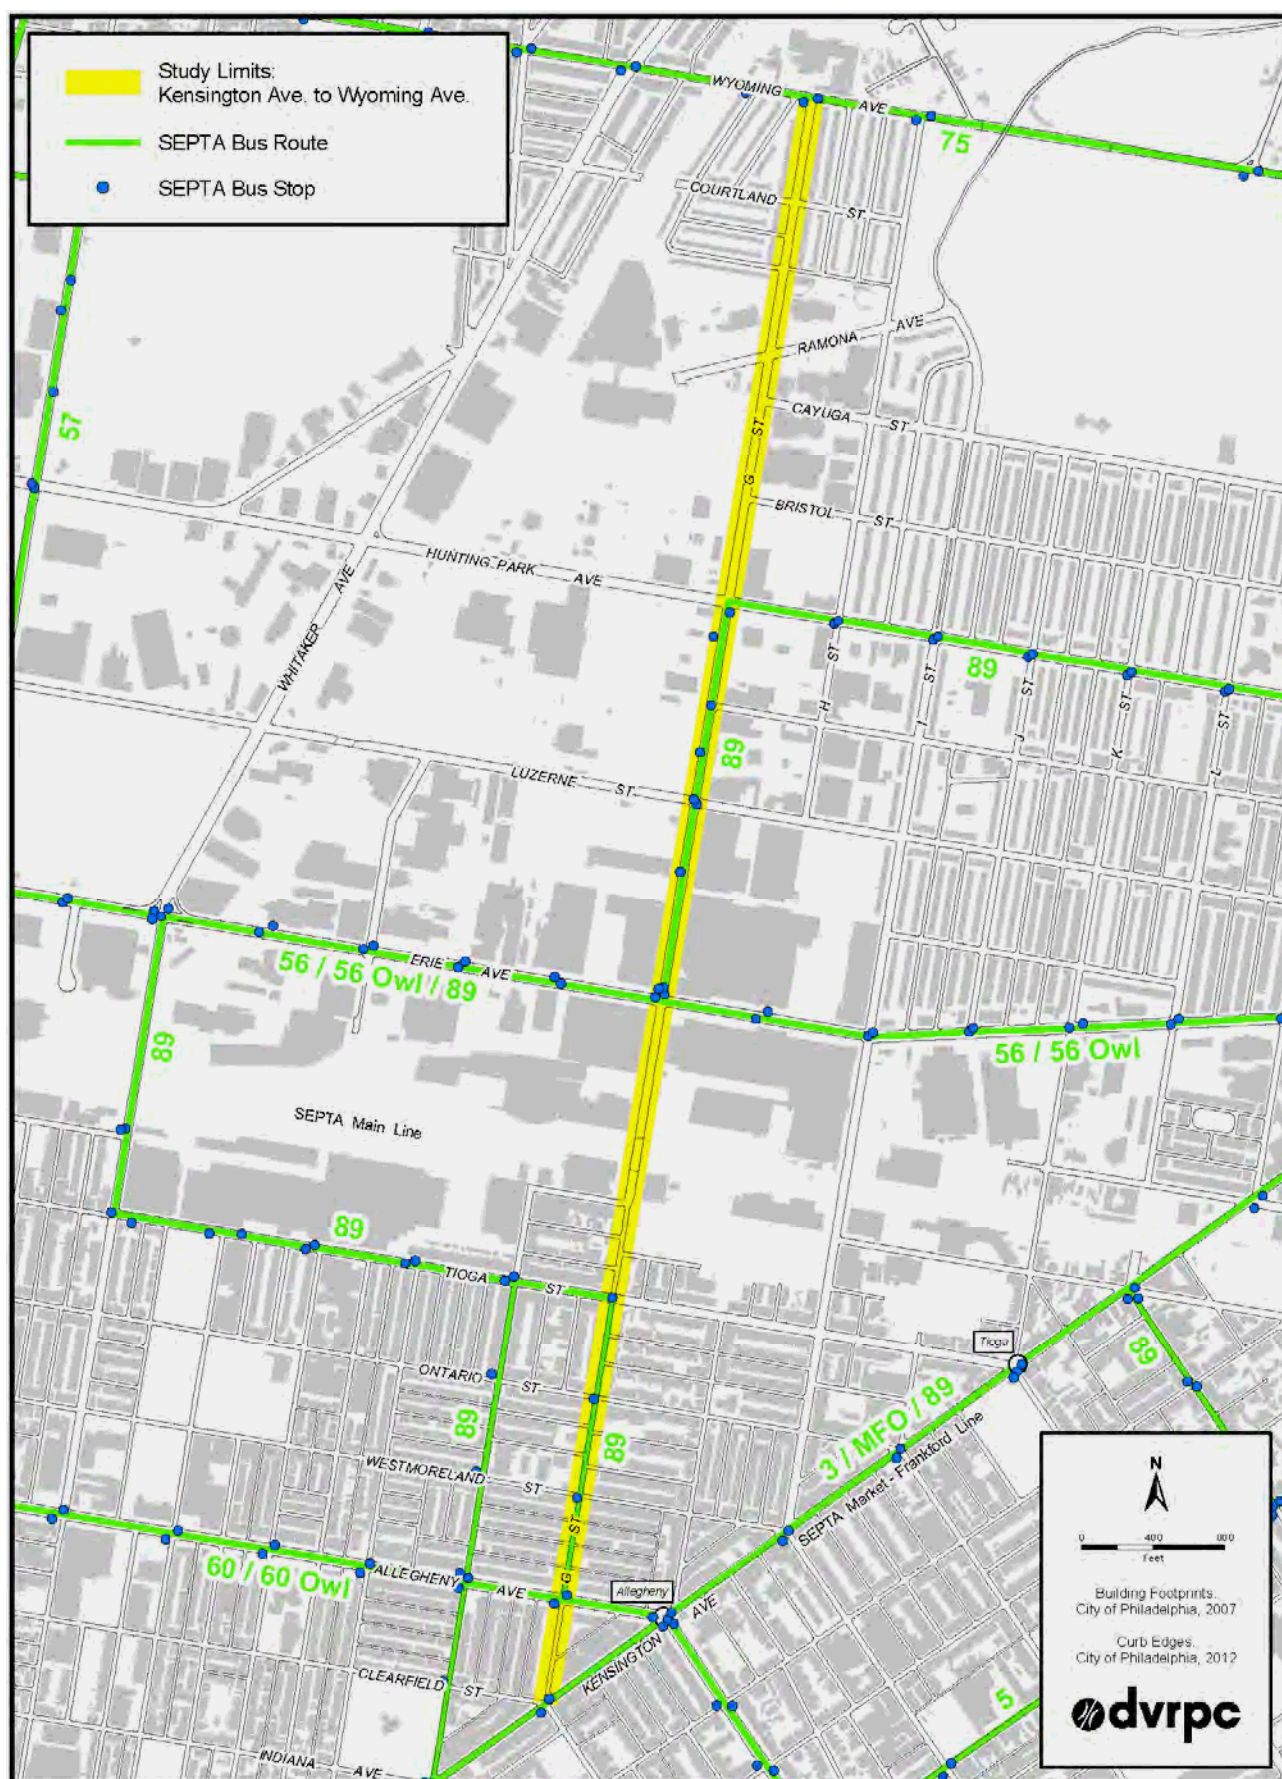
Figure 4: G Street Transit Network

The study corridor is fairly well served by bus transit with stops and connecting services easily accessible by foot and typically within less than a half mile from anywhere along the corridor (see Figure 4). There is one SEPTA bus that runs along a segment of the G Street study corridor and two SEPTA buses that run across the study corridor. SEPTA's 89 bus follows G Street between Erie Avenue and Hunting Park Avenue on its route from Front Street at Dauphin Street to the Arrott Transportation Center. SEPTA's 56 and 56 Nite Owl buses cross G Street at Erie Avenue, and the 60 and 60 Nite Owl buses cross G Street at Allegheny Avenue.

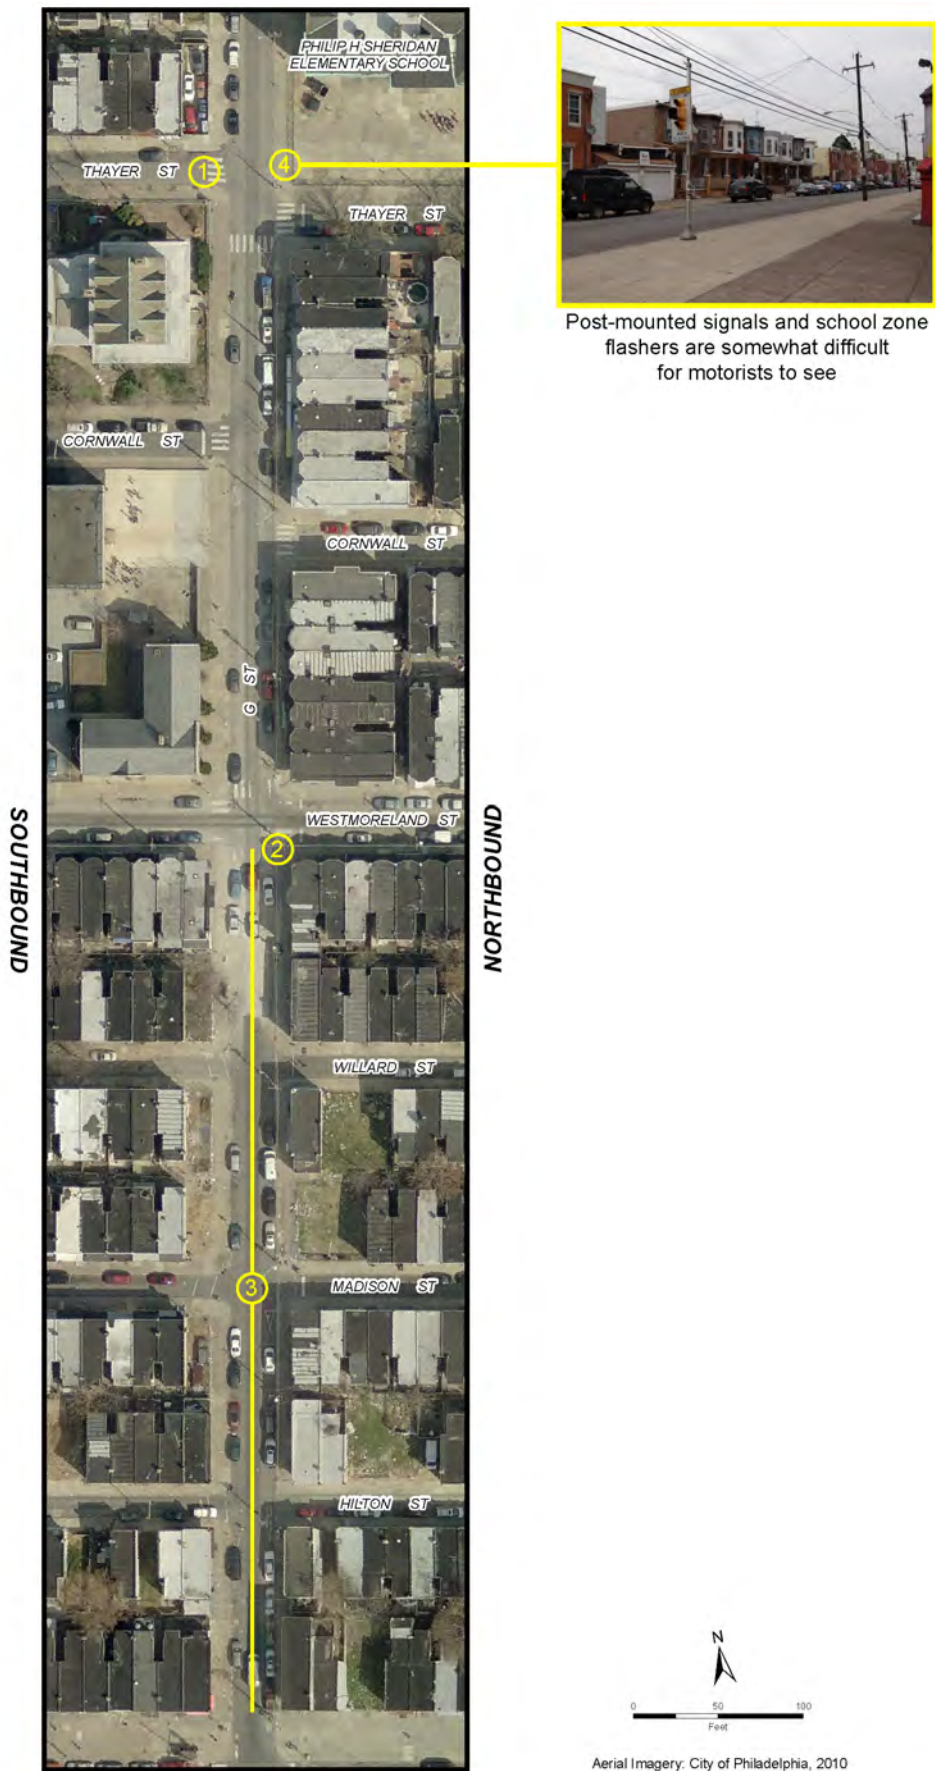
Figure 7: Panel 2 (G Street: Hilton Street to Thayer Street)

Site-specific Issue	Potential Strategy	Difficulty to Implement	Estimated Safety Benefit	Responsible Agency
Panel 2 1. Crossing over G St. at Thayer St., there is a missing pedestrian crossing sign on WS of G St., and a missing "no parking box" on the WS approaching the crosswalk; 2. At Westmoreland Ave., the "No Turn on Red" signs (possibly other signs also) are too low; 3. Distance between controlled crossing opportunities is too long (from Allegheny Ave. to Westmoreland Ave.); 4. Post-mounted signals and school zone flashers are somewhat difficult for motorists to see.	1. Replace sign, re-stripe "no parking box"; 2. Check sign height, make code compliant; 3. Conduct study to identify an appropriate location midway between controlled crossings on G St. for a striped and ramped crossing; 4. Evaluate location of signals and signs to improve visibility.	Low Low Medium Medium	High Medium TBD TBD	Streets Department Streets Department Streets Department Streets Department

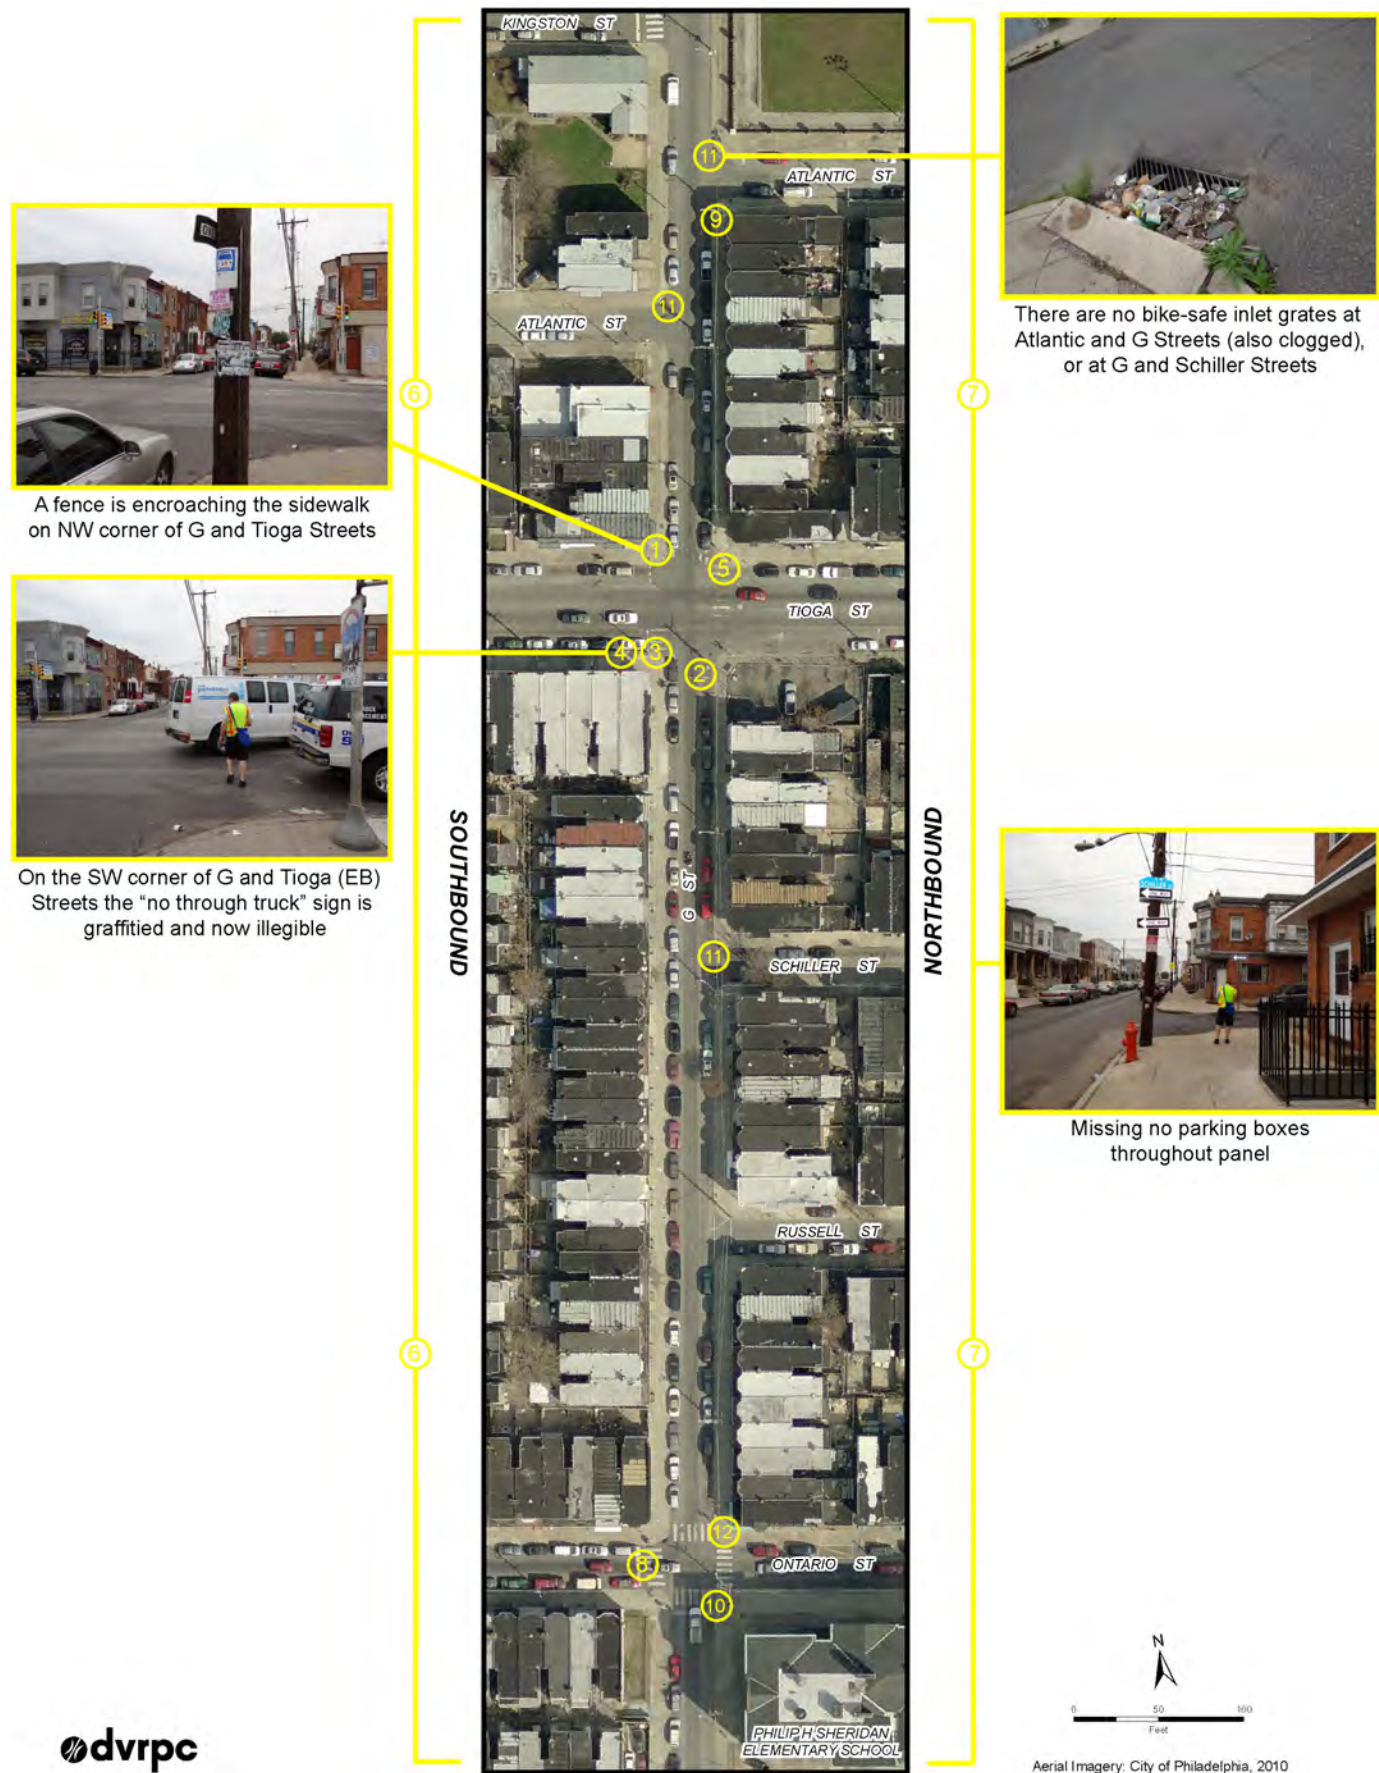
Figure 8: Panel 3 (G Street: Ontario Street to Kingston Street)

Site-Specific Issue	Potential Strategy	Difficulty to Implement	Estimated Safety Benefit	Responsible Agency
Panel 3 1. A fence is encroaching the sidewalk on NW corner of G and Tioga Streets;	1. Enforce code violation;	Medium	High	Philadelphia Police

2. The bus zone at G and Tioga Streets has insufficient signing & markings (missing bus stop boxes);	2. Add proper signs and re-stripe the bus stop boxes;	Low	High	Streets Department

3. The pedestrian signal head on the SW corner of G and Tioga Streets is twisted, and signal head visor is missing;	3. Realign signal head and replace missing signal visor;	Low	Medium	Streets Department

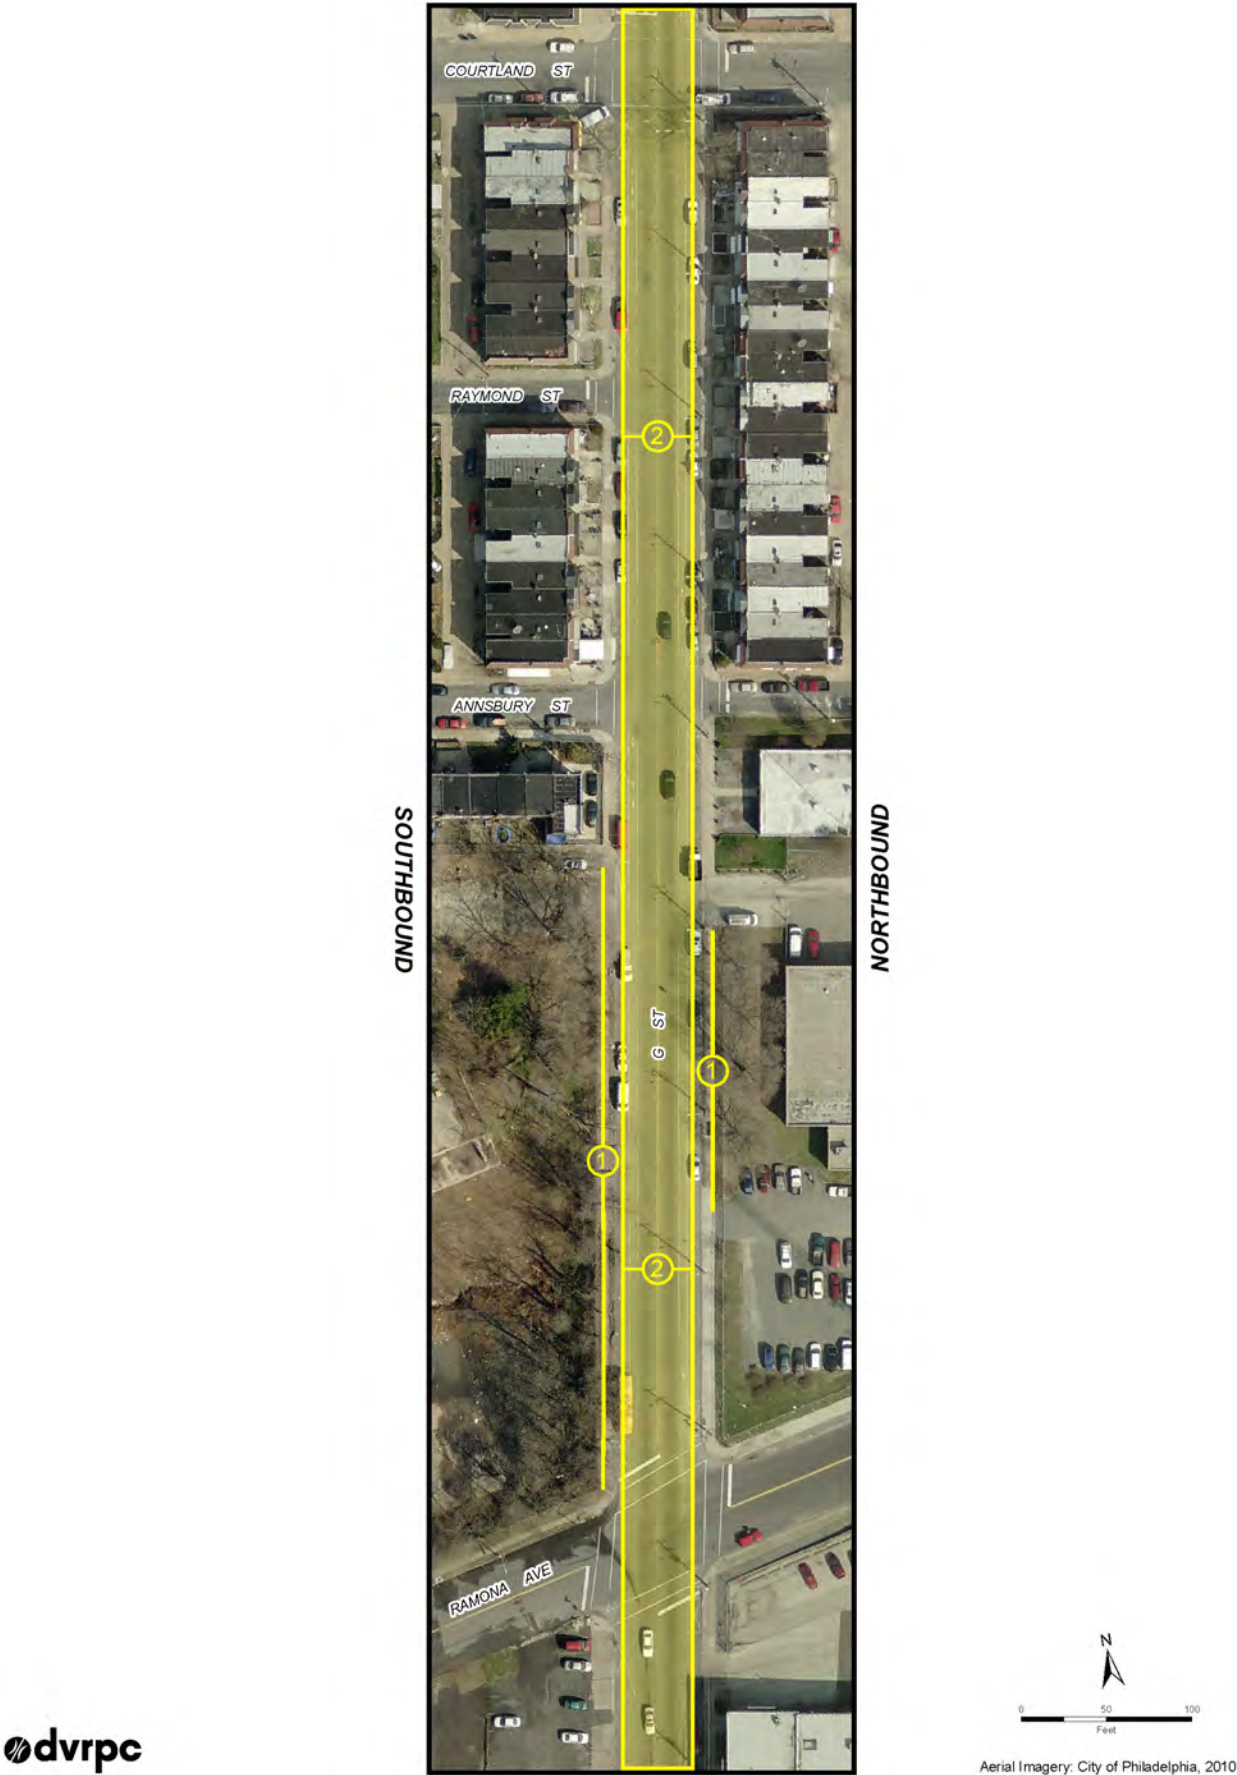
Figure 14: Panel 9 (G Street: Ramona Avenue to Cortland Street)

Site-Specific Issue	Potential Strategy	Difficulty to Implement	Estimated Safety Benefit	Responsible Agency
Panel 9 1. Narrow sidewalks have intermittent deterioration and are obstructed by trees; 2. All striping is faded.	1. Work with private property owner to repair as needed; 2. Re-stripe pavement markings.	Medium Low	Medium High	City of Philadelphia Streets Department

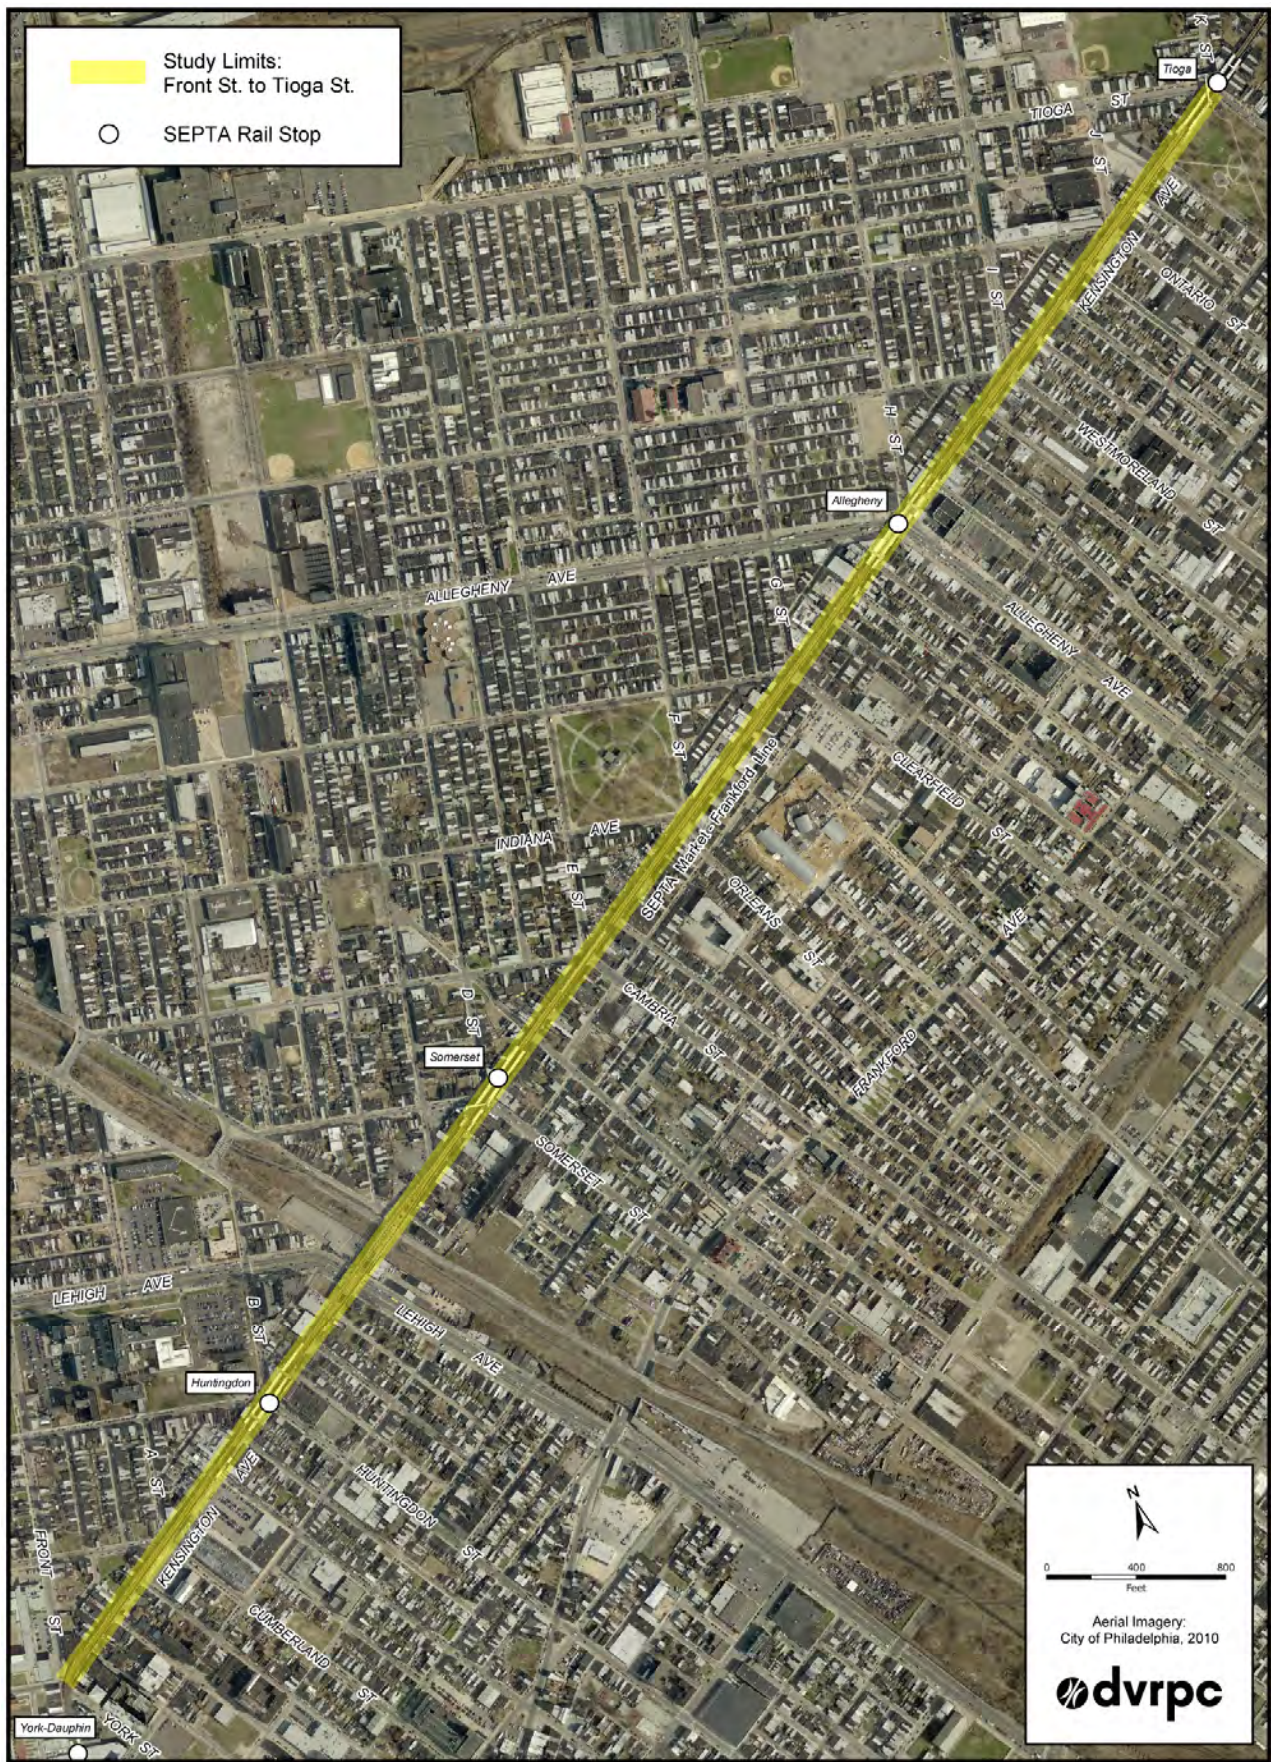
Figure 16: Kensington Avenue Study Area

Kensington Avenue is classified as a major collector and has a posted speed limit of 25 mph. It is a two-way street with a two-lane cross-section. In both directions, there are sidewalks and bike lanes, and the shoulders are reserved for on-street metered parking spaces, intermittent loading zones, and striped bus-stop zones. Kensington Avenue has 35 intersections in the study area: 23 unsignalized and 12 signalized. Of the 12 signalized intersections, 11 have a 5-leg configuration due to the diagonal orientation of Kensington Avenue. This situation presents additional safety considerations for pedestrians and for drivers making turning movements.

The Market-Frankford Elevated Line runs the length of Kensington Avenue over the street and has four station stops along the study corridor (note: the York-Dauphin station is located outside the study limits, but it is shown on Figures 16, 17, and 18 for reference). These station stops are at Tioga, Allegheny, Somerset, and Huntingdon streets. The Market-Frankford Nite Owl Express Bus (labeled as “MFO” on Figure 18) follows the route of the train line twice per night on weekdays after the conclusion of train service.

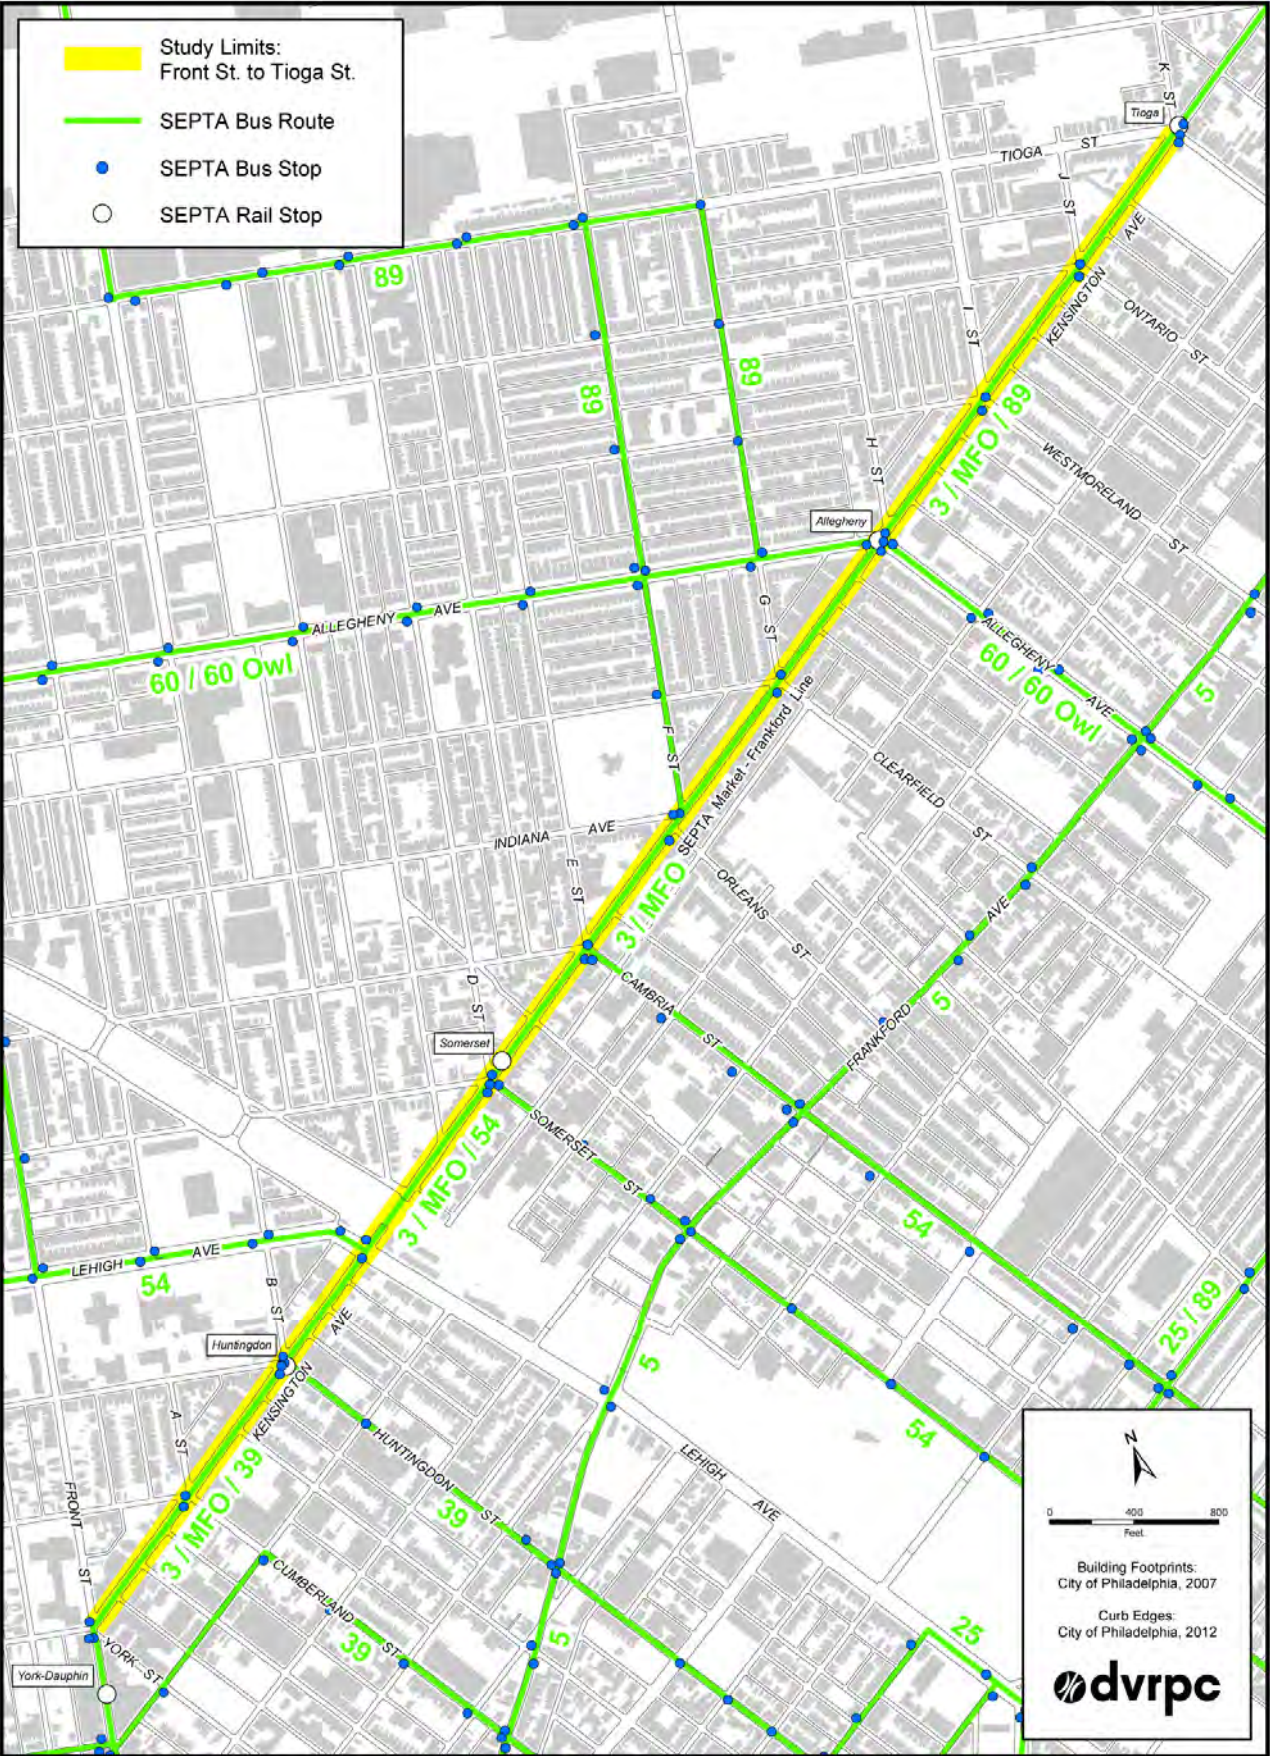
Figure 18: Kensington Avenue Transit Network

Transit service is frequent and varied in the Kensington Avenue corridor. The SEPTA 3 bus runs the length of Kensington Avenue through the study area (see Figure 18). Three other SEPTA buses run along segments of the corridor (39, 54, and 89 buses), and another crosses the study corridor. The 39 bus runs on Huntingdon and Cumberland Streets, and briefly on Kensington Avenue. The 54 bus runs on Lehigh, Somerset, and Cambria Streets, and briefly on Kensington Avenue. Last, the 89 bus plies G and F Streets, runs partly on Kensington Avenue, and serves the Arrott Transportation Center. SEPTA's 60 bus and 60 Nite Owl service both cross Kensington Avenue at Allegheny Avenue.

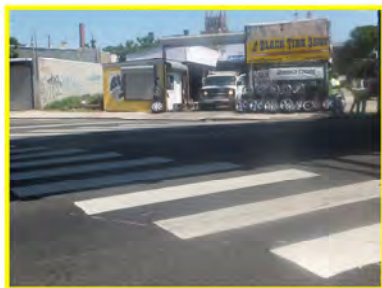
At Cumberland St., a retail driveway on the ES is a potentially illegal access to the street creating an additional conflict

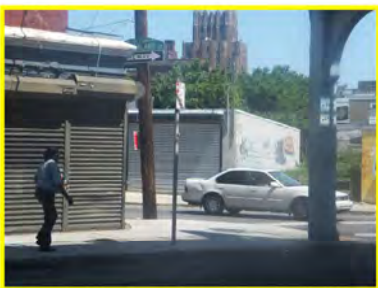
At Cumberland St., the street name sign located on the WS is blocked by a building and obstructs sight lines for drivers approaching the intersection

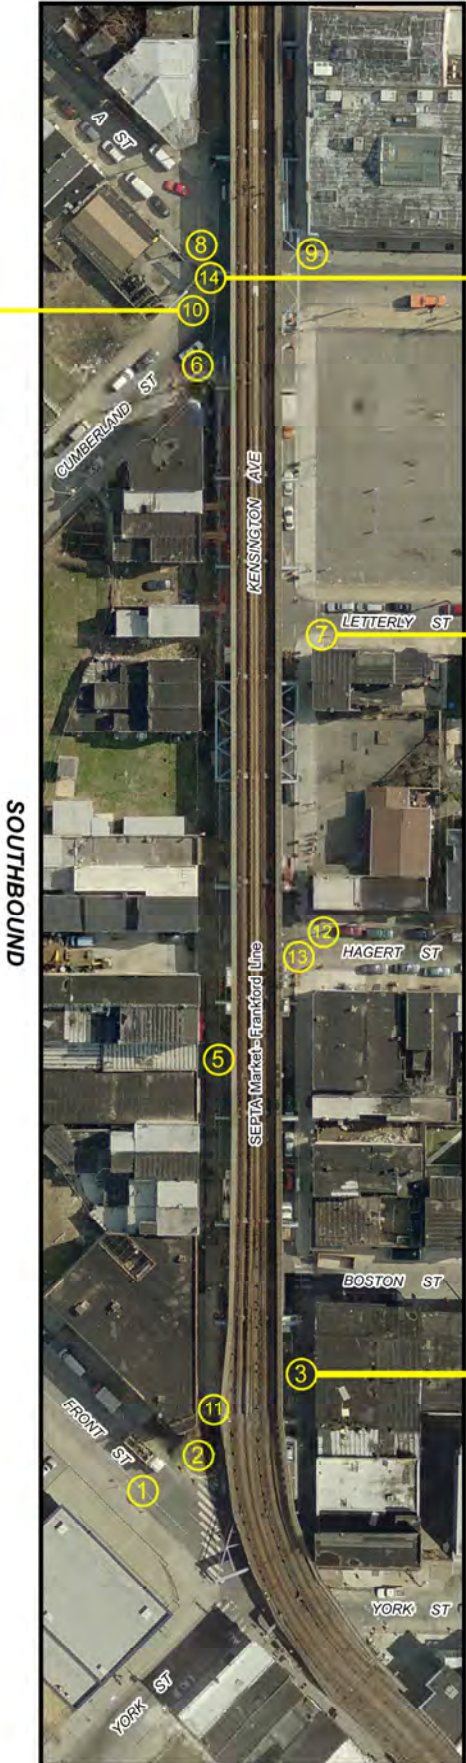
At Letterly St., a column/pole obstructs a street sign

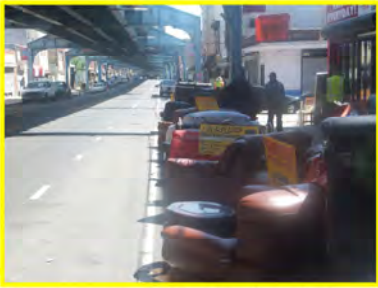
Furniture, etc. is blocking the bike lane and sidewalk

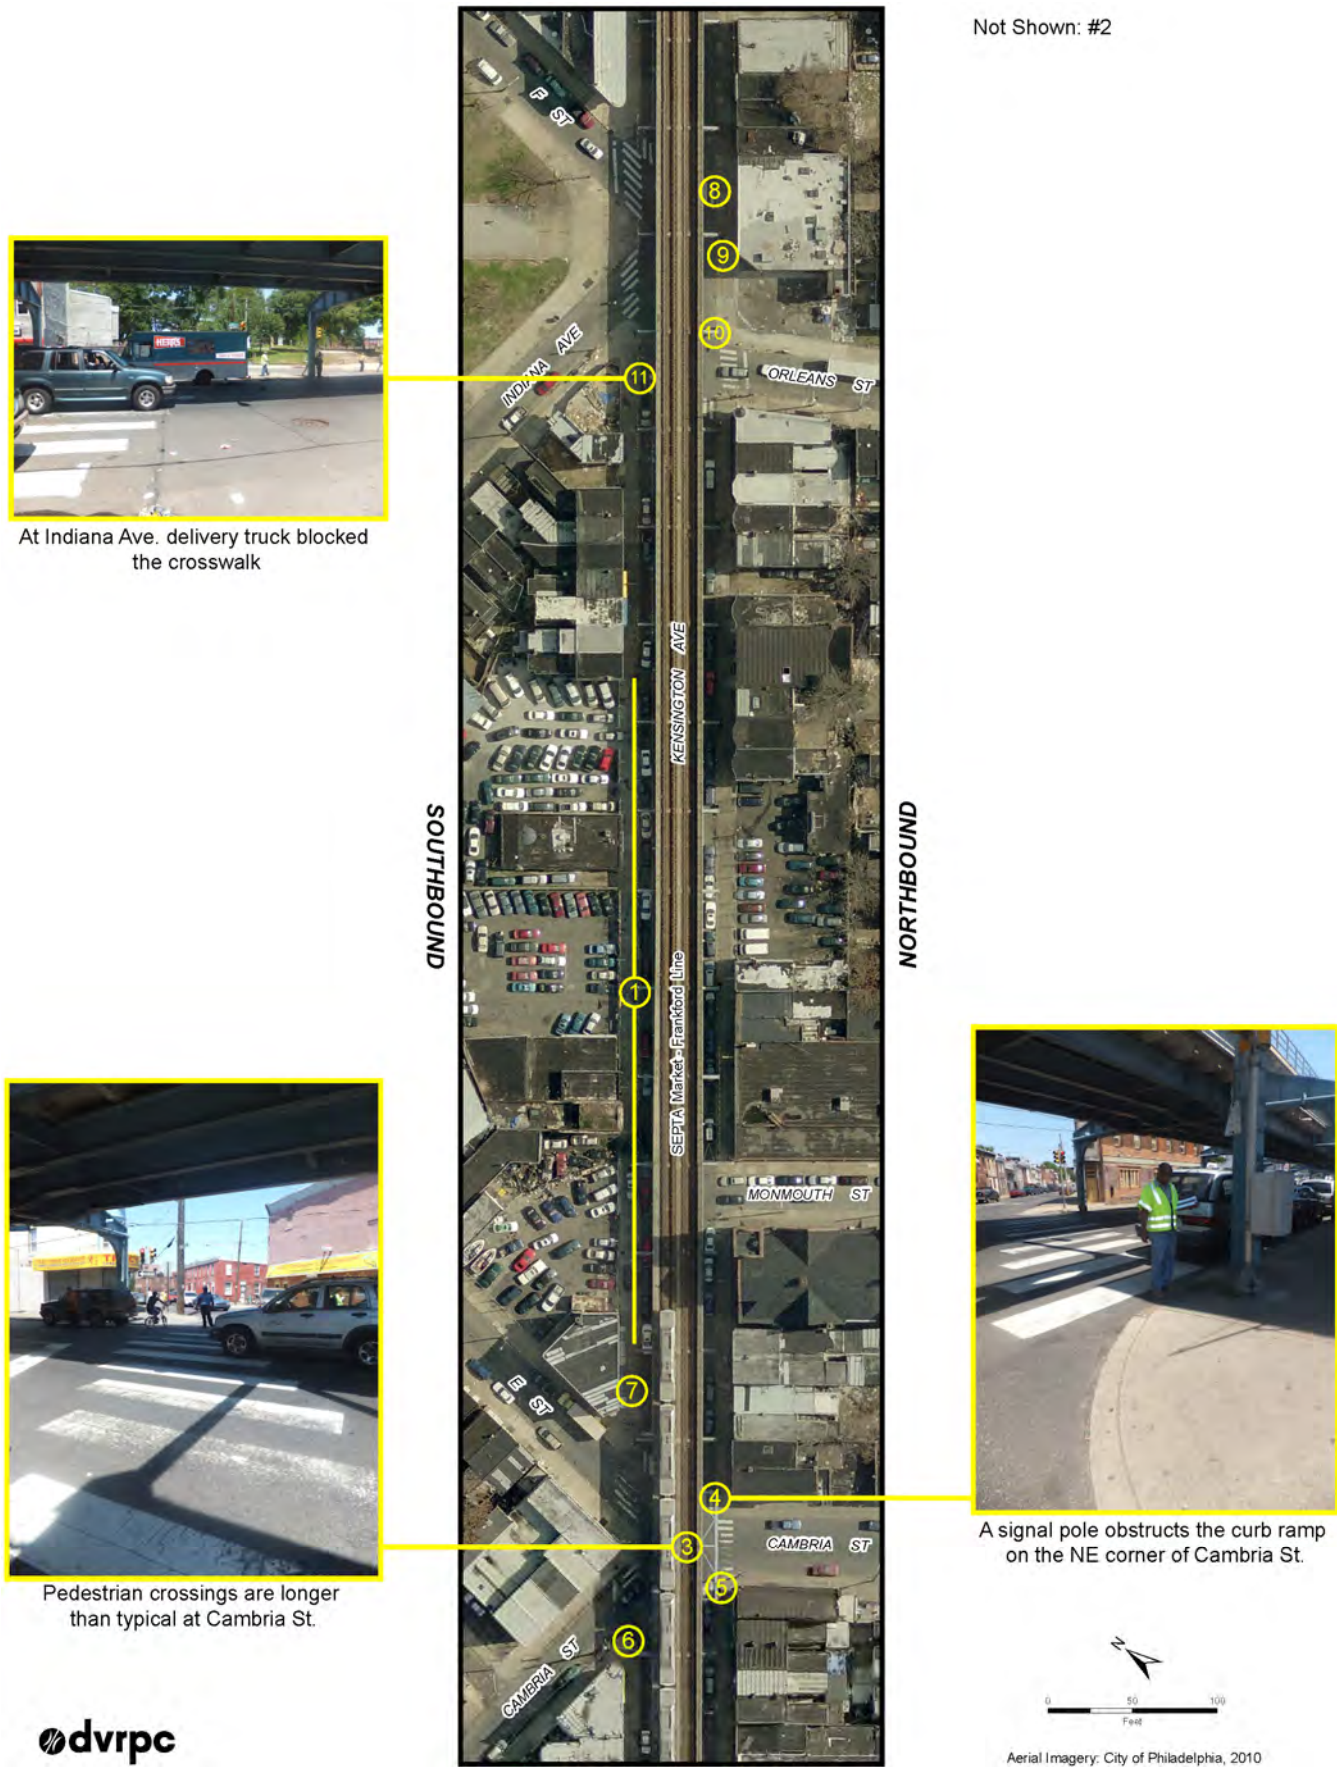
Figure 24: Panel 5 (Kensington Ave.: Cambria Street to F Street)

Site-Specific Issue	Potential Strategy	Difficulty to Implement	Estimated Safety Benefit	Responsible Agency
Panel 5				
1. There are excessive curb cuts, especially along the SB side;	1. Evaluate need for an access management plan;	Low	Medium	Streets Department

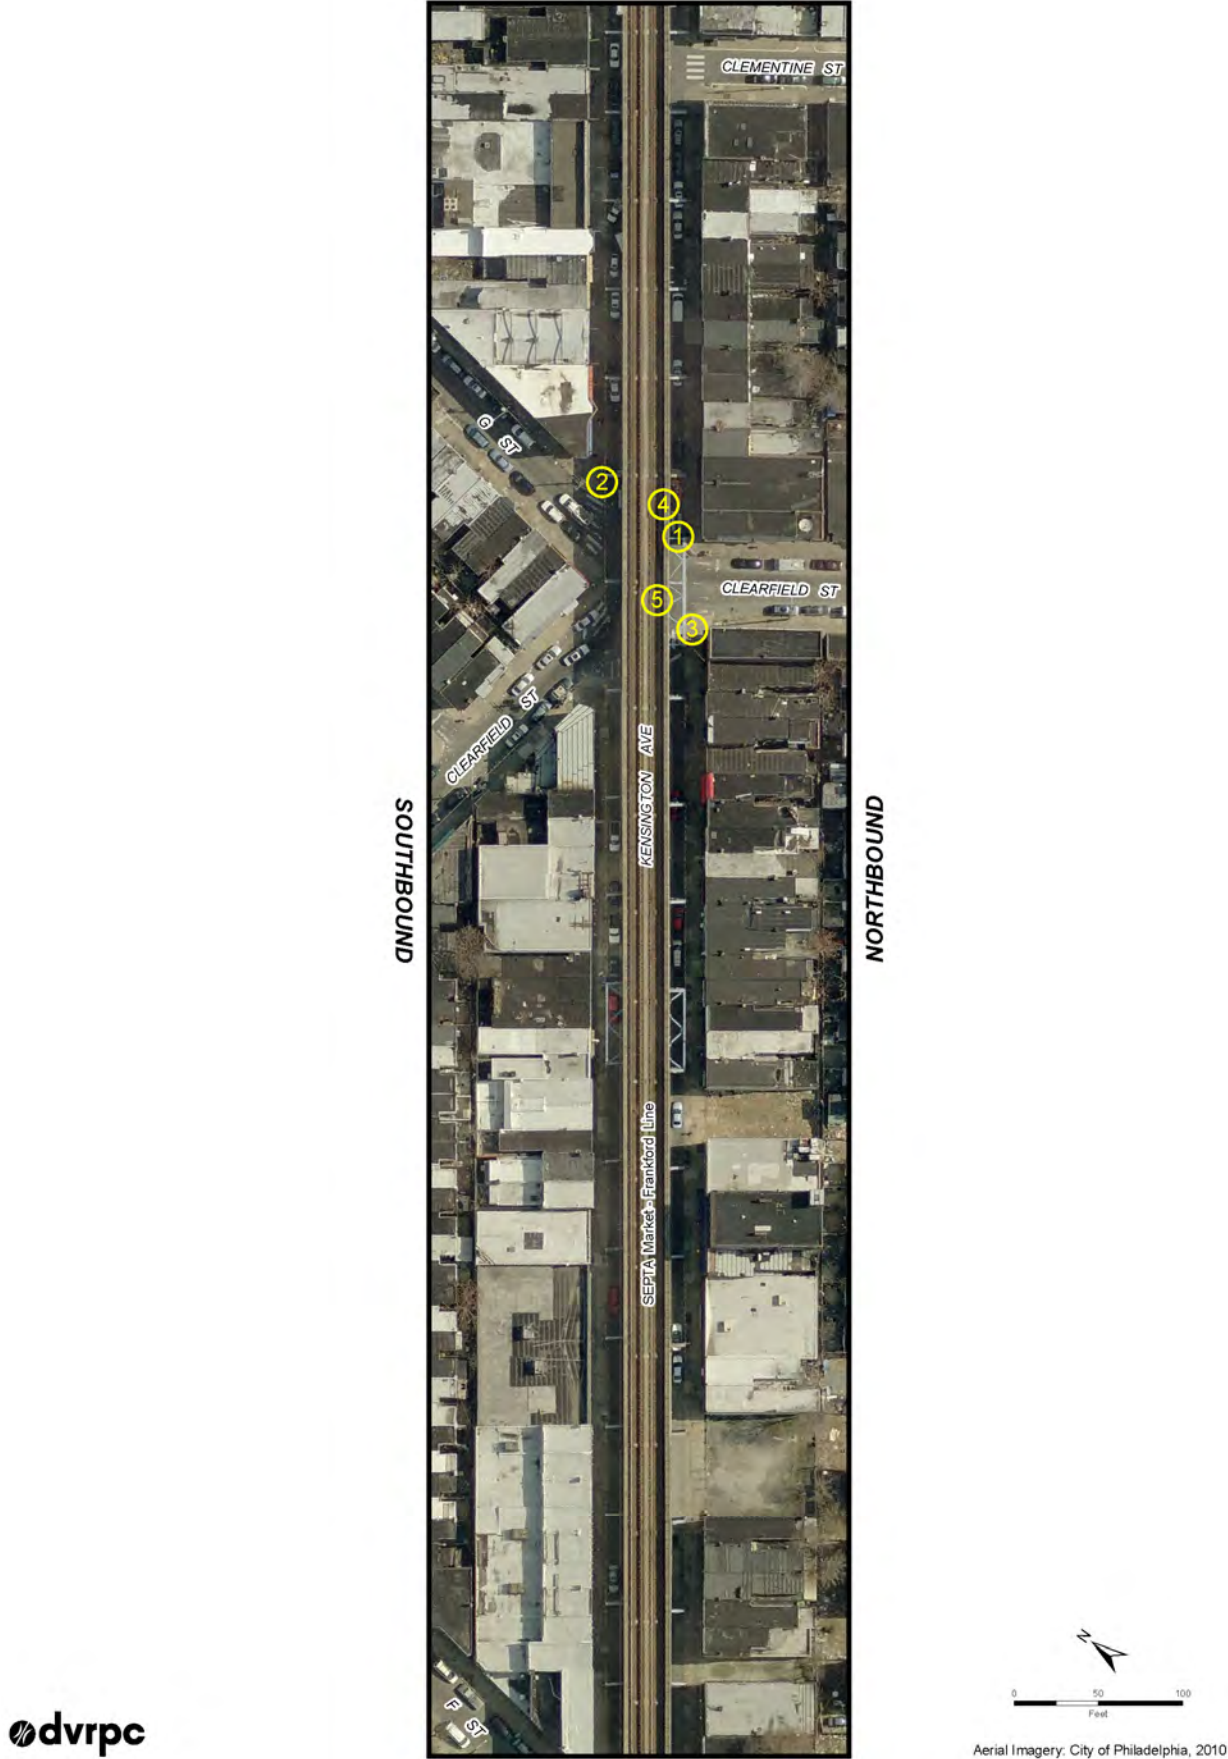
Figure 25: Panel 6 (Kensington Ave.: F Street to Clementine Street)

Site-Specific Issue	Potential Strategy	Difficulty to Implement	Estimated Safety Benefit	Responsible Agency
Panel 6 1. At Clearfield and G Streets, pedestrian clearance time is only 4 seconds on pedestrian head, and only one signal head for crossing two intersection legs; 2. Signal visors are missing on the NW corner of G St.; 3. Schools located on Clearfield St. south of Kensington Ave. produce heavy pedestrian volumes at and around the intersection during school begin and end times; 4. The pedestrian head is obstructed on the NE corner for crossing; 5. Left turn restriction from Kensington Ave. at Clearfield St. is being ignored	1. Re-time signal to increase the walk time (may be part of corridor-wide signal re-timing), evaluate need for additional signal head; 2. Replace missing signal visor; 3. Conduct follow-up study to quantify problem and recommend improvements; 4. Evaluate situation and relocate signal or add second head; 5. Supplement signs with more/better placed signs and pavement markings to reinforce the restriction (verify with video at K&A and at Clearfield St.)	Medium Low Medium Medium Low	High Medium TBD High Medium	Streets Department Streets Department Streets Department Streets Department Streets Department
