Bristol Township Energy Assessment

Township Administration and Police Building

Township Pump Stations

2501 Bath Road, Bristol, PA 19007

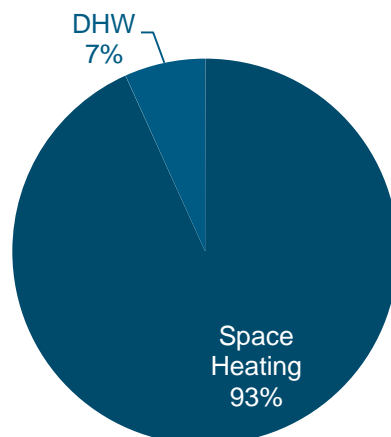
Figure 3: Natural Gas End Uses

- Ninety-three percent of natural gas is used for heating; the remainder heats domestic hot water (DHW) as shown in Figure 3 below.

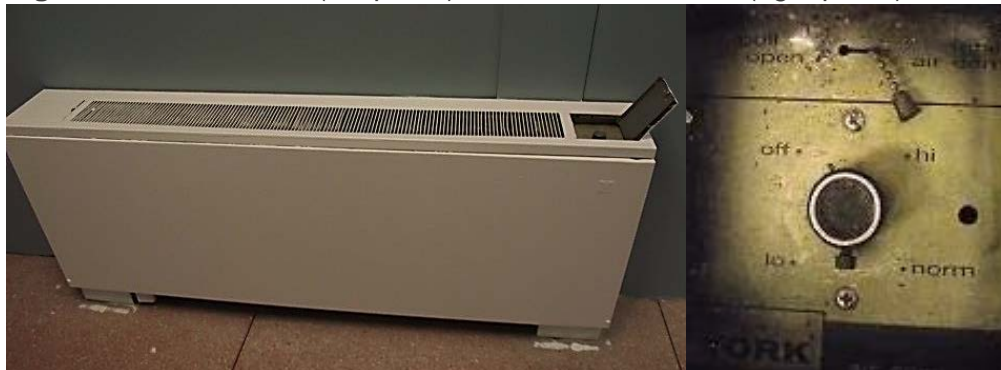
This building is heated via a perimeter hot-water system comprising three Weil McLain PFG boilers (305 MBH² each, 81 percent thermal efficiency) and perimeter FCUs. The boilers were replaced in 2004 and are in good condition, but the FCUs are in very poor condition and have manual fan controls as shown in Figure 5. Hot water circulates continuously through each coil regardless of fan operation or heat call, and uncontrolled, continuous radiant heat causes overheating, occupant discomfort, and wasted energy. During our site visit, outside air temperature was 35°F, but windows were open due to excessive heat indoors.

Figure 5: Fan Coil Unit (left photo) with Manual Controls (right photo)

- As a short-term measure, PES recommends installing gas service to the RTUs, disabling the hot-water system and using the gas furnaces installed in the RTUs. This will allow both heating and cooling to be controlled via the existing, programmable thermostats and is the least expensive way to eliminate the overheating problems and to reduce maintenance costs. It will also yield some energy savings by eliminating hot-water pumping and standby losses in the hot-water loop.

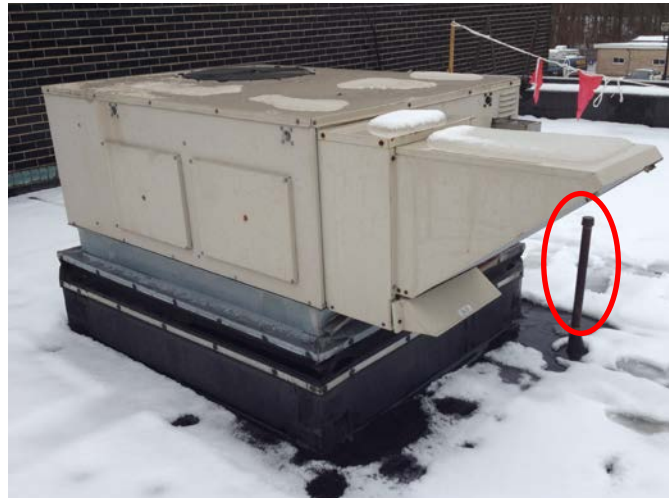
Appendix A contains an inventory of HVAC equipment. Primary cooling and air distribution is provided by 13 package RTUs, 12 of which are Lennox units manufactured in 1997. The units were in storage for 15 years before being placed into service in the winter of 2011–2012. The RTUs, which appear to have been stored outside, are in poor condition despite their short service life. Their efficiency is also low by today's standards, and while they have natural gas heating capabilities, they are not connected to a gas line. Despite the gas line penetrations through the roof, as shown in Figure 6 below, these lines are not connected to anything; there is no existing natural gas piping running through the building to serve the RTUs.

Figure 6: Typical Package Rooftop Unit, gas line disconnected

As a second step, the township should develop an HVAC replacement plan to begin replacing the aging RTUs with the highest possible efficiency heating/cooling package RTUs (12-14 EER⁴, >80 percent AFUE⁵). Despite their short service life, the 12 Lennox RTUs manufactured in 1997 are in poor condition. While the efficiency of package units is inherently limited by their “off-the-shelf” configuration, this measure will nevertheless improve cooling efficiency by an average of 30 percent compared with the existing units and may result in annual energy savings of more than \$2,300 per year.

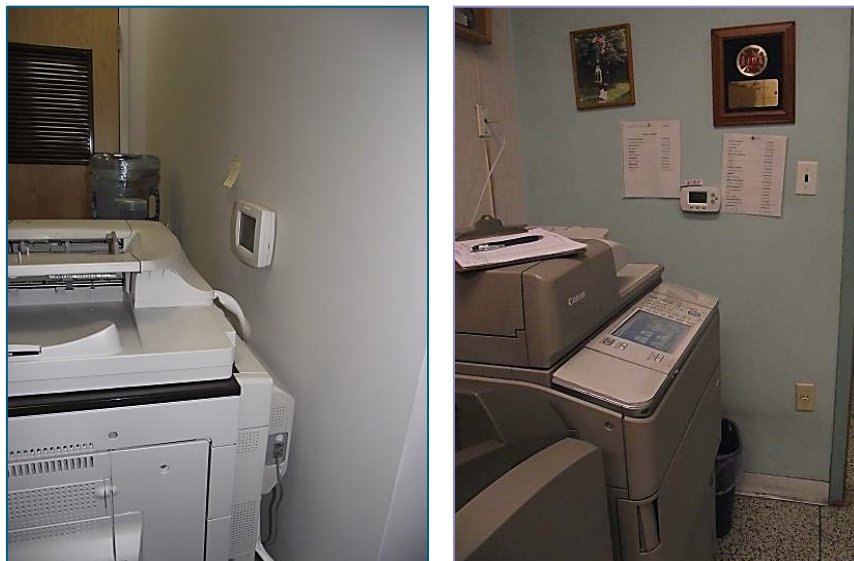
PES also noted that large copiers and printers are placed directly under thermostats in several areas of the building, as shown in Figure 7 below. These copiers emit significant heat directly to the thermostat temperature sensors, which can cause the air conditioning to run excessively and, when used to control heating, prevent heat from turning on. This causes employee discomfort and increases the use of space heaters and fans, which further suppresses the central HVAC system and increases energy expenses.

Figure 7: Improper Thermostat Placement

- The copiers and printers should be moved away from the thermostats to ensure proper operation and improved employee comfort.
- The boilers should not be decommissioned immediately; rather, the measure outlined above should be tested first to ensure that heating from the RTUs is adequate. When decommissioning is validated, however, be sure to fully decommission pumps and boilers so they do not continue running. As shown in Table 2, this measure may reduce energy costs by nearly \$2,000 per year. Although the cost of running the gas lines represents a capital investment, facility investments will be necessary given the aging conditions of the HVAC systems.

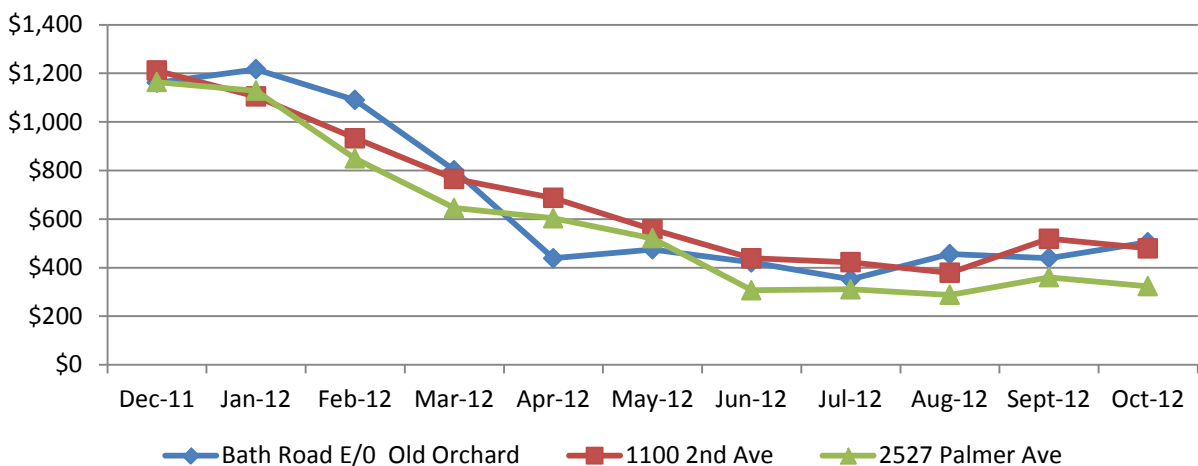
Figure 9: Selected Pump Station Energy Costs (11 months, 2011–2012)

In 2012, Bristol Township spent approximately \$50,000 on electricity for its 18 pump stations. A review of energy bills shows that three of the pump stations had notably higher wintertime electricity use when compared with the other stations' energy use. Specifically, the Bath Road, 2nd Avenue, and Palmer Avenue pump stations had peak wintertime energy use that was as much as 75 percent higher than summertime energy use, as shown in Figure 9 below.

At the township's other pump stations, energy use did not typically follow this pattern, suggesting that the high wintertime electricity use at these stations is due to factors other than snow or rainfall.

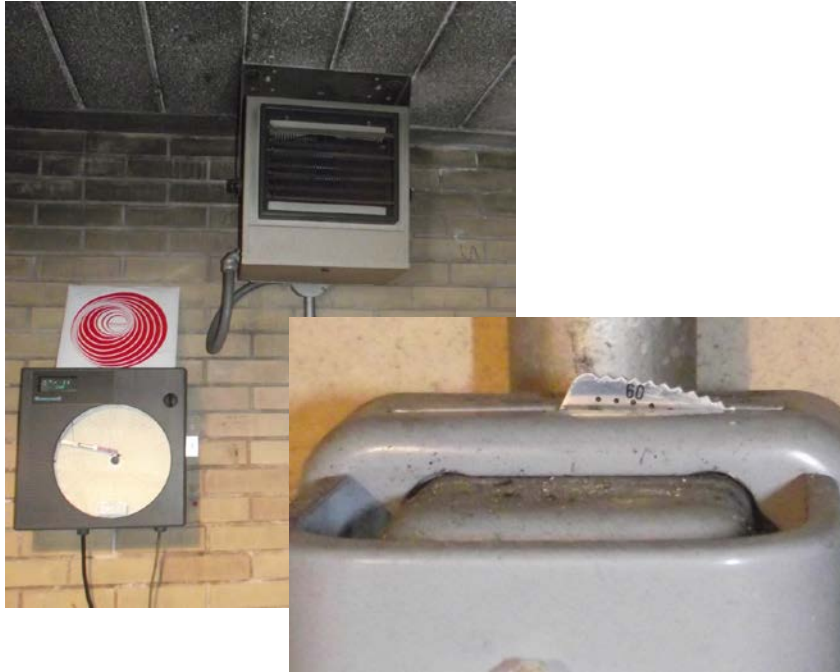
This pump station contains three 10-horsepower pumps, a backup generator, two electric unit heaters with wall-mounted thermostats, and fluorescent and incandescent light fixtures. PES found that the pump station indoor air temperature felt quite warm. The recorded air temperature was 75°F on the ground level and 68°F below ground, even though both thermostats were set as low as possible, well below 60°F. Figure 10 below shows the station's ground-level unit heater and its thumbwheel thermostat reading below 60°F. This indicates that the unit heaters were operating without control. While it is possible that the unit heater is not responding to the thermostat, PES suspects that the thermostats are dysfunctional.

Figure 10: Ground-Level Unit Heater, with low thumbwheel setting

PES recommends replacing the two wall-mounted thermostats in the Bath Road pump house and setting the new units no higher than 55°F. During installation, the unit heater should be evaluated to ensure that it is functioning properly and responding to the thermostatic control. If needed, the unit heater should be repaired/replaced.

This should be sufficient to prevent freezing while optimizing energy conservation. Based on the conditions observed during the site visit, this measure could reduce electricity use at this pump station by approximately 17 percent, saving \$1,250 per year at today's electricity prices.
