Cheltenham Township Energy Assessment

Rowland Community Center

400 Myrtle Ave, Cheltenham, PA 19012

APRIL 2016

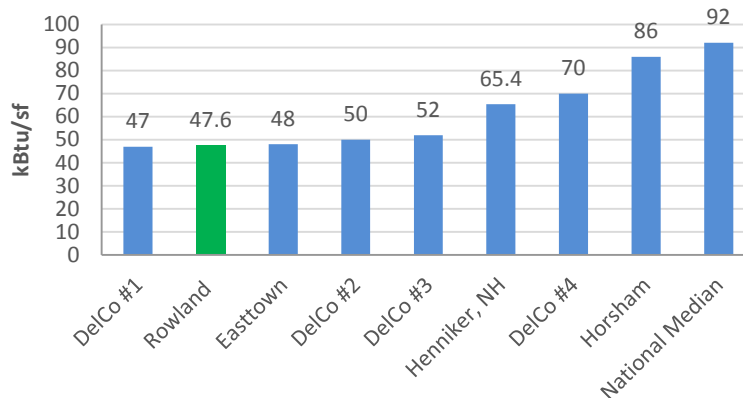
Figure 1: Regional Energy Use Intensity Scores: Libraries

The center's energy use intensity (EUI)—a common measure of total energy use per square foot—is 47.6 kBtu per sf. As shown in Figure 1 below, this energy benchmark compares favorably with other local libraries, which is the most suitable category of buildings for the Rowland Community Center. However, Rowland Community Center's favorable score is likely due to low occupancy and significant underuse of the building, as large portions remain unoccupied.

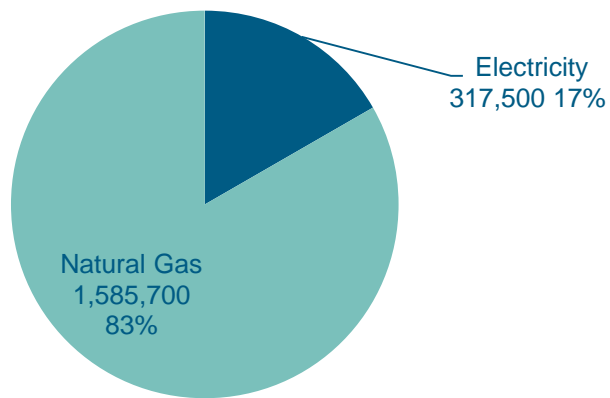
Figure 2: Energy Use in kBtus (10³ Btu)

- Natural gas comprises 83 percent of all energy used, as shown in Figure 2 below.

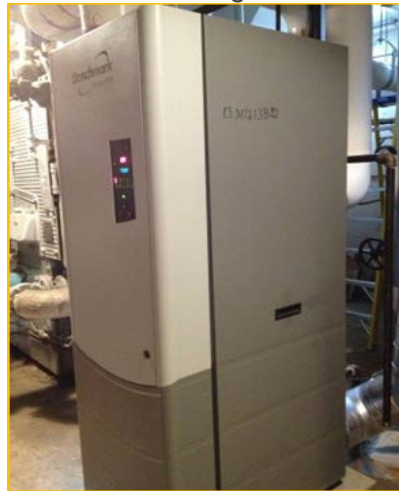
Figure 5: Condensing Hot Water Boiler

Hot water is provided to perimeter fan-coil units (FCUs) by a gas-fired Aerco Benchmark condensing hot water boiler (2,000 MBH, 91 percent thermal efficiency) installed in 2010. An image of the condensing hot water boiler is shown as Figure 5 below. This unit is in excellent condition and includes many energy-saving features such as a condensing heat exchanger, a 20:1 turndown ratio, and hot water reset control. At its lowest output, it is capable of achieving an operating efficiency of over 99 percent.

However, the other components of the heating system (i.e., FCUs, piping, thermostatic controls) are significantly older and were not designed to take advantage of the boiler's energy-saving features. There are two reasons for this:

- *High water temperatures.* Unlike conventional boilers, which corrode if return water temperatures are too low (i.e., below 140°F to 150°F) due to acidic flue gas condensation, condensing boilers operate most efficiently at low return temperatures (generally below 120°F). In fact, they lose their efficiency advantage at high return temperatures. Figure 6 below illustrates the performance curve of condensing hot water boilers. The FCUs in Rowland require higher (160°F) water temperatures and are thus not designed to operate with this boiler.
- *High heating load.* Condensing boilers are also most efficient at low loads, because they can modulate, or “power down,” with reduced hot water demand (i.e., on a mild winter day, or after setpoint is reached) (Figure 6). The water piping system in Rowland, however, requires constant water volume regardless of heating demand.

The high temperature, high water volume, and continuous, uncontrolled operation of the fan coil unit system continually place significant and high energy demands on the boiler, preventing it from operating in energy-efficient modes. As a result, the township is not realizing its investment in this expensive piece of equipment.

To enable the boiler to achieve its efficiency potential, and to significantly improve heating performance, Cheltenham Township can install more sophisticated controls (i.e., programmable controls in each room); convert the piping to a variable-flow, low-temperature loop; and replace the FCUs with units designed to operate at lower water temperatures (i.e., units with greater heat exchange surfaces). This will require significant capital investment, depending on the design and condition of the existing components, and should be a priority in any future renovation.

In addition, the Aerco Benchmark boiler is capable of outside air reset control, which conserves energy by reducing hot water supply temperature as outside air temperature increases. This is a common energy conservation strategy and should be implemented on this boiler if it is not already. It should not require any changes to the existing FCUs or hot water loop components. A typical control sequence would deliver 160°F water at ambient temperatures below 20°F, 130°F water at temperatures above 50°F, and ramp linearly between 160°F and 130°F at outside temperatures between 20°F and 50°F. This control strategy could reduce space heating energy use by 4 to 6 percent and save from 600–900 ccf of natural gas per year, further reducing gas costs by \$660–\$1,000 annually at current prices.

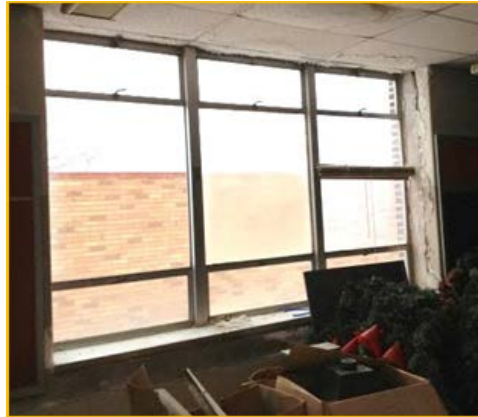
Figure 8: Typical Window

Windows in most of the building were installed in 1964 when the one-story school addition was constructed and are generally in poor condition. The combination of poor thermal characteristics and air infiltration around the window frames may be causing significant energy waste. An image of a typical window at the Rowland Community Center is provided as Figure 8 below.

Due to the low occupancy levels in much of the building, it is unlikely that replacing the windows is cost-effective at this time. However, if parts of this facility are to be rented or leased, upgrading the windows should be a priority in any future renovation.

When these windows are replaced, the bid documents should specify an assembly U-factor (i.e., glazing and frame) of at least 0.45 Btu per $\text{hr}\cdot\text{ft}^2\cdot^\circ\text{F}$. This represents an estimated 51 percent improvement in thermal performance over the existing windows and may reduce annual energy costs by nearly \$4,000 versus the existing windows.

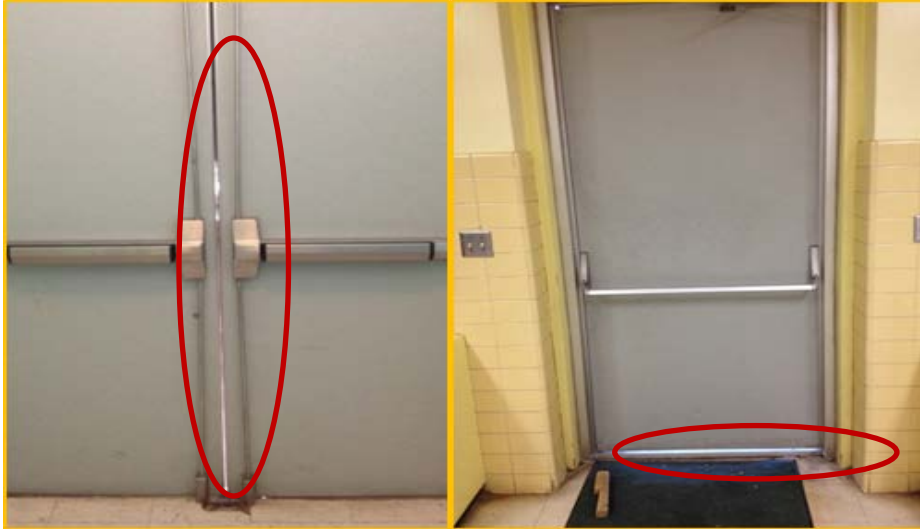
Figure 9: Doors Lacking Weatherproofing/Sweeps

PES noted that several of the metal exterior doors have insufficient weatherproofing and door sweeps, and they have sizeable air gaps around the frames and door bottoms, as shown in Figure 9 below. In many cases, this is a relatively simple fix requiring new weather-stripping around the door frame and a door sweep on the bottom. PES recommends installing a high-quality vinyl weather-stripping product with a metal backing that is mechanically attached (bolted) to the door. Adhesive-backed weather-stripping is insufficient and should be avoided.

PES also noted that the east interior vestibule doors are missing; as a result, the vestibule is ineffective at blocking cold air infiltration. This vestibule should be repaired before the next heating season.
