Phoenixville Borough Energy Assessment Civic Center

123 Main Street, Phoenixville, PA 19460

Practical Energy Solutions of West Chester, PA

APRIL 2016

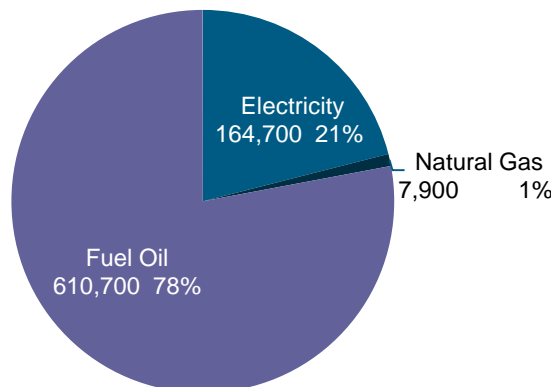
Figure 1: Energy Use in kBtu (10³ Btu)

- On a Btu basis, more than two-thirds of all energy used is due to the use of #2 heating oil for space heating, as shown in Figure 1 below.

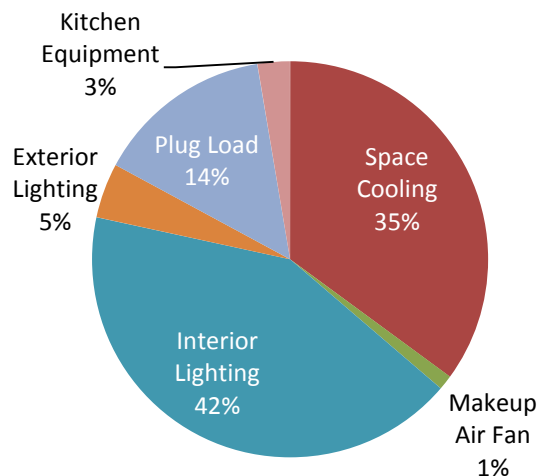
Figure 2: Electricity End Uses

- Figure 2 below shows all electricity end uses. Forty-two percent of all electricity is used for lighting, and 35 percent is used for air-conditioning.

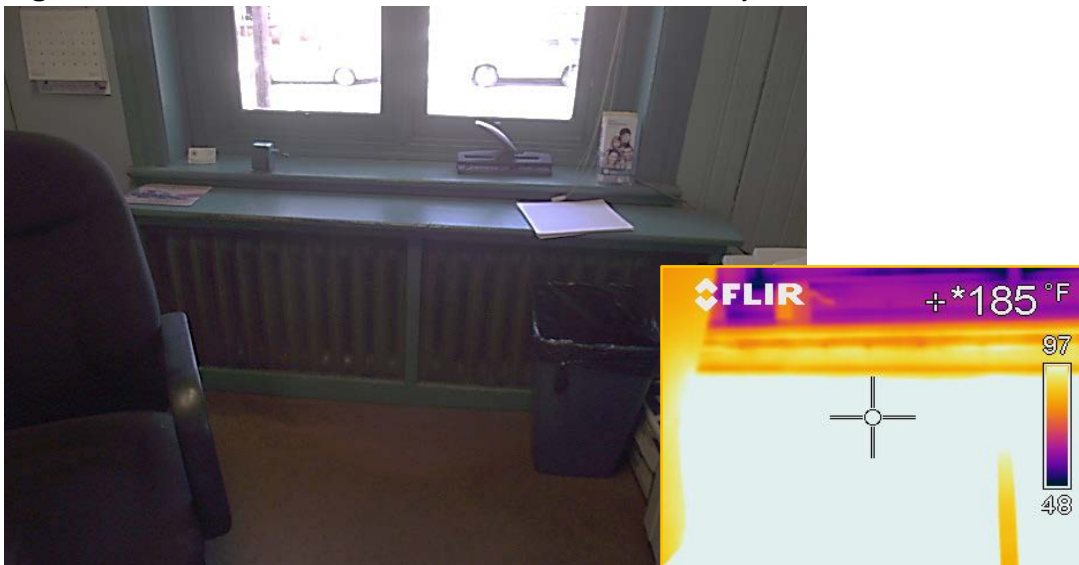
Figure 3: Uncontrolled Steam Radiator in Close Proximity to Office Worker's Desk

These thermostats must be set high (typically 75°F to 85°F) to provide sufficient heat to the floor above, causing significant overheating and energy use on the floors below. Specifically, personnel must increase the first-floor thermostat setpoint to adequately heat the daycare center above, and this overheats the first-floor offices. Similarly, to heat the gym, employees turn the basement thermostat up to 85°F and manually open the unit heater steam valves. This, in turn, overheats the entire basement, and if employees forget to set back the thermostat after the gymnasium is no longer in use, this energy use can go unnoticed for days.

As a result, many rooms are overheated, and employees are uncomfortable. Figure 3 below shows two images captured during PES's site visit in the first-floor front office. The photograph on the right of Figure 3 is an image taken with an infrared camera. The circle centered in the infrared image was aimed at one of the steam radiators and measured 185°F, while the temperature above the radiator near the window measured closer to 48°F. As shown in the picture on the left of Figure 3, this radiator was within several feet of an employee's desk.

Installing TRVs on the most relevant single-pipe radiators in the facility within each temperature zone will allow the radiators to maintain their own setpoints, which should reduce overheating and conserve energy.

These devices are relatively inexpensive, and installing the TRVs will reduce current heating energy use by as much as 18 percent.

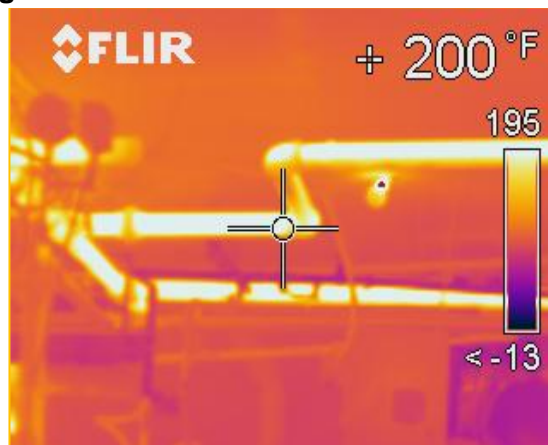
Figure 4: Heat Loss via Uninsulated Steam Pipes

PES also observed that long lateral piping sections were uninsulated. According to the borough's HVAC contractor, asbestos insulation was removed in the 1980s. As a result, there is significant heat loss, and significant premature condensation causes pipe degradation and leakage, requiring ongoing repairs. Figure 4

is an infrared image captured during the site visit showing high (200°F) surface temperature of the steam pipes and a high ambient temperature in the mechanical room, indicating significant energy loss.

Installing mineral fiber or equivalent pipe insulation could reduce current heating energy costs by up to 7 percent, assuming 1" insulation on piping 4" in diameter and smaller, and 2" insulation on pipes larger than 4". Table 3 shows the energy savings and paybacks for these immediate HVAC measures.

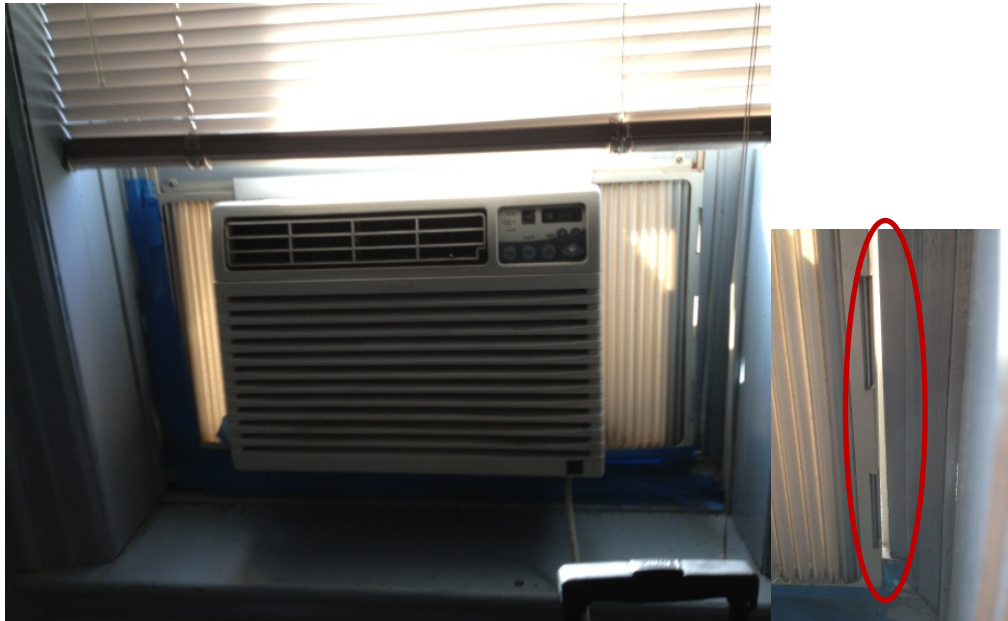
Figure 5: Window Air Conditioner, With Infiltration

The building also contains window air conditioners for the offices and daycare. At the time of our wintertime visit, several air conditioners remained in place. Employee interviews indicate that some additional units may have been removed for the winter. The units that remained in place were in generally poor condition and were not sealed in the window frame, allowing significant air infiltration, as shown in Figure 5. This increases both heating and cooling energy use and costs.

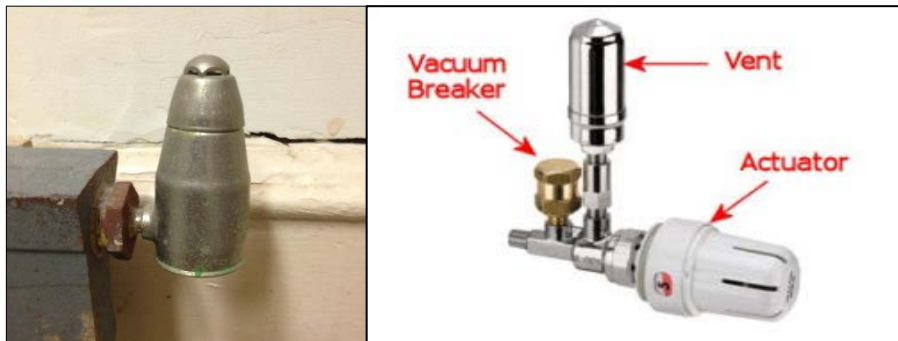
Figure 6: Existing Air Vent (left) and Sample Replacement TRV (right)

Care must be taken to choose a TRV for the single-pipe steam system, as this method of steam distribution differs significantly from other steam heating systems. The one-pipe TRV, which will replace the existing radiator air vent, is equipped with an adjustable thermostatic operator that allows the radiator to fill with air (and therefore block steam flow) when the temperature setpoint is met. The TRV should also have a built-in vacuum breaker to prevent condensate from getting trapped in the radiator. Figure 6 below shows an image of the existing air vent on the left and a sample illustration of a one-pipe TRV to the right.

Since the one-pipe TRV functions by controlling air escape from the radiator, it will work only if the boiler is controlled by temperature, not steam pressure. Leaving a pressuretrol in place will force constant steam pressure and prevent proper TRV operation. To ensure compatible boiler operation, consider a timed outdoor air sensor for the boiler or a master programmable thermostat that will not continuously call for heat, and disconnect the two manual thermostats in the building. In addition, radiators with covers should be installed with remote temperature sensors to ensure proper function.

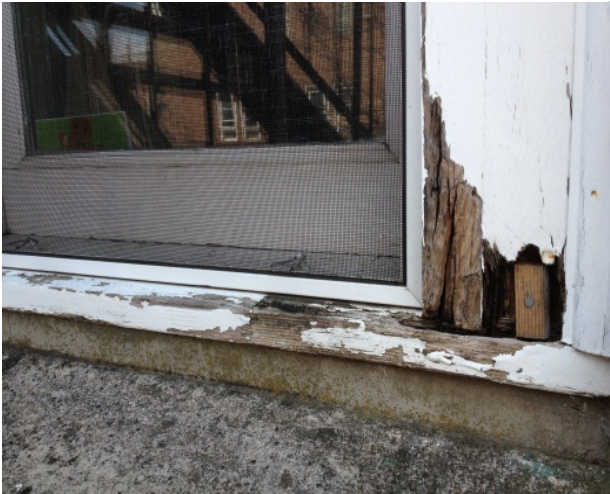
Figure 7: Window Frame

PES investigated the major building envelope components including walls, windows, and doors for signs of poor energy performance. The building envelope is generally in good condition with the exception of the first-floor windows, which show signs of damage and decay as shown in Figure 7 below. These windows should be replaced, but this will yield negligible energy savings because the existing windows have relatively good thermal performance due to their wood frames and double-paned glazing.

Finally, PES recommends replacing windows on the first floor of the building due to significant frame damage and placing a doorsweep on the second-floor daycare exterior door.

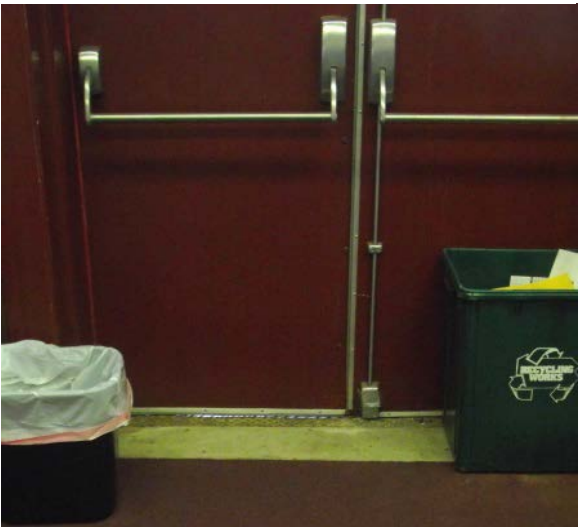
Figure 8: Daycare Door

PES noted a visible air gap around the bottom of the second-floor exterior door in the daycare center, as highlighted in the red circle in Figure 8 below. In many cases, this is a relatively simple fix requiring new weather-stripping around the door frame and a door sweep on the bottom. PES recommends installing a high-quality vinyl weather-stripping product with a metal backing that is mechanically attached to the door. Adhesive-backed weather-stripping is insufficient and should be avoided.
