Enhancing PART Bus Stops in the Pottstown Area

July 2023

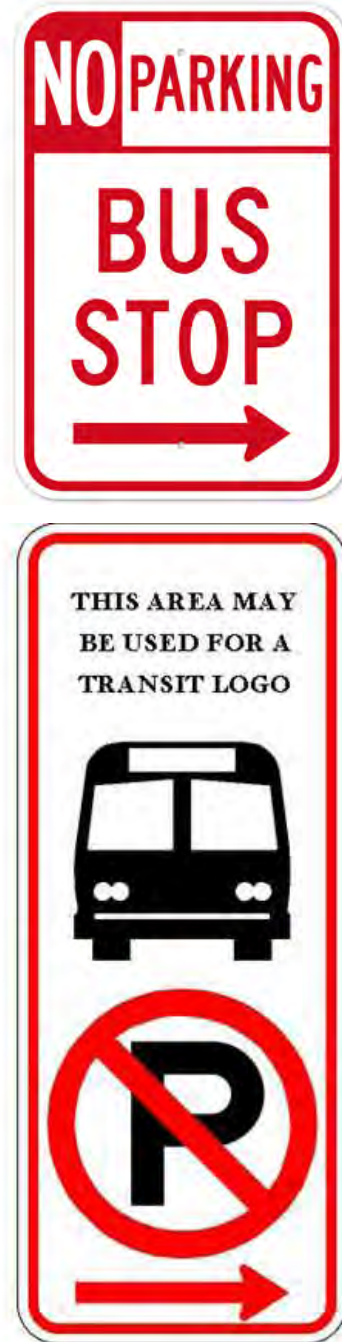
Figure 8: MUTCD No Parking Signage for Bus Stops

The interaction between parked vehicles and buses is considered in locations where on-street parking or loading occurs. To ensure that buses have ample space to decelerate, stop, and accelerate, parking should be restricted using signage and the bus zone should be delineated using pavement markings and/or painted curbs. Pavement striping indicating the bus stop location also provides additional visibility for the stop area. Two examples of no parking signs are provided in Figure 8.

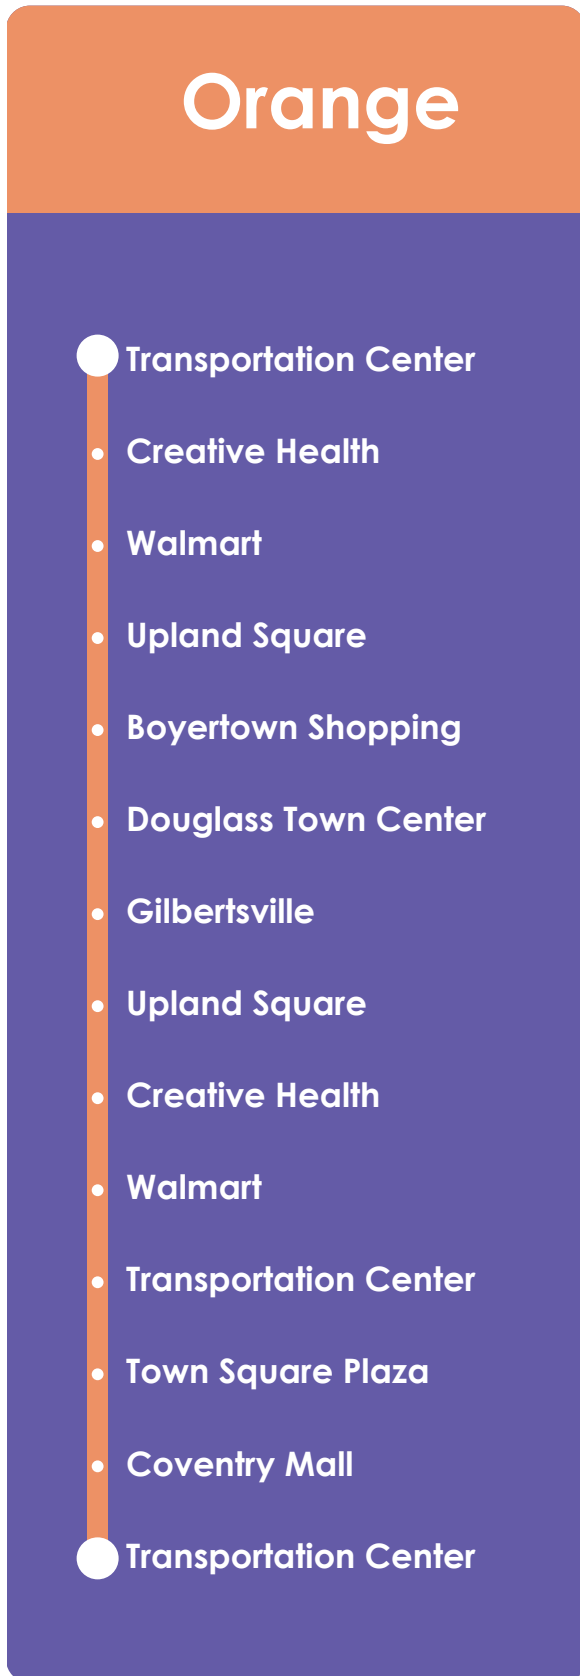
Figure 11: Enlarged Route Description Sign

New signs address some of the largest concerns from riders, namely identifying which route stops at a particular stop, along with a detailed route description.

The recommended signs were designed in a modular manner, so that they could be paired with other signs as appropriate. For example, the PART system map is recommended at higher-ridership stops, but can be complemented with the more diagrammatic line signs shown in Figure 11.

The sign concepts presented in Figures 11 and 12 were designed to comply with ADA readability standards. However, many sign elements, such as text height, must be verified during fabrication. See the link below for more information on ADA signage requirements.

The project team also considered color-blindness when developing new signs. Tritanopia, which is a form of blue-yellow colorblind, can make blue and purple hard to distinguish, but other types of color-blindness do not pertain to the color scheme used in these signs. Adding shadow and contrast to the blue sign may be necessary before fabrication. Monochromatic signs can also be considered.

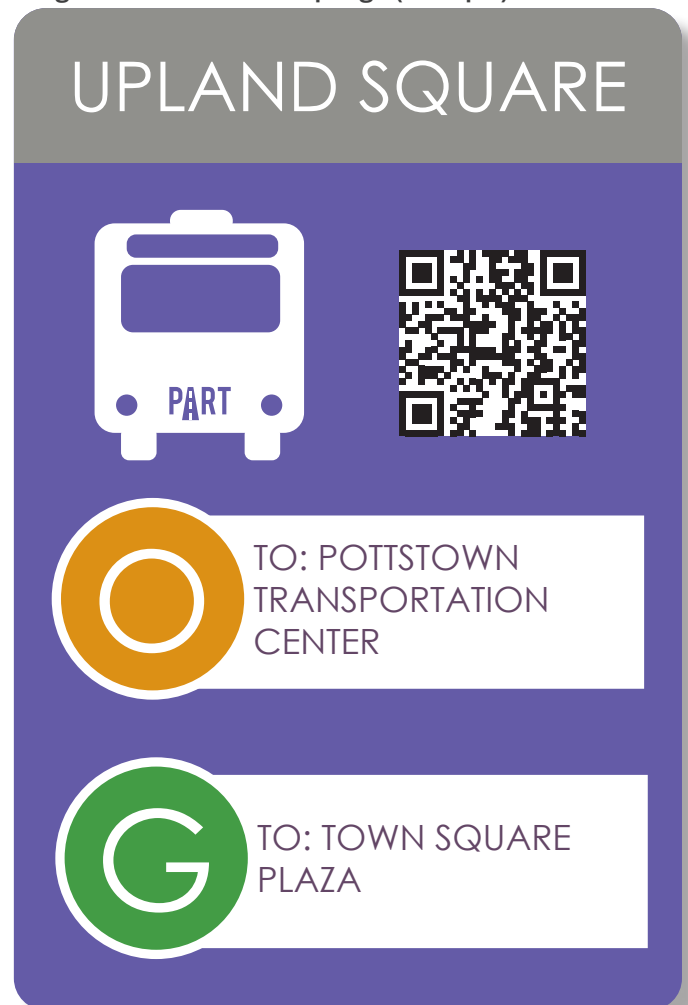
Figure 12: Standard Stop Sign (Example)

Figure 12 shows a conceptual recommendation for a typical stop sign. With a large number of current and potential riders expressing interest in online maps or schedules, the design includes a QR code topoint to those resources. Recommended stop signs also include the name of the stop and the routes.

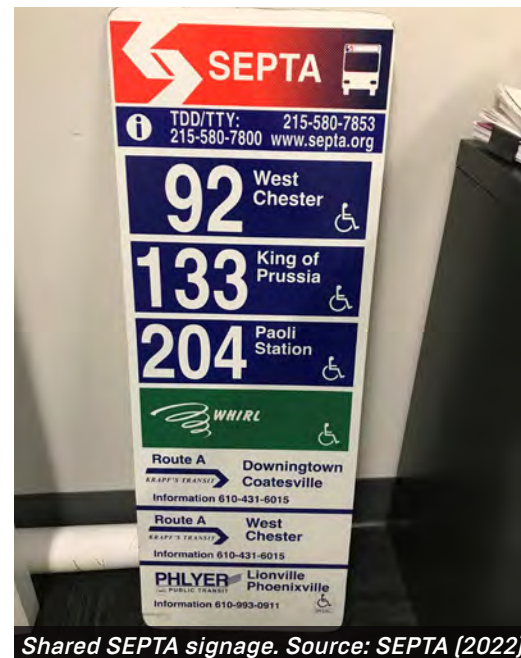
Beyond central Pottstown, along the High Street corridor, SEPTA bus stop signs already exist at the inventoried stop locations shared with PART. Joint signs could be created for shared bus stops that include SEPTA bus stop ID information along with the necessary PART route and stop information. SEPTA has previously produced joint signs for stops shared with Transportation Management Association of Chester County for its SCCOOT

Shared SEPTA signage. Source: SEPTA (2022)

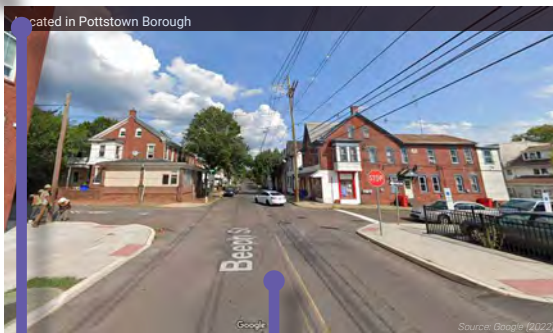
Beech & Evans

The Westbound Yellow line stops in front of the Beech Street Factory Lofts on Beech Street. There is no information indicating that a bus stops here. An existing building overhang provides shelter for waiting passengers, but a bench and trash can, along with a PART sign with branding and route information, is recommended to increase visibility. Signs should be placed in an area without a planted buffer between the sidewalk and the curb to signify an appropriate passenger loading area. A bus zone should be painted in the street to prevent vehicles from parking or blocking the passenger loading area.

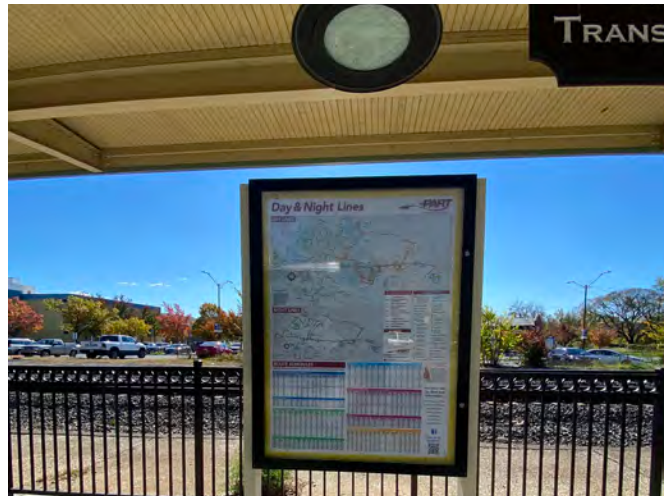
Charles W. Dickinson Transportation Center Signage
Source: DVRPC (2021)

The transportation center serves as the main transfer hub for the entire PART system. All PART routes stop here, often at the same time during the hour to allow for easy and efficient transfers. There is ample shelter and seating, some lighting, and even outlets for charging while waiting for the bus. Being adjacent to High Street in Downtown Pottstown, sidewalks are abundant. The most substantial need for improvement is signage and information. While signs exist to show that the bus stops at the transportation center, they are small and outdated.

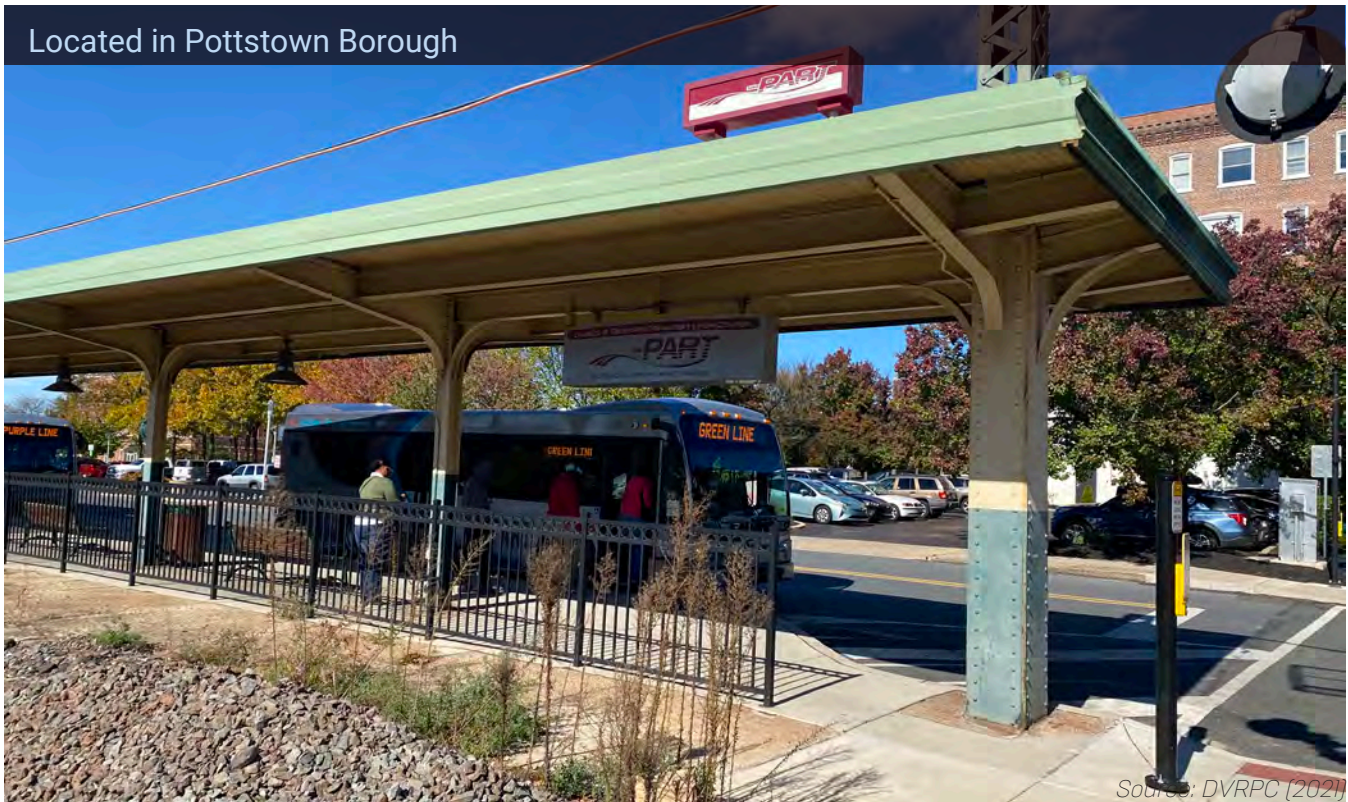
Charles W. Dickinson Transportation Center

Similarly, there is a large board displaying a printed ride guide with map and schedules. However, the routes and schedules are no longer accurate. While the ride guide presents some information about fares and transfers, the font is small and it is difficult to see through the scraped plastic covering. Since this is the transportation center, any and all information someone would need to learn how to ride the system should be easily available here, even if that means multiple standing sign boxes are needed.

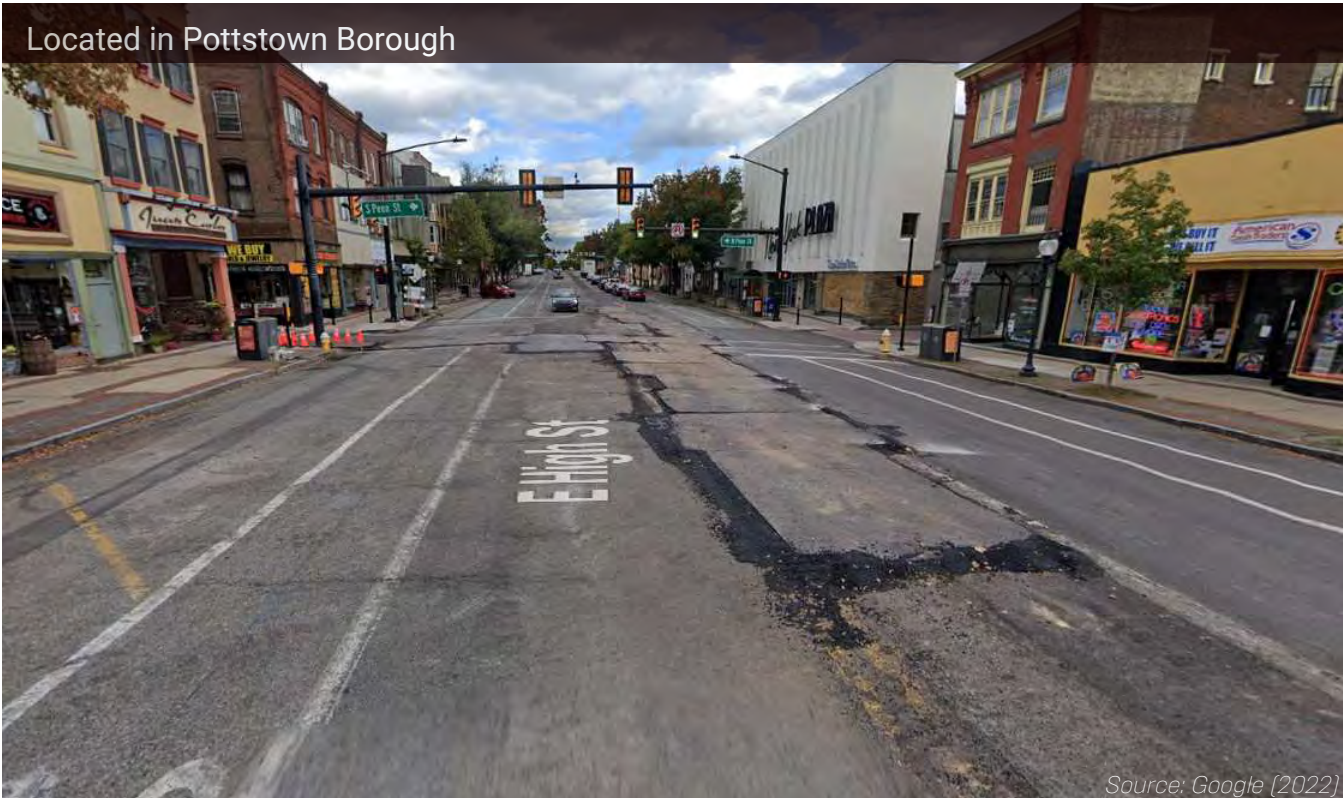
High & Penn

Both the Blue and Purple Lines stop at the intersection of High & Penn, with the eastbound bus (Blue Line only) stopping at its southeast corner (in front of the New York Plaza) and the westbound bus stopping at its northwest corner (in front of the Twice as Nice Auction Hunters). This stop is located in the high-density, Downtown area and both the Blue and Purple Lines run into the night, so it is necessary for this stop to be as complete with amenities and accessibility as possible.

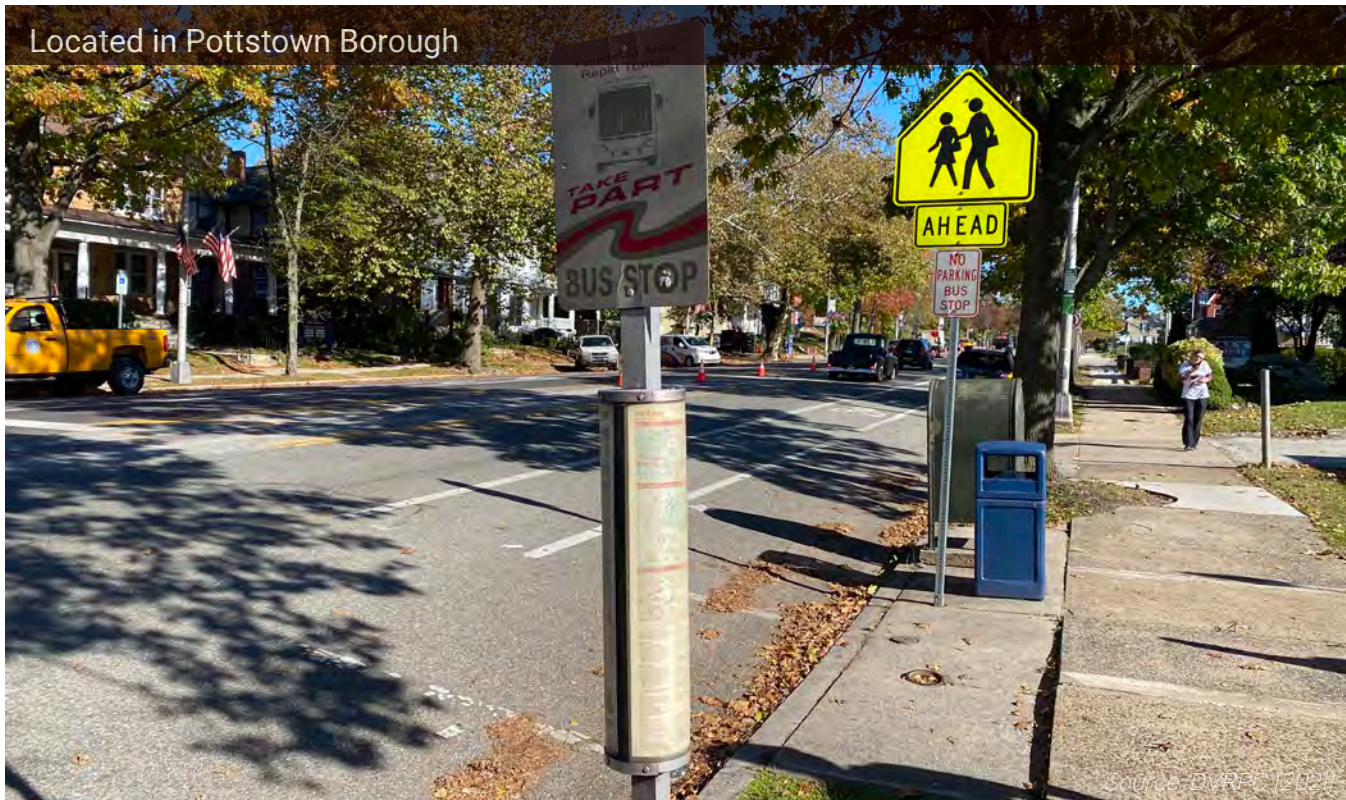
The offset intersection of High & Adams is located just east of the Downtown Pottstown core. The Blue and Yellow PART routes stop on either side of the street, along with SEPTA's Route 93, connecting Pottstown to the Norristown Transportation Center.

A sign indicating the PART stop location is currently present, but could be improved with updated branding and additional route and transfer information, making it easier to identify and use the system. While a shelter with ADA-compliant seating would be nice for consistency along the High Street commercial corridor, space is limited between the sidewalk and the curb and adjacent properties also have limited excess space near the sidewalk.

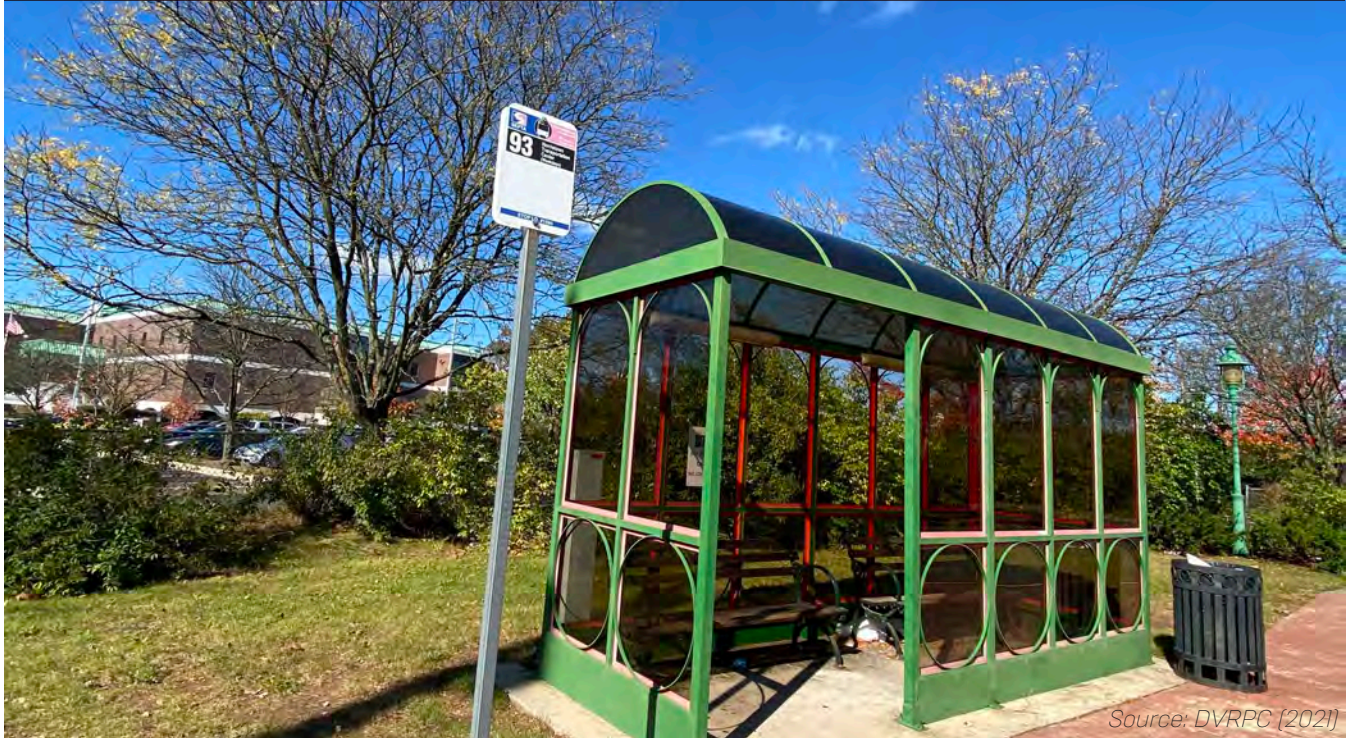
Located in Pottstown Borough

The Green Line stops at Montgomery County Community College a few blocks from Downtown Pottstown. This stop provides ample space for waiting, loading, and ramp deployment, as well as well-maintained amenities. While there is some lighting in the area, it could be improved, since students use the bus after hours and may often be waiting in the dark after evening classes.

There are signs detailing SEPTA's service at the stop, but no PART-specific signs. Signs with PART branding and route information are a priority. Additionally, a full system map is recommended to increase awareness of the useful connections that can be made using the PART system.

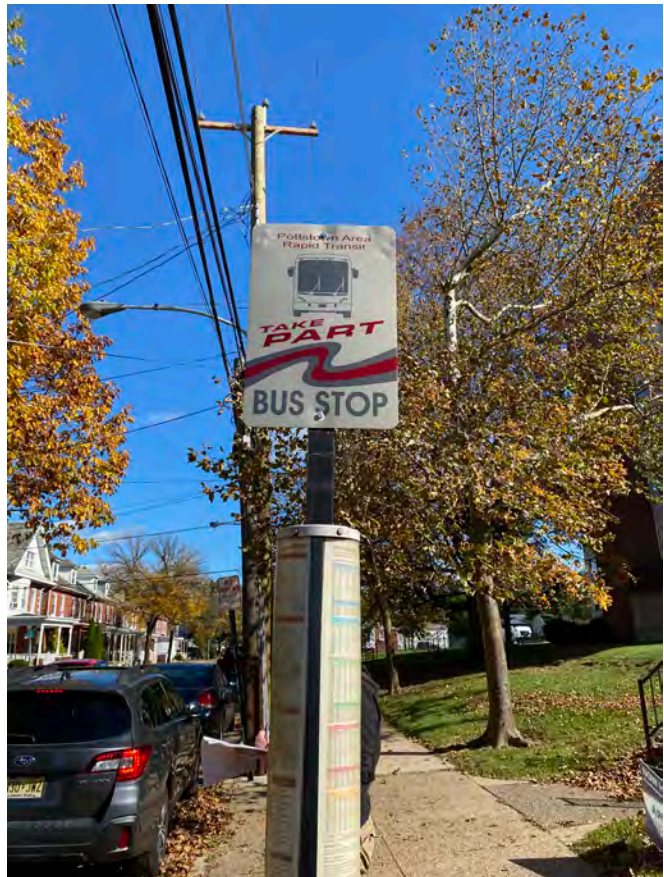
Figure 26: Neighborhood PART Stops

A neighborhood stop with old signage. Source: DVRPC (2021)

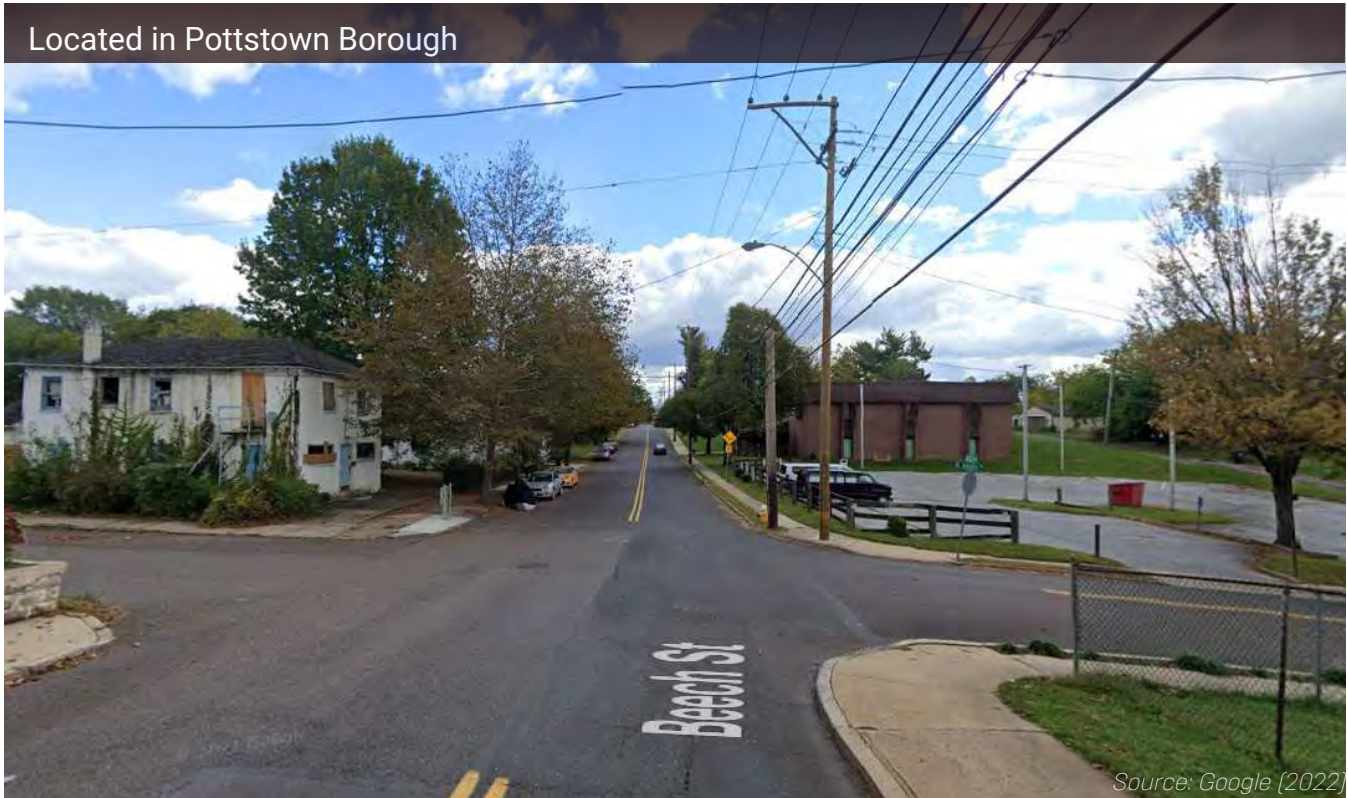
Located in Pottstown Borough

The Yellow Line stops at the intersection of Beech & Adams, with the northbound-turning-eastbound bus stopping at its southeast corner and the westbound bus stopping at its northeast corner. While this stop is in a relatively high-density area, for neighborhood stops, only the most essential stop amenities and accessibility features are recommended. There is no indication that a bus stops here. To solve this problem, signage with PART branding and route information needs to be installed. The northbound/eastbound side has a light pole, and a light pole for the westbound side would be nice,

but is not needed because the Yellow Line primarily operates during daylight hours. There is enough room for riders to wait for and load the bus on both sides, but these areas are not designated, and the passenger loading area for the northbound/eastbound side is not paved. The westbound side has enough room for a ramp to be deployed from the bus for wheelchair access, but the northbound/eastbound side does not, at least without forcing riders into the grass. To solve this problem, the sidewalk needs to be widened. Lastly, while both sides have sidewalk access, the sidewalks leading to the westbound side are in poor condition and need to be improved.

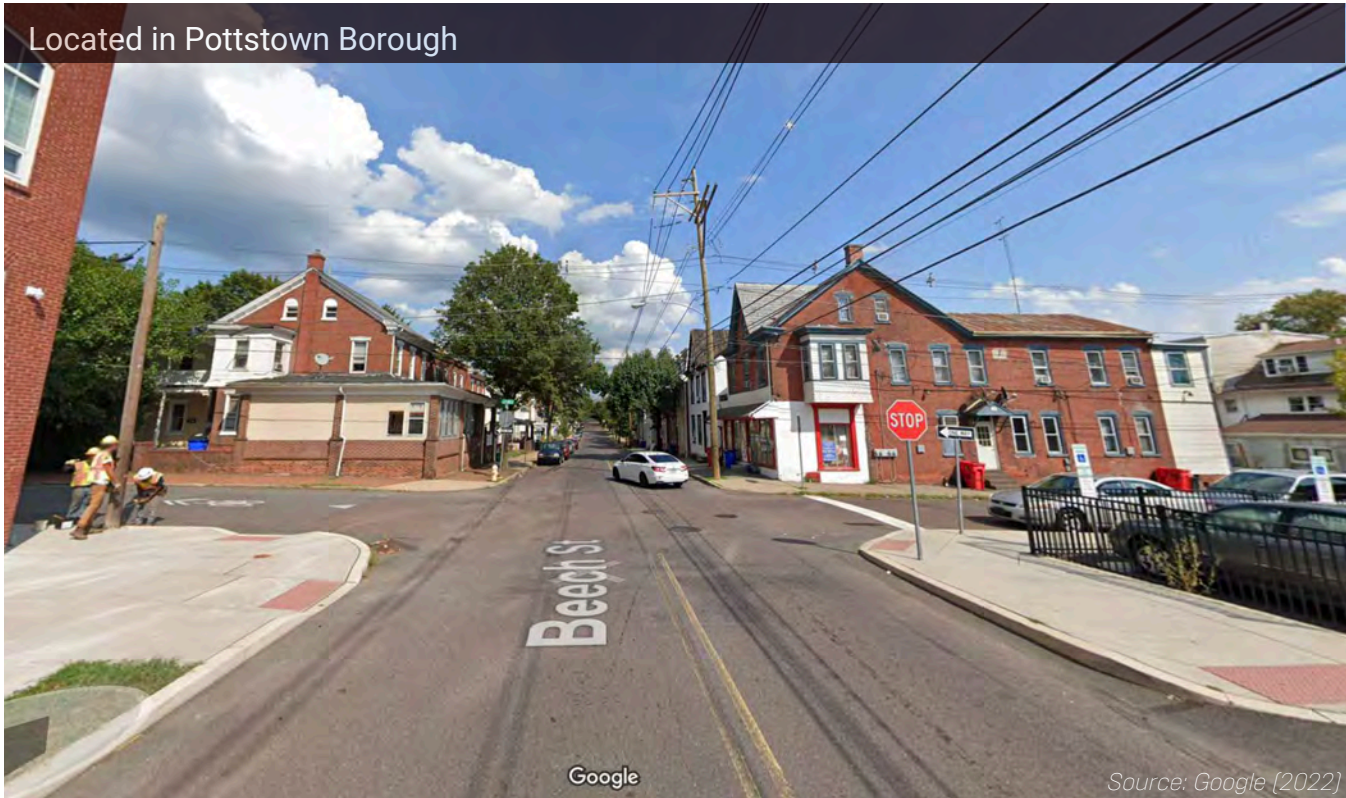
Located in Pottstown Borough

The Westbound Yellow Line stops in front of the Beech Street Factory Lofts on Beech Street. There is no information indicating that a bus stops here. An existing building overhang provides shelter to waiting passengers, but a bench and trash can, along with a PART sign with branding and route information, is recommended to increase visibility.

Signs should be placed in an area without a planted buffer between the sidewalk and the curb to signify an appropriate passenger loading area. A bus zone should be painted in the street to prevent vehicles from parking or blocking the passenger loading area.

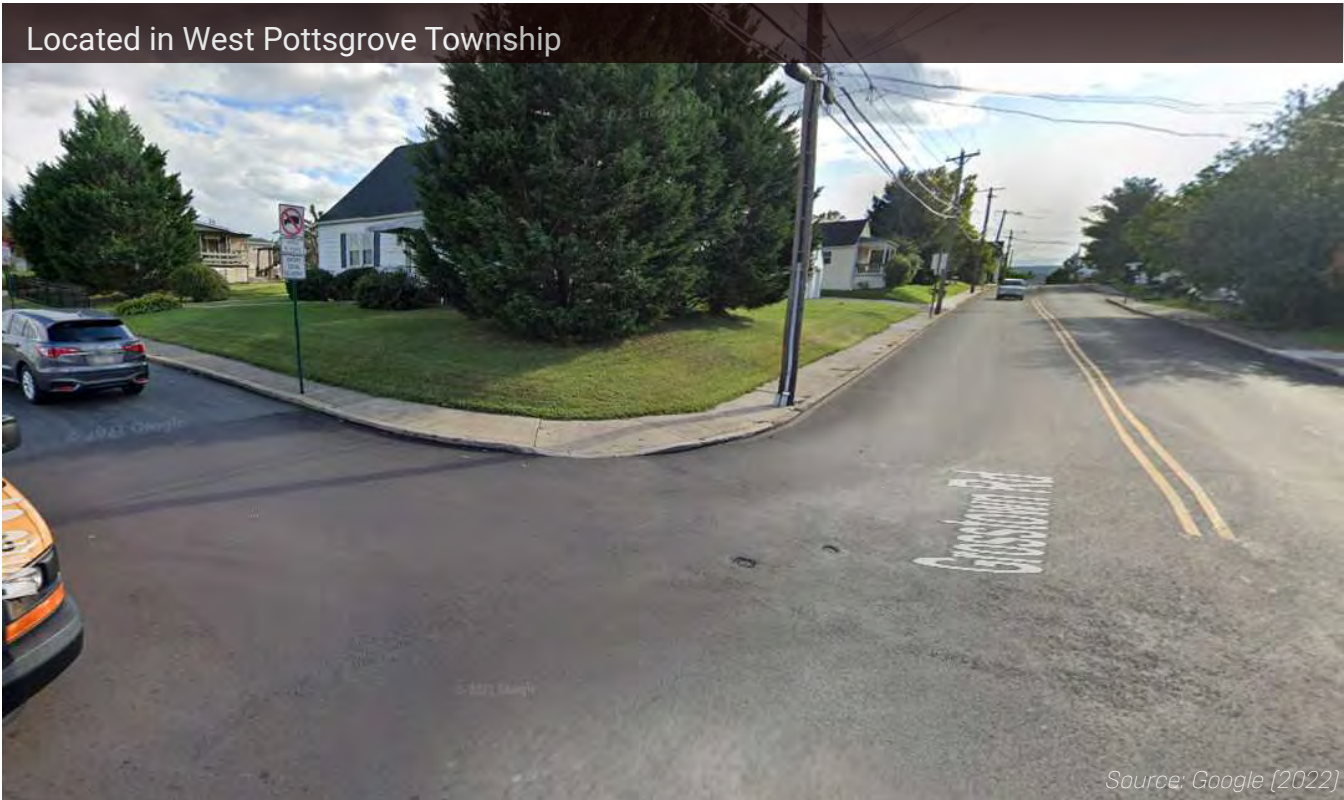
Berks & Grosstown

The Green Line stops at the southeast corner of Berks & Grosstown. There is currently no indication that a bus stops here. Signs and route information are a priority. While there is sidewalk leading to this intersection, it is very

narrow, limiting the potential installation of any shelter or street furniture. A larger concrete pad is recommended next to the new sign to designate a waiting and passenger loading area, and create space for ramp deployment.

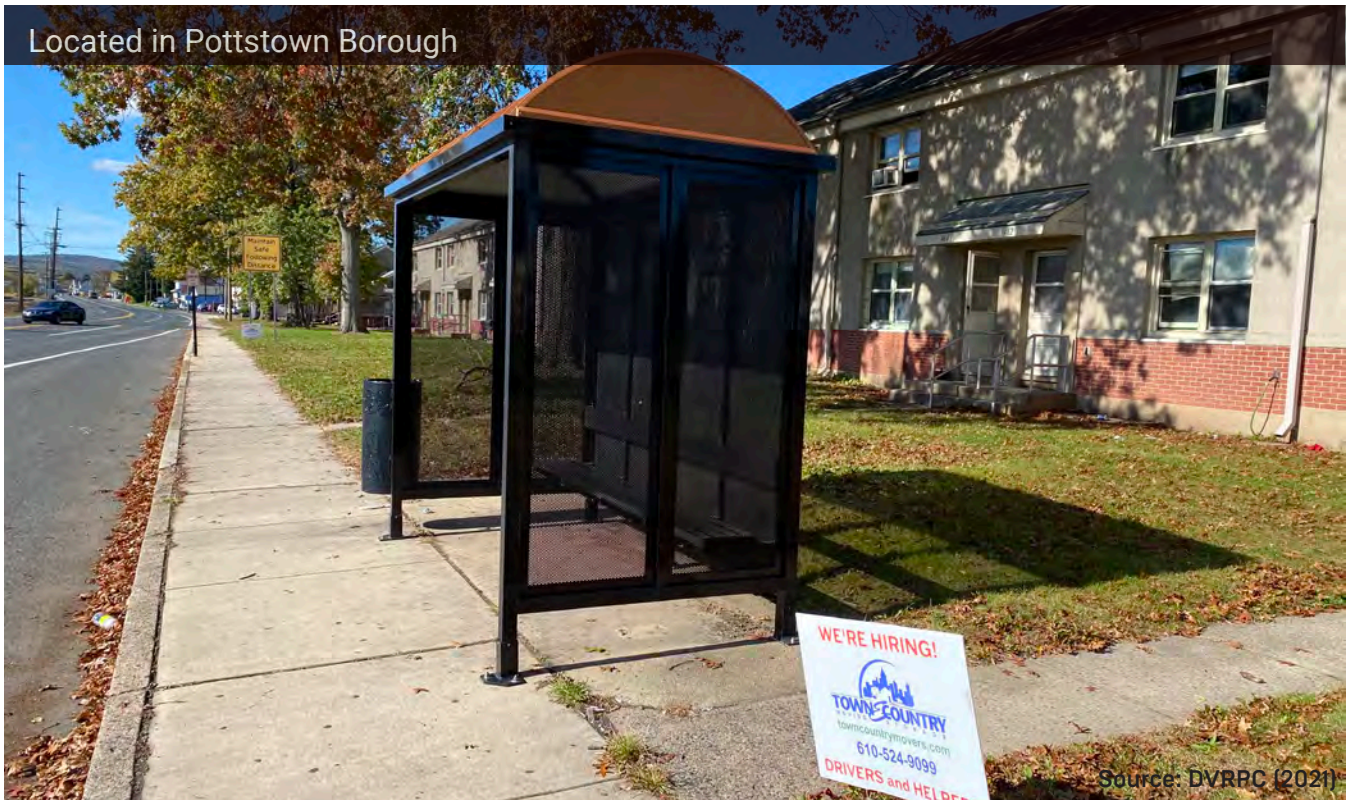
Located in Pottstown Borough

The Green Line stops along High Street in front of the Bright Hope Community. This neighborhood stop is accessible via sidewalk and has most of the recommended amenities, including a shelter, seating, and a trash can. There is ample waiting and loading space, as well as room to deploy a wheelchair ramp.

The greatest need in this location is information. Signs with PART branding and route information are a priority for addition to the existing shelter.

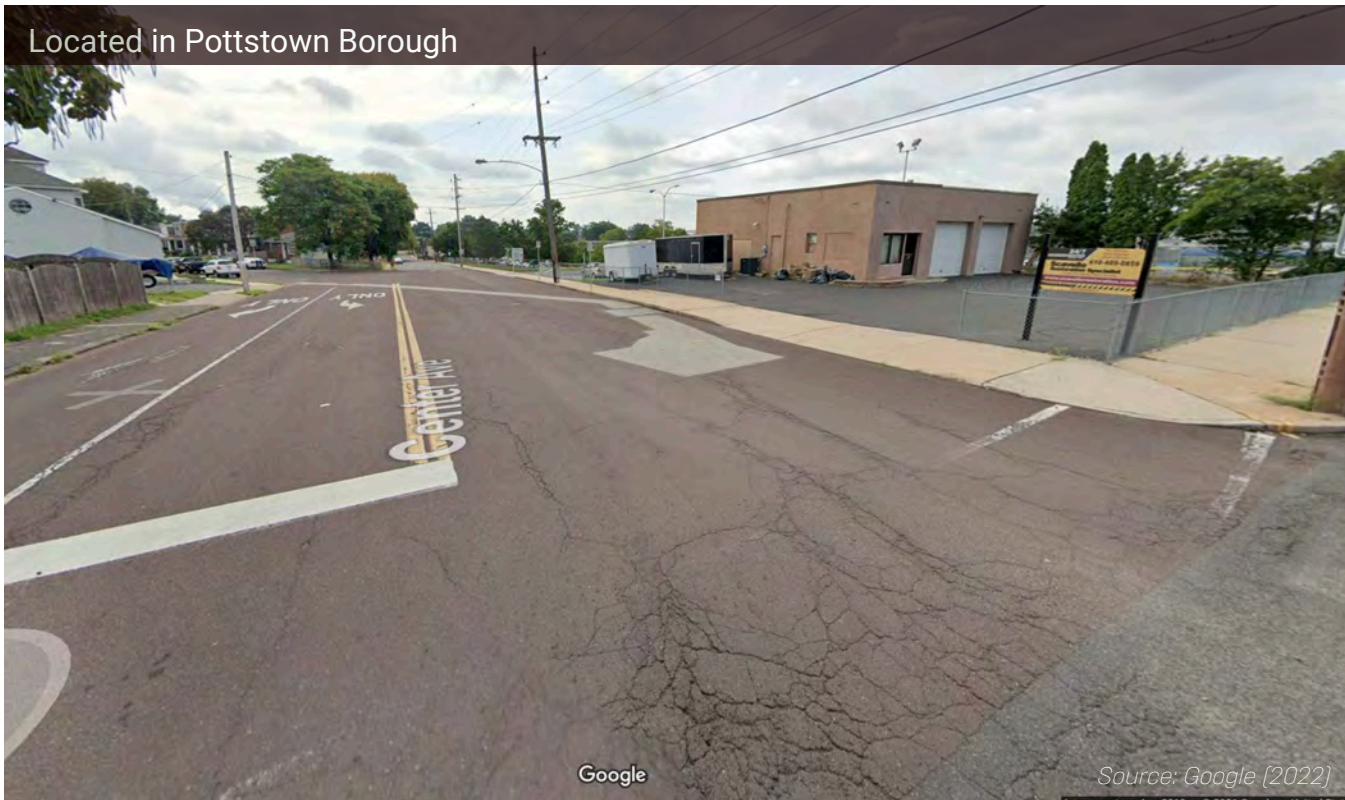
Center & Keim

The Yellow Line stops at the intersection of Center & Keim. The only indication that a bus stops here is a no parking sign along Center Avenue. There is no designated waiting or passenger loading area and no amenities for passengers waiting for the bus. While narrow sidewalks may limit the amenities that

will fit in the stop area, existing sidewalks are wide enough to support a passenger loading area with space for ramp deployment. Signs with PART branding and route information are a priority for implementation at this stop. Sign placement will help designate waiting and passenger loading areas for passengers.

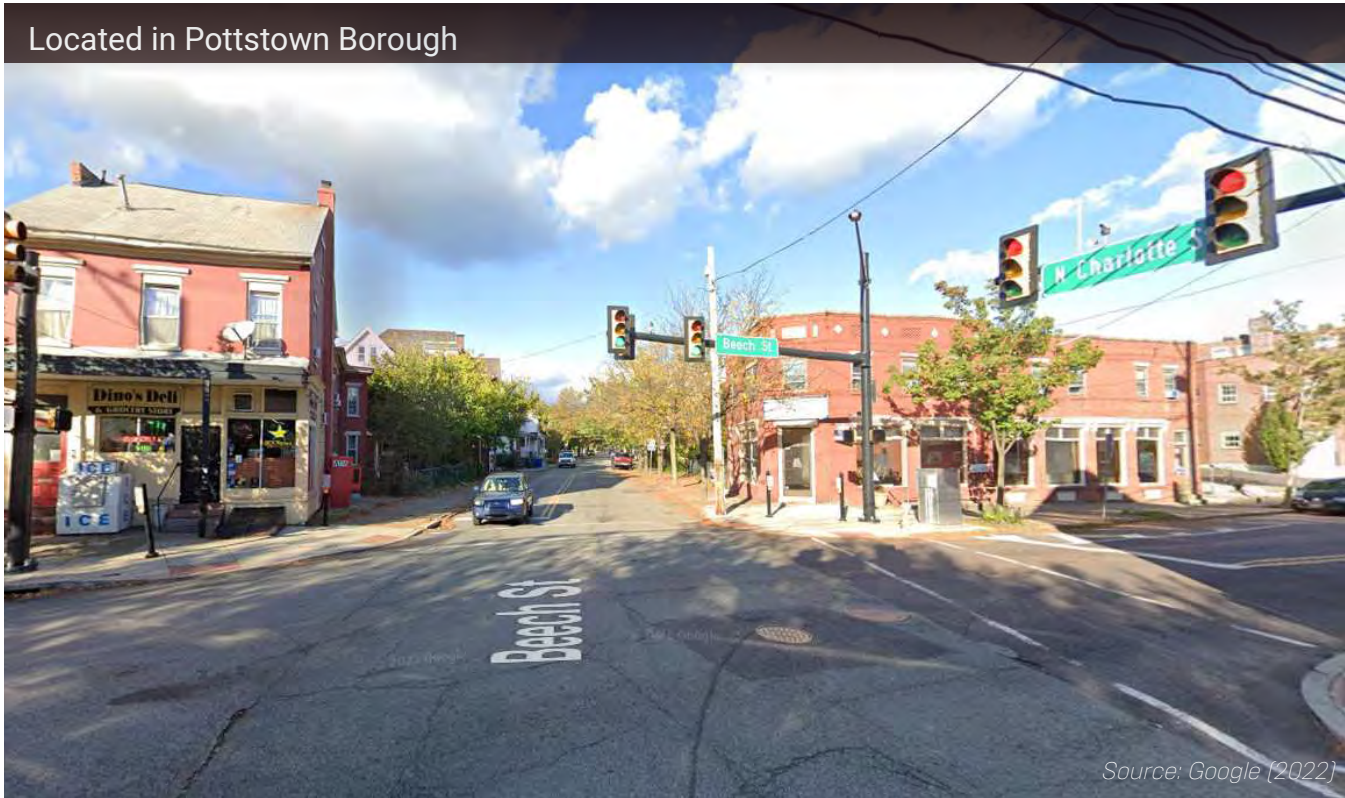
Located in Pottstown Borough

Both the Purple Line and Yellow Line stop at the intersection of Charlotte & Beech Streets, with the southbound Purple Line stopping at its northwest corner (in front of Dino's Deli and Grocery Store) and the westbound Yellow Line stopping at its northeast corner.

While this stop is in a relatively high-density area, for neighborhood stops, only the most essential stop amenities and accessibility features are recommended. The only indication that a bus stops here is striping in front of the northeast corner.

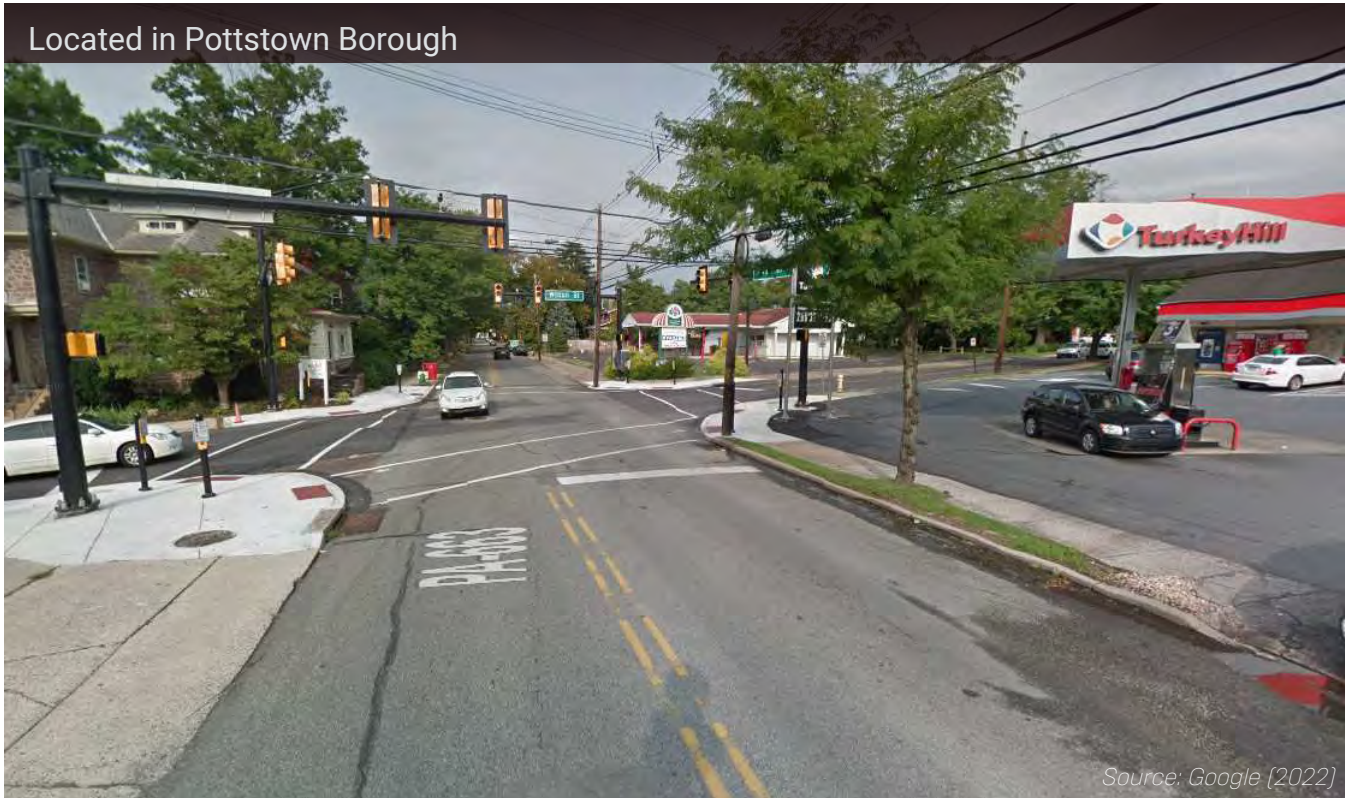
Charlotte & Wilson

The Purple Line stops at the intersection of Charlotte & Wilson, with the northbound bus stopping at its southeast corner (in front of the Turkey Hill Mini Mart) and the southbound bus stopping at its northwest corner. This neighborhood stop is located in a relatively high-density area and is also a high-ridership stop on Saturdays. While it does not require every amenity or accessibility feature, it does need more than the typical neighborhood stop. There currently is no indication that a bus stops here. Signs with PART branding and route information are necessary on both sides.

This stop has little extra space available for shelters, seating, and trash cans, so while these amenities would be nice, it is not realistic to add them in the near future. The southbound side has a light pole, but the southeast corner would benefit from additional lighting, as the Purple Line runs into the night. There is enough room for riders to wait for and load the bus on both sides, but the passenger loading area on the northbound side is not paved. There is enough room for a ramp to be deployed from the bus for wheelchair access on both sides, though the ramp would block most of the sidewalk.

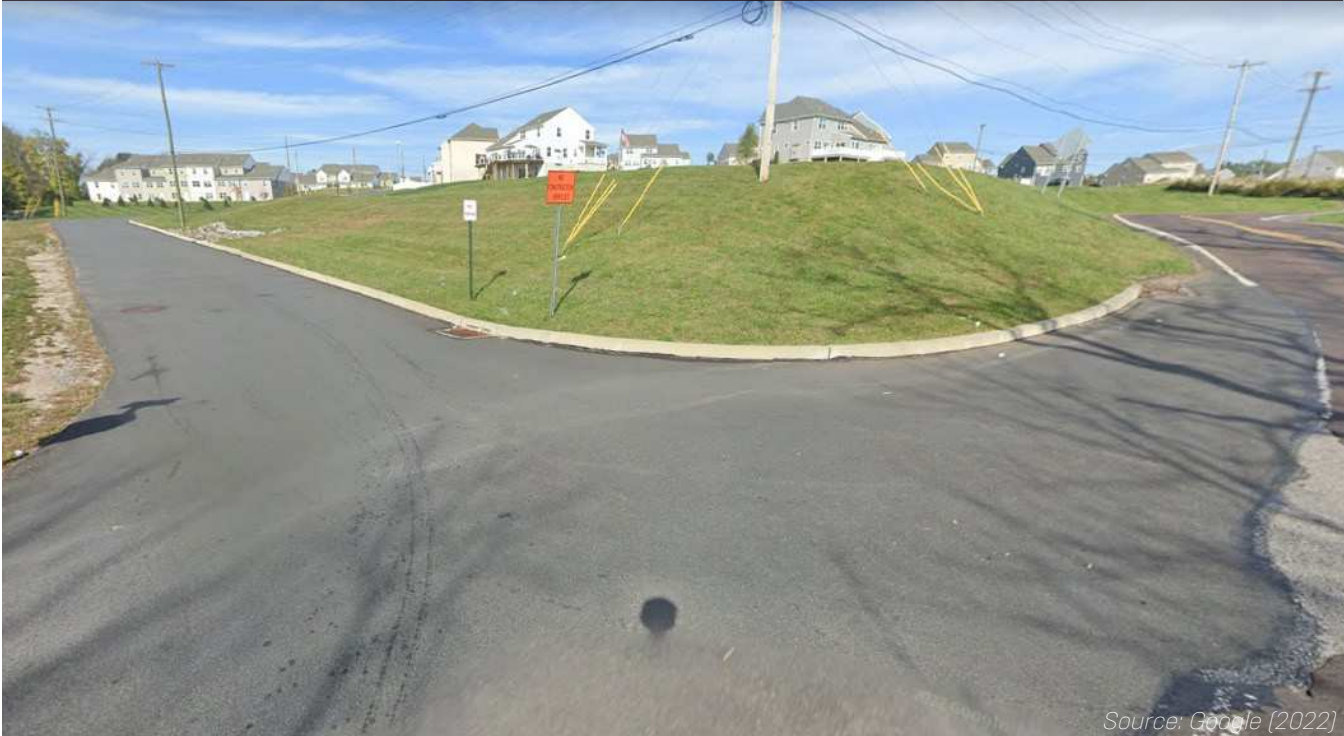
Cross & Moyer

The westbound Orange Line stops at the northeast corner of the intersection of Cross & Moyer. This neighborhood stop is in an isolated, low-density area, and is not considered a high-ridership stop. There is currently no indication that a bus stops here. Signs with PART branding and route information are necessary to increase visibility of the PART service in this area. Lighting would be nice, but since the Orange Line primarily operates during daylight hours, it is not a high priority.

The stop is on a large, grassy knoll, so there is no level space for riders to wait for and load the bus, or for a ramp to be deployed from the bus for wheelchair access. A concrete pad for waiting and loading is recommended. Also, there is no access to the greater sidewalk network. Creating new sidewalk connections is beyond the scope of specific stop area recommendations, but is something that would benefit PART access in this area.

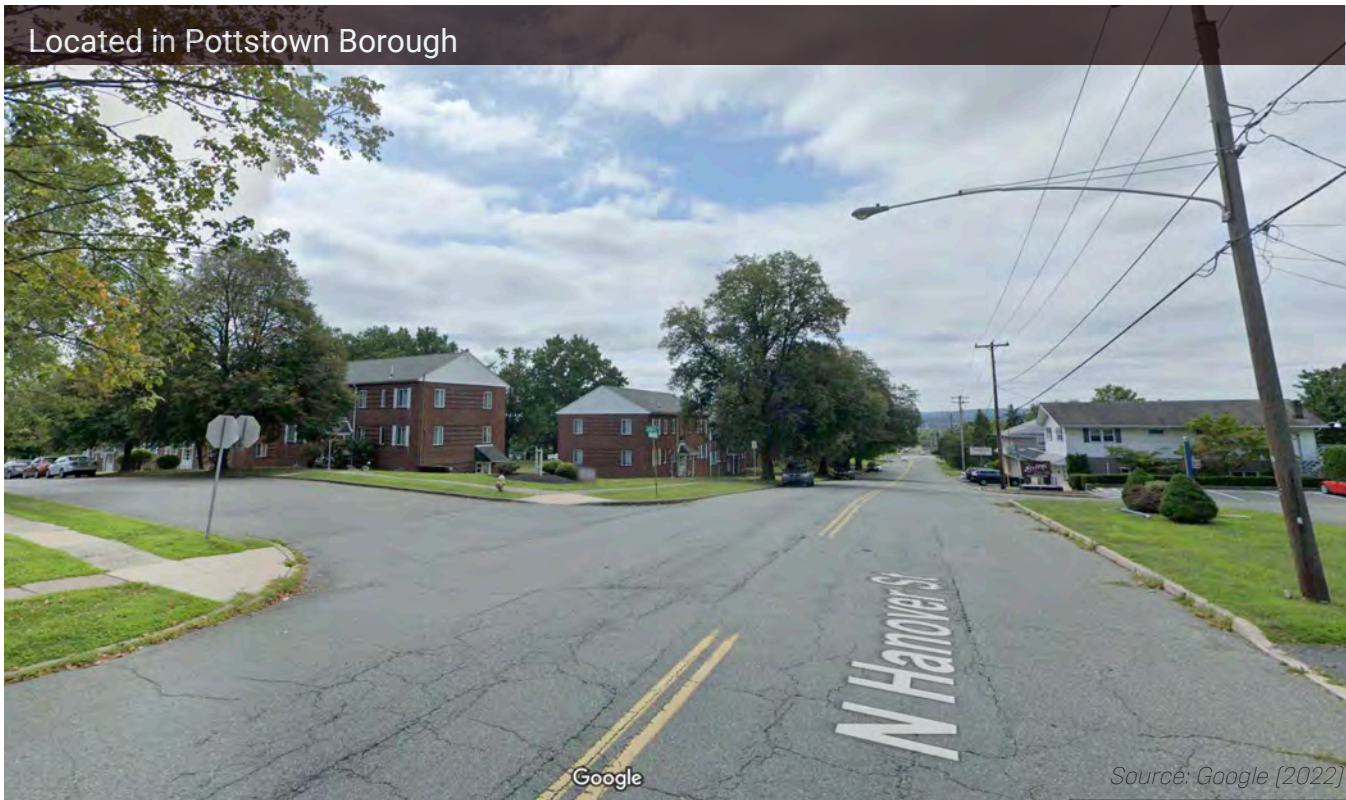
Grace & Hanover

The Yellow Line stops near the intersection of Grace & Hanover, as the bus turns right from Grace to Hanover Street. There is currently no indication that a bus stops here, so signs with PART branding and route information are a priority. Sign placement can be used to designate a waiting area. A concrete pad in the grass strip between the sidewalk and the curb is recommended for loading and ramp deployment.

Since this is a relatively low-ridership neighborhood stop, additional amenities such as shelter and seating would be nice, but are not required. Additional sidewalks in the neighborhood on the west side of Hanover Street would increase sidewalk connectivity to and from this stop location.

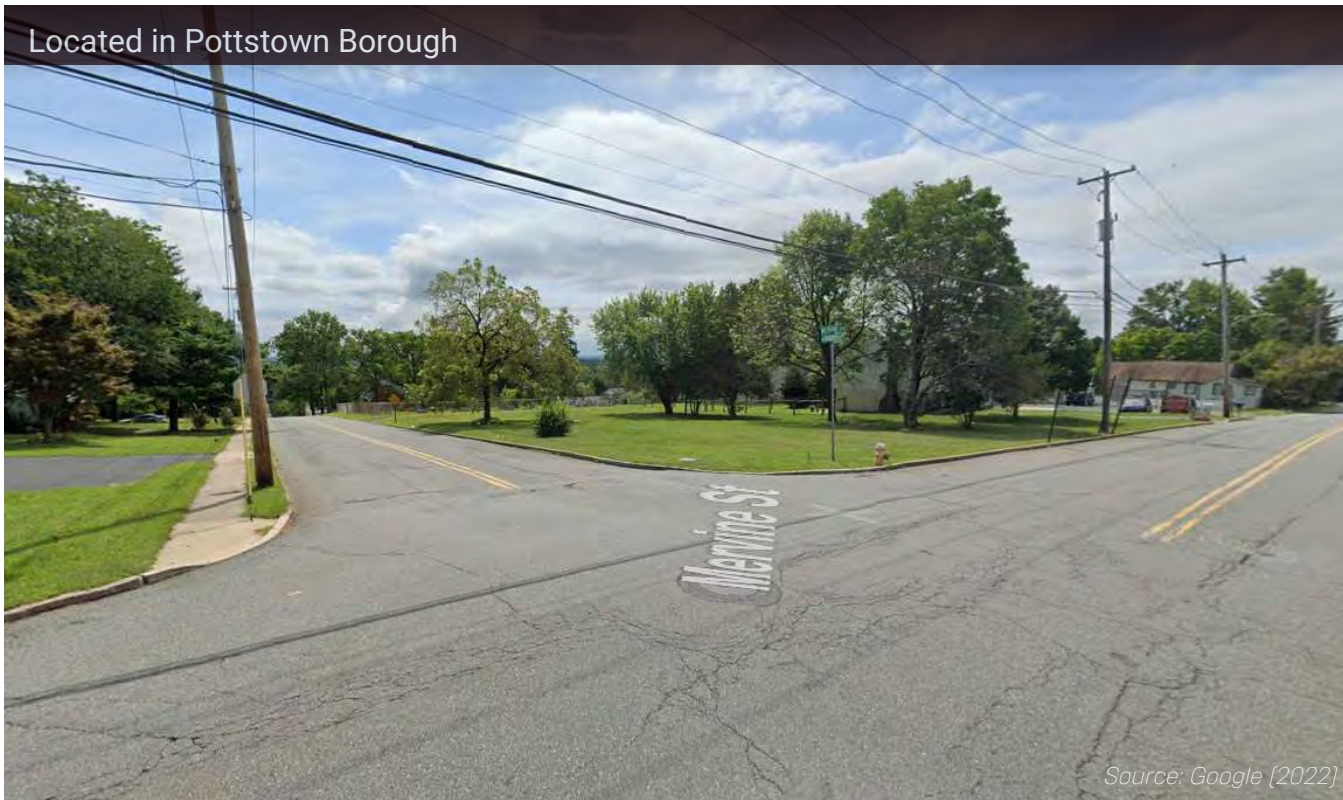
Hanover & Mervine

The northbound-turning-eastbound Yellow Line stops at the southeast corner of Hanover & Mervine. There is currently no indication that a bus stops here. PART signs with branding and route information are a priority on both sides. While amenities such as a shelter, seating, and trash cans would be nice, they are not needed in the low-density/ridership area.

There is a light pole across the street from the stop, which likely provides enough light because the Yellow Line primarily operates during daylight hours.

There is room for passengers to wait for and load the bus, but these areas are not designated, paved, or connected to the greater sidewalk network. Furthermore, while there is enough room for a ramp to be deployed from the bus for wheelchair access, the lack of paving and sidewalk access renders it useless. To solve these problems, a concrete pad is needed to accommodate waiting and loading. Additionally, a sidewalk is recommended to connect the existing sidewalk across Mervine Street to the existing sidewalk at Hanover Street and Master Street. Implementing this sidewalk may require coordination with the property owners along the path.
