Enhancing PART Bus Stops in the Pottstown Area

July 2023

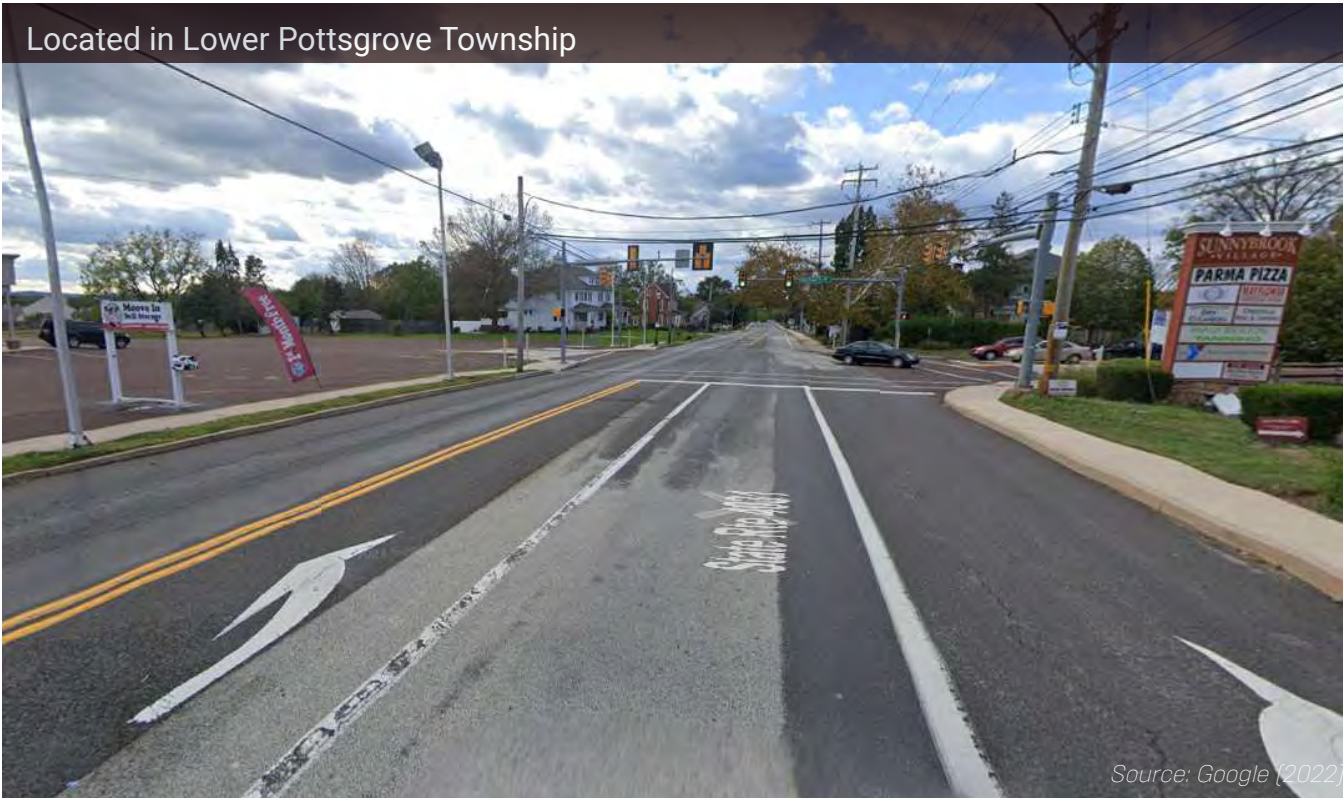
Heritage Drive

Both the Blue Line and Purple Line stop at the intersection of High Street and Heritage Drive, with the eastbound bus stopping at its southwest corner and the westbound bus stopping at its northeast corner (in front of Sunnybrook Village). The only indication that a bus stops here is SEPTA sign on both sides. To solve this problem, signs with PART branding and route information need to be added on both sides.

There is currently lighting on the eastbound side, but lighting needs to be added for the westbound side, as both the Blue Line and Purple Line run into the night.

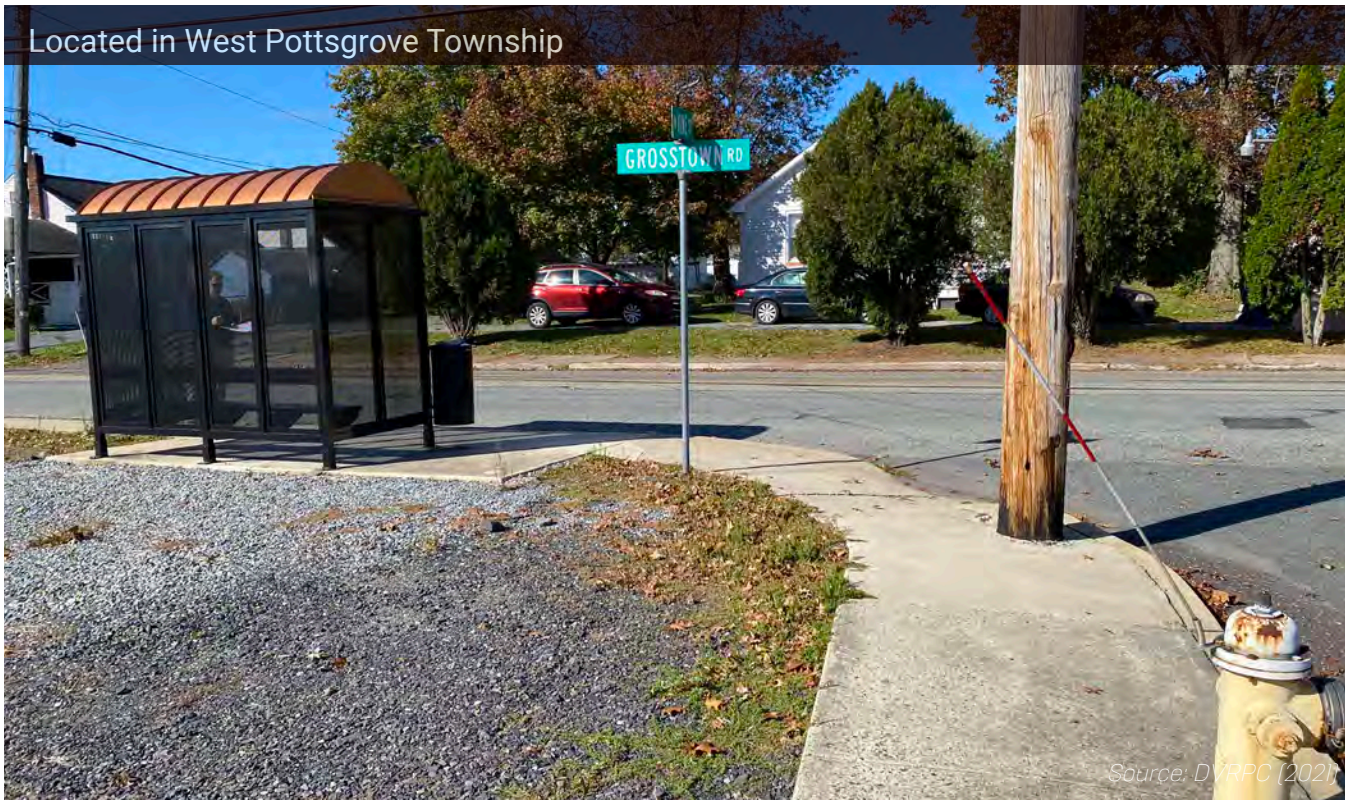
High & Grosstown

The northbound Green Line stops on Grosstown Road, just after turning from High Street. This is a high-ridership stop on the western end of the High Street corridor, and is the western-most stop in the PART system. South of High Street and the adjacent railroad tracks, pedestrians and cyclists can access the Schuylkill River Trail. Completing the sidewalk along Grosstown on the south side of High Street would improve access between the Trail and the PART system.

A shelter with seating and a trash can already exist at this location and there is ample space for loading and ramp deployment. Adding signage is a priority, and since this stop is on the western end of the PART service area, a full system map could help inform riders of other lines and local connections. A designated no-parking area would help ensure the bus always has space to stop.

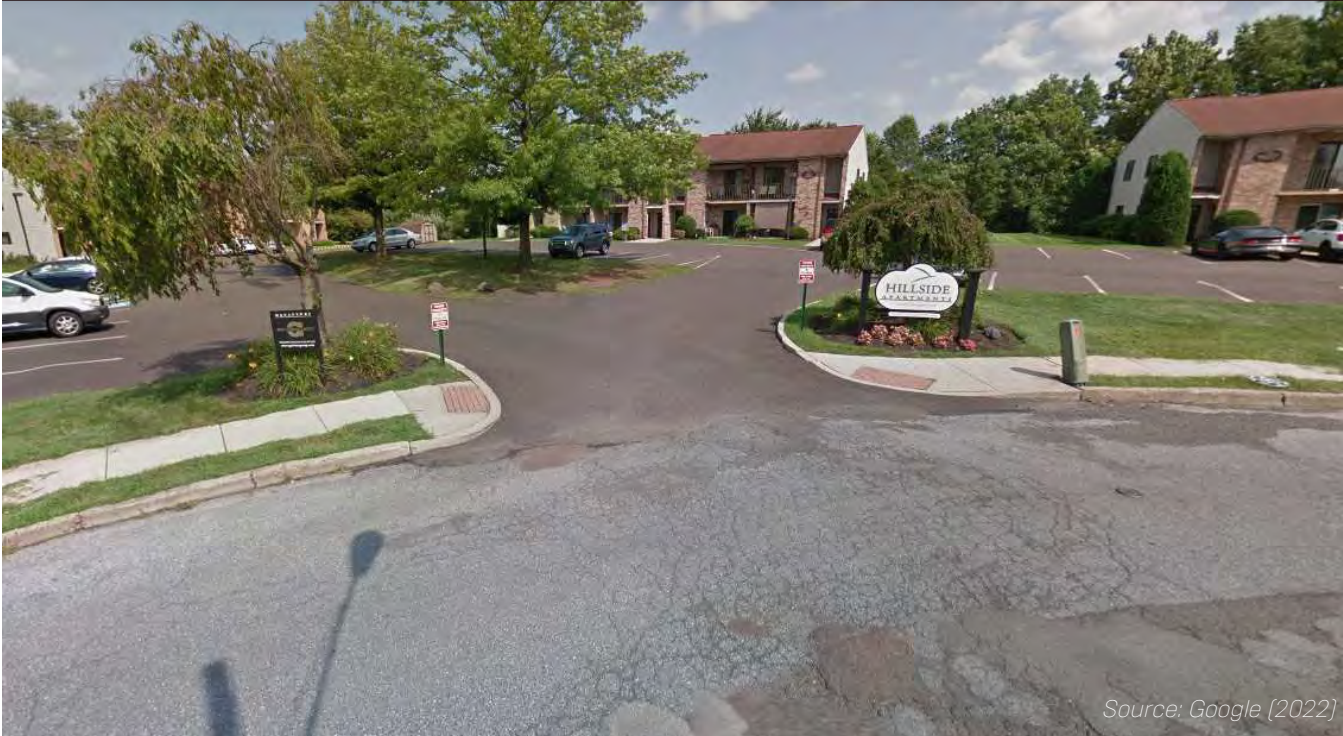
Hillside Apartments

The northbound-turning-westbound Yellow Line stops at the corner of Hillside and Queen Street, within the Hillside Apartment complex. This stop is in a relatively high-density area. There is currently no indication that a bus stops here. To solve this, signage with PART branding and route information needs to be implemented. A light that illuminates the stop already exists across the street.

There is ample room for riders to wait for and board the bus, which could be designated with sign placement. A concrete pad is recommended between the sidewalk and curb to create space for ramp deployment and loading. This stop is on private property, so any improvements would need to be approved and coordinated with the property owner.

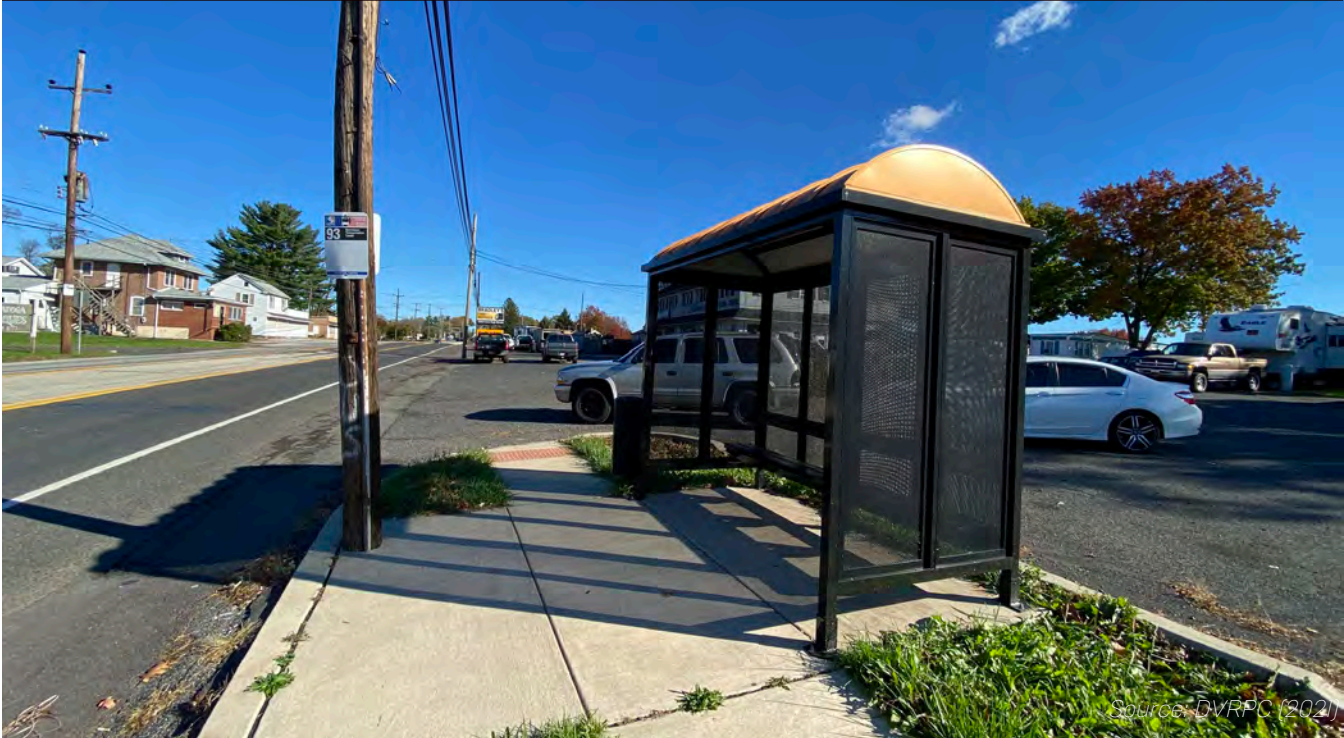
The Blue Line stops at the Hilltop stop along High Street in Sanatoga. The eastbound side has an existing shelter with seating, a trash can, and small waiting and passenger loading areas. The sidewalk in front of the shelter is just large enough for loading and has curb ramps, but they lead into large driveways with no other sidewalks nearby. There is currently a SEPTA sign, but no indication that a PART bus stops there. In the westbound direction, the stop has no amenities and no PART signage.

The stop is located by a utility pole surrounded by grass, making access challenging. Most likely, passengers board from or unload into the adjacent driveways. A dedicated waiting and passenger loading area is recommended on this side. A sign with PART branding and route information is a priority in both directions. Given that both stops are adjacent to driveways and no parking is permitted, there is no need for additional roadway striping to mark the bus zone.

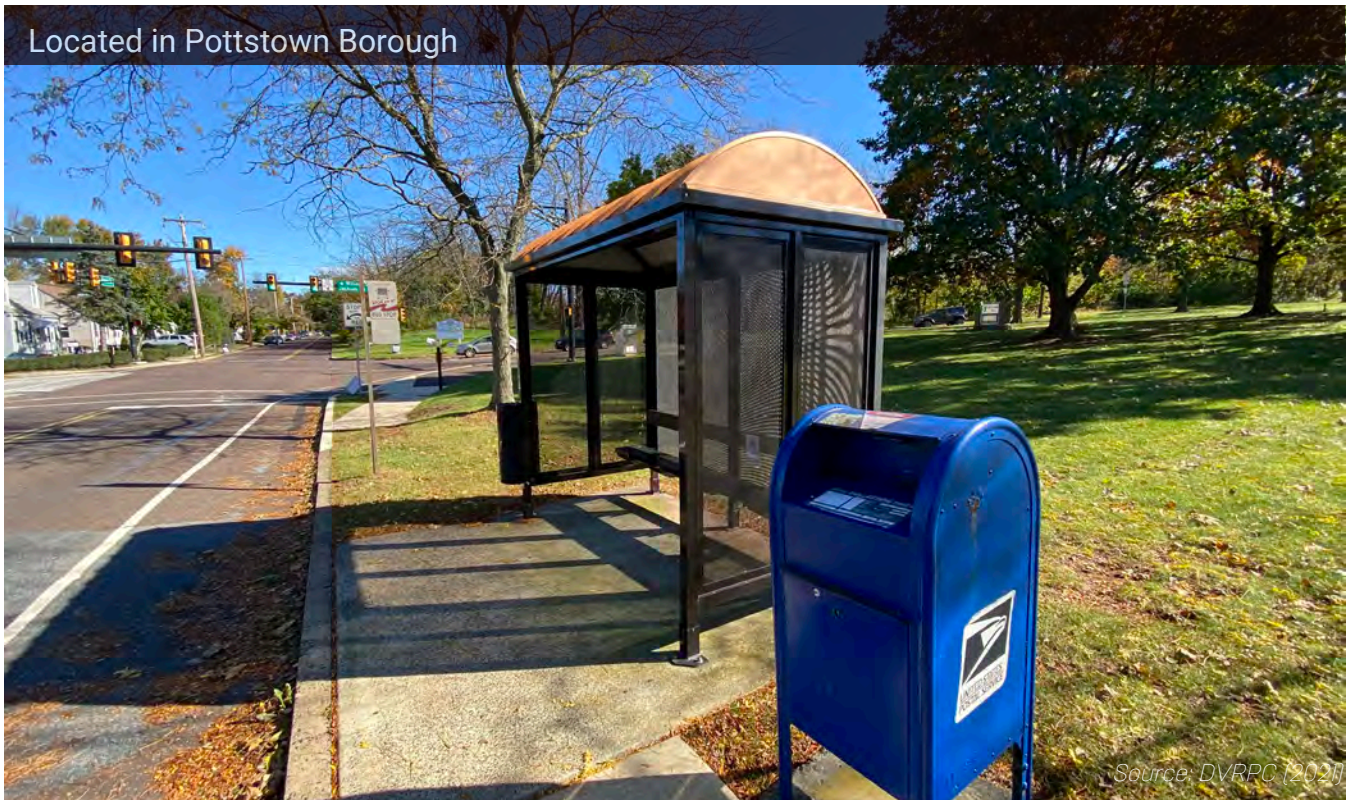
Pottstown YMCA (The Complex)

The stop near the YMCA, served by the Yellow Line, is one of the more complete stops in the PART system. A shelter, seating, trash can, and sidewalk access are present. There is even a bus stop sign with PART branding. The sign should be updated to include new PART branding and route information. While sidewalk access is decent, completion of the sidewalk adjacent to the stop would improve sidewalk connectivity. Also, increasing the size of the concrete pad would allow space for ramp deployment and maneuvering of

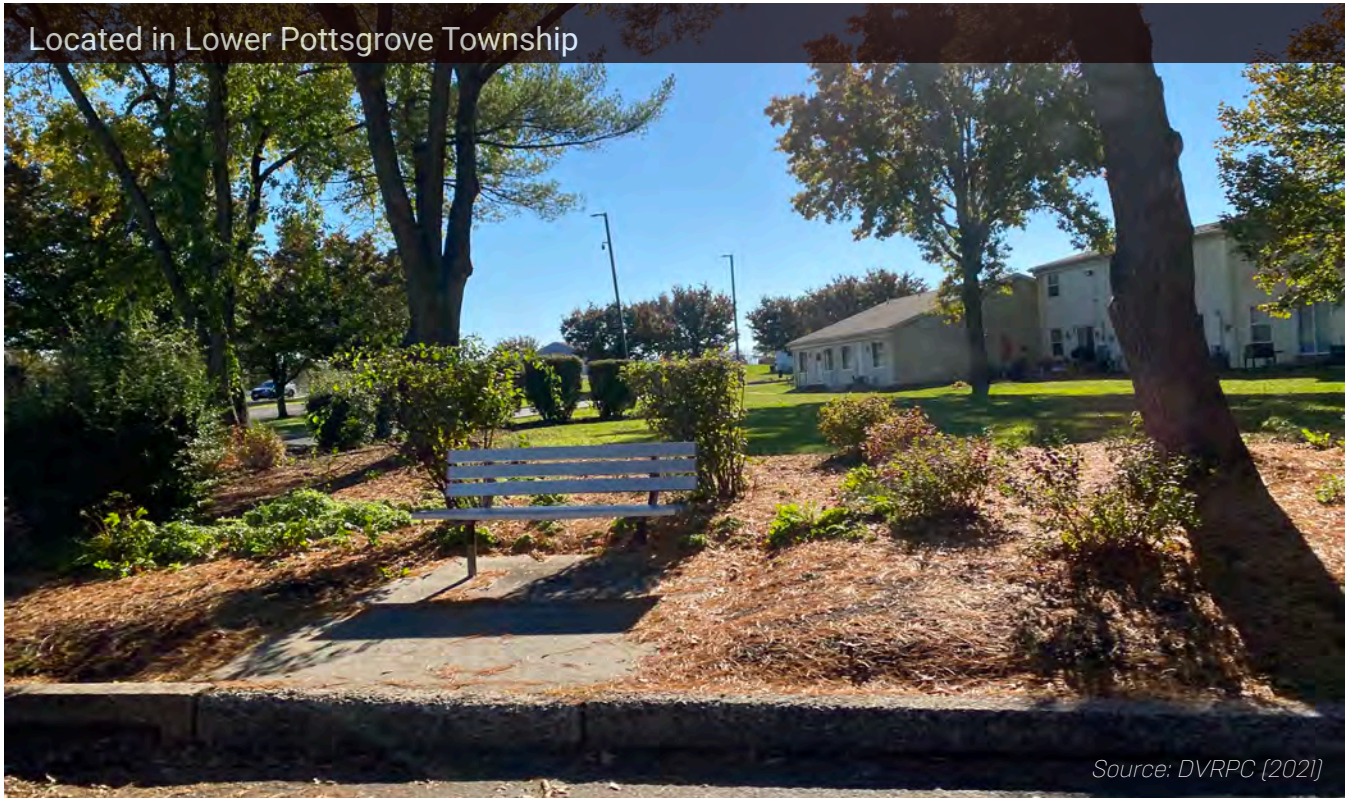
Located in Lower Pottsgrove Township

The Purple Line serves the Rolling Hill stop on Buchert Road with access to the Buchert Ridge, Walnut Ridge, and Rolling Hills communities. A bench with a small passenger loading area in the eastbound direction and a no parking sign are the only indications of a bus stop in this area. The passenger loading area is too small for ramp deployment, is not well connected to nearby sidewalks, and does not include a curb ramp, which could be improved to make the waiting area easier to access.

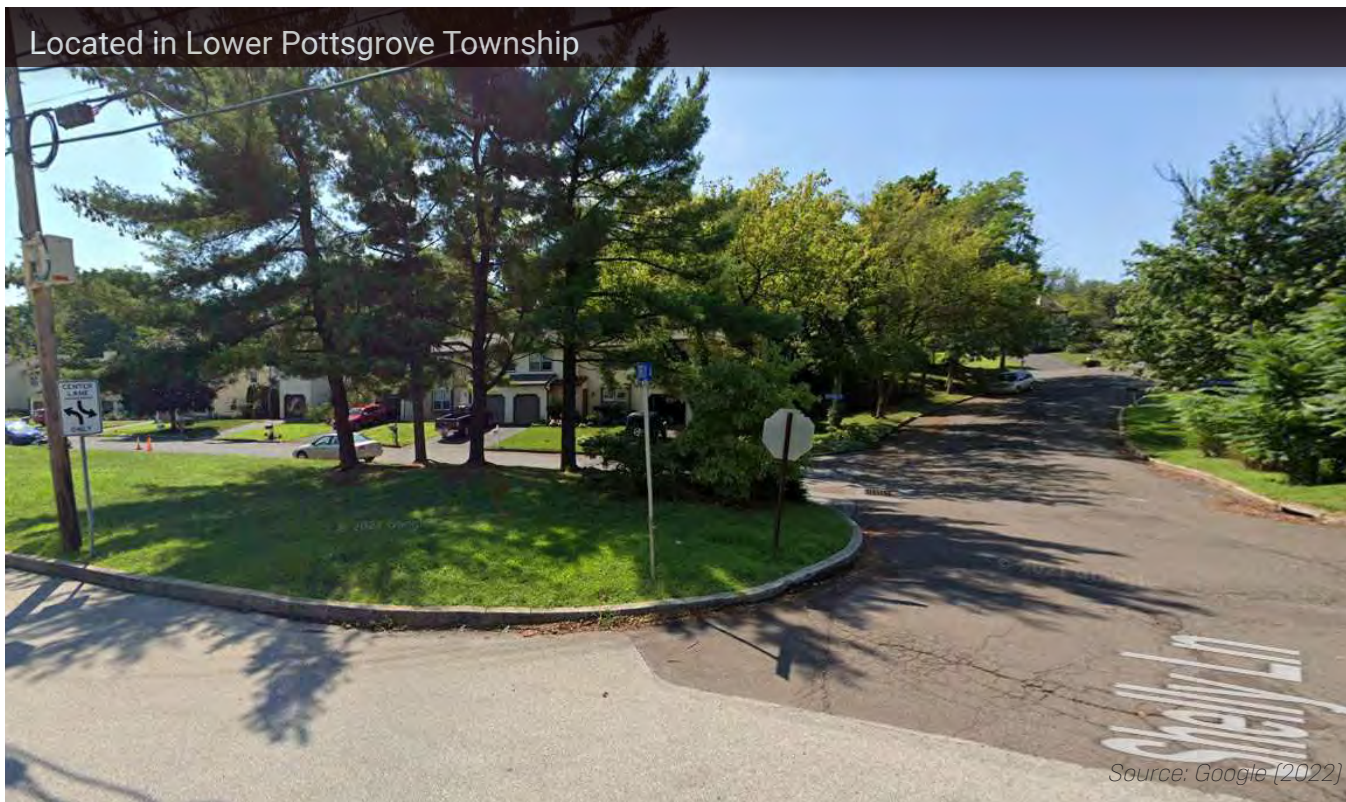
Sanatoga Ridge

The Blue Line stops at Sanatoga Ridge, with the eastbound bus stopping at the southeast corner of High Street and Shelly Lane and the westbound bus stopping directly across High Street. There is currently no indication that a bus stops here. To solve this, signage with PART branding and route information needs to be installed. Since the Blue Line runs into the night, the lack of lighting needs to be addressed on both sides of the street. The eastbound side has room for riders to wait for and board the bus, though these areas are not designated, paved, or connected to the greater sidewalk network.

Meanwhile, the westbound side has a grassy knoll with no room for waiting and loading. Since there are no paved areas on the east or west side of the roadway, it is not possible to safely deploy a wheelchair ramp at this bus stop. To solve these problems, a new sidewalk from the nearby Commons Drive development should be constructed to the eastbound side with enough room for waiting, loading, and a ramp, while short sidewalk from the development immediately east should be constructed to the westbound side of High Street with enough space to wait, load, and deploy a wheelchair ramp.

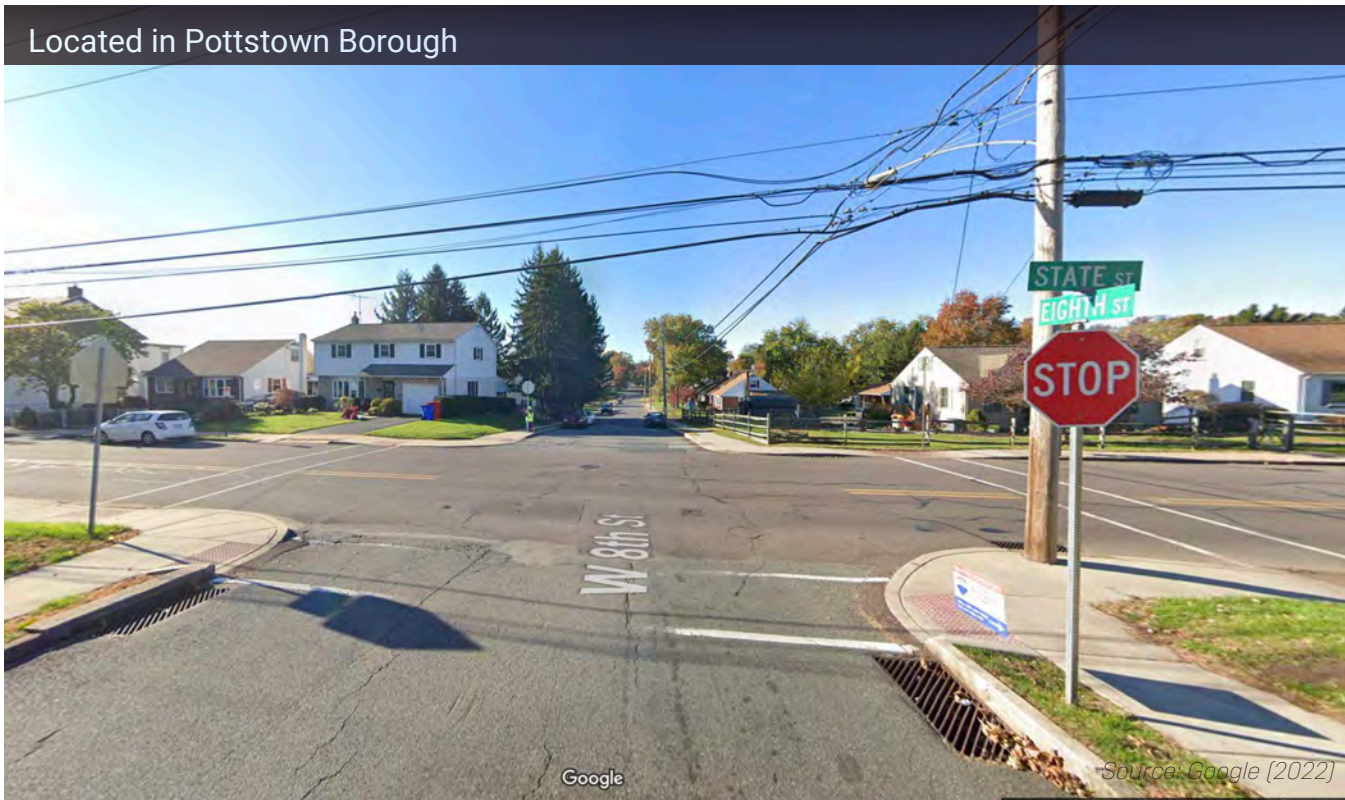
Located in Pottstown Borough

The northbound Green Line stops along State Street near the intersection with 8th Street. This neighborhood stop location is currently only indicated by the presence of no parking signs along State Street. Based on the surrounding land uses (residential and school), it is likely a low-ridership stop and is therefore not a priority for a shelter or seating. However, signage is a priority. This neighborhood is well connected by the sidewalk network, but the sidewalks along

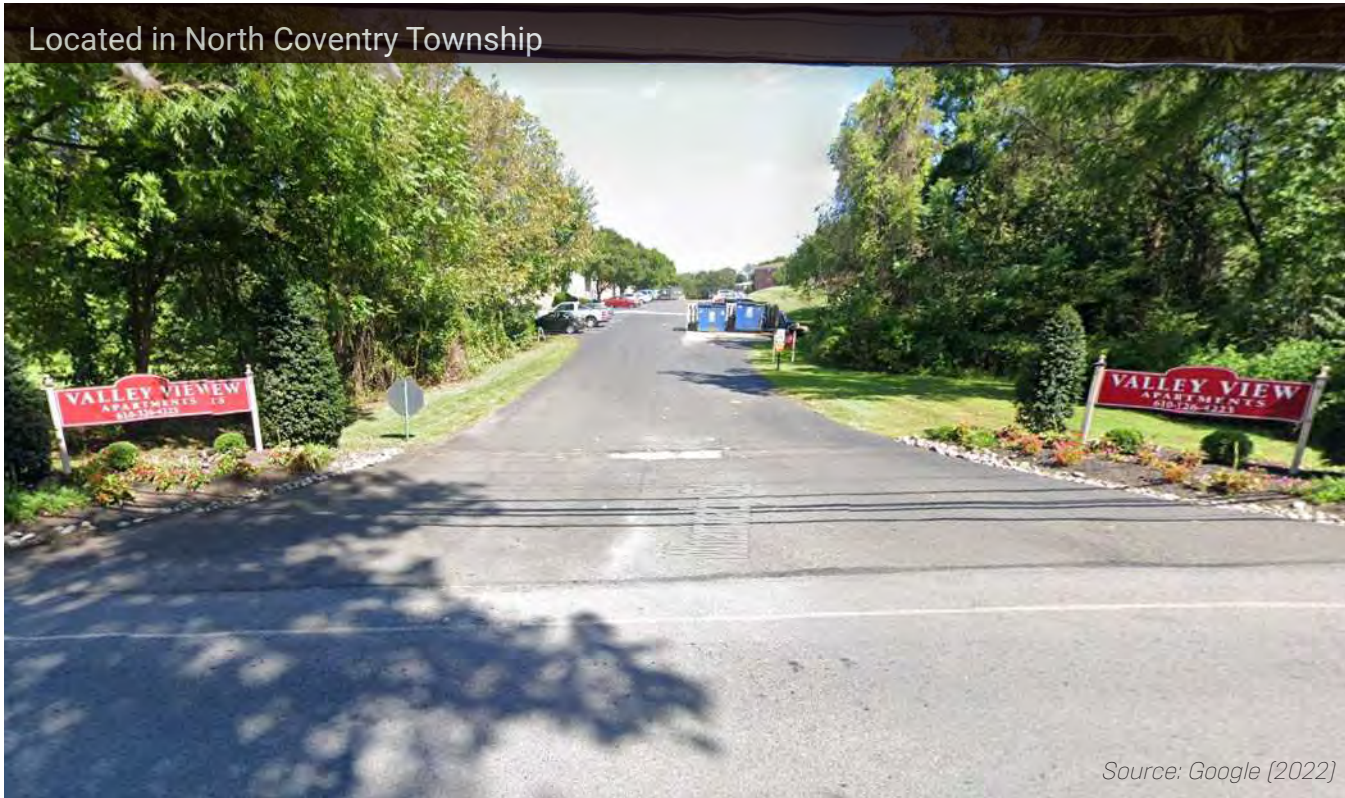
Valley View Apartments

The northbound Orange Line stops by the driveway of the Valley View Apartments. This is a neighborhood stop in a low-density area. There is no indication that a bus stops here. To solve this problem, signage with PART branding and route information needs to be installed. This stop currently lacks street lighting, but the Orange Line primarily runs during the daylight hours, so lighting is not a high priority. There is currently no off-road area for passengers to wait for or board the bus. A concrete pad is recommended to designate a safe passenger loading area with ample space for ramp deployment.

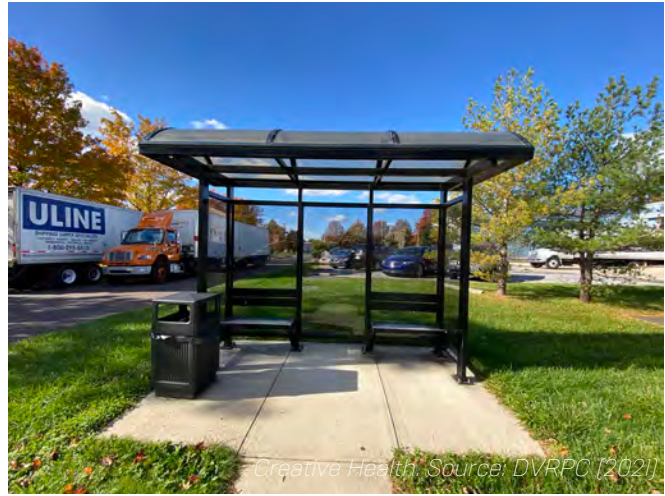
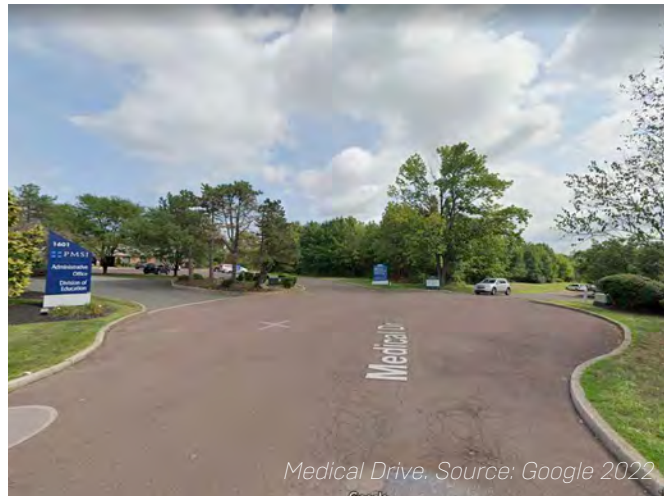
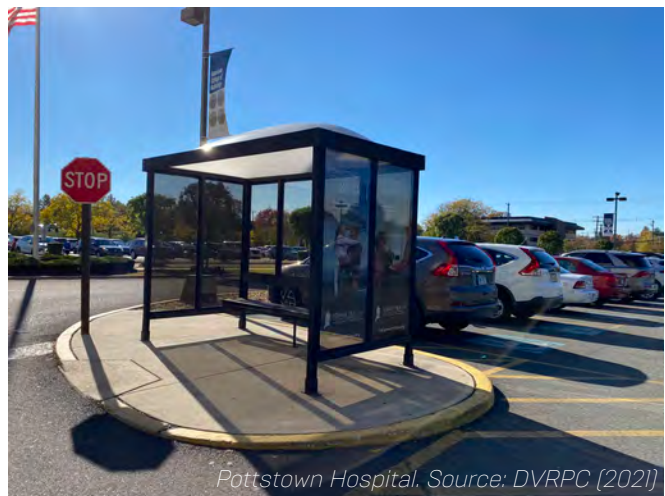
Figure 69: Services PART Stops

PART routes stop at a variety of medical and other service offices, providing access to essential services. Because of this, service stops should be as complete as possible. A number of these stops already have some amenities, such as shelters. Additional amenities such as ample seating and generous waiting and loading areas would benefit waiting passengers whose appointments may not always align well with bus schedules. Signage, route, and schedule information should be added to increase visibility and make stops easier to find.

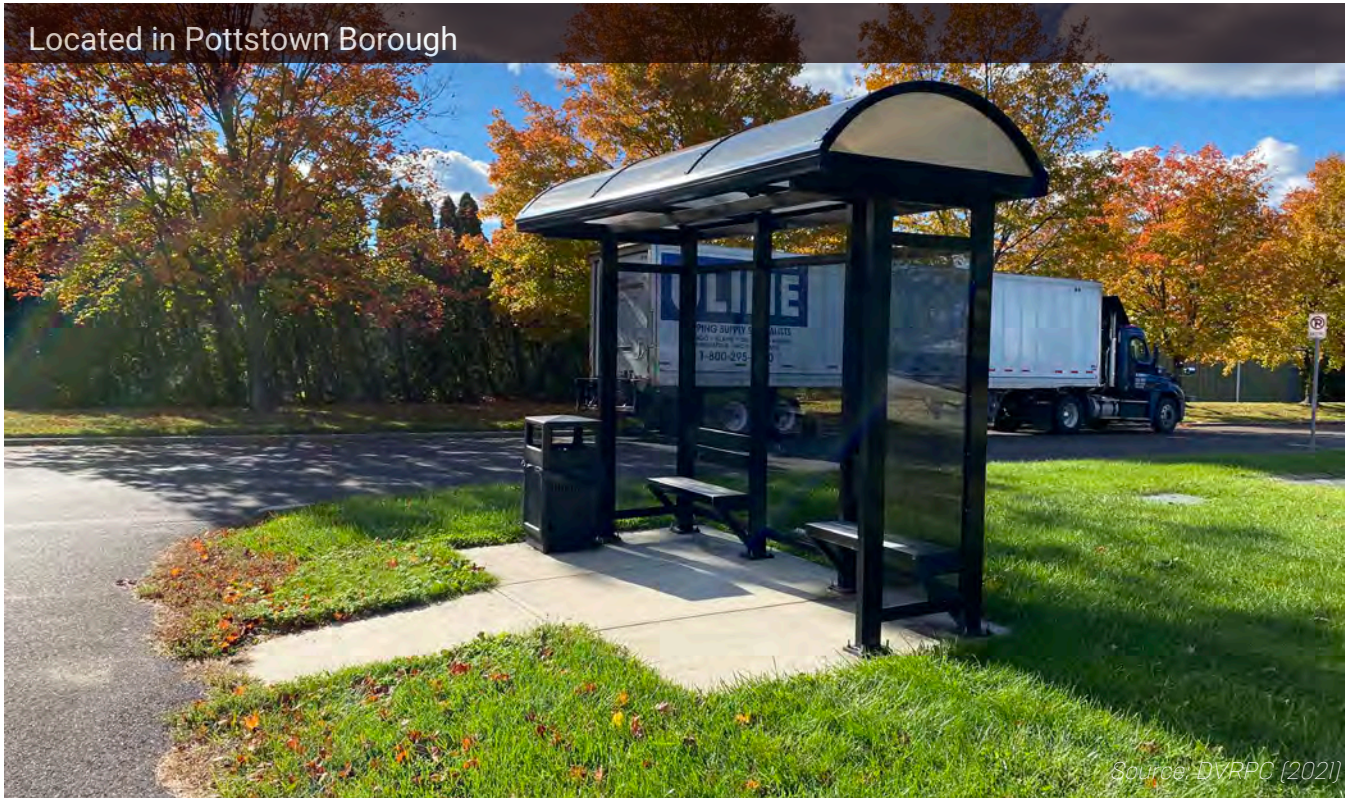
The Orange Line stops in the parking lot of the Creative Health Services medical building. There is a well-maintained shelter with seating and a trash can, and there is ample space for waiting. Expanding the concrete pad is recommended to allow for easier maneuvering of mobility devices and space for ramp deployment.

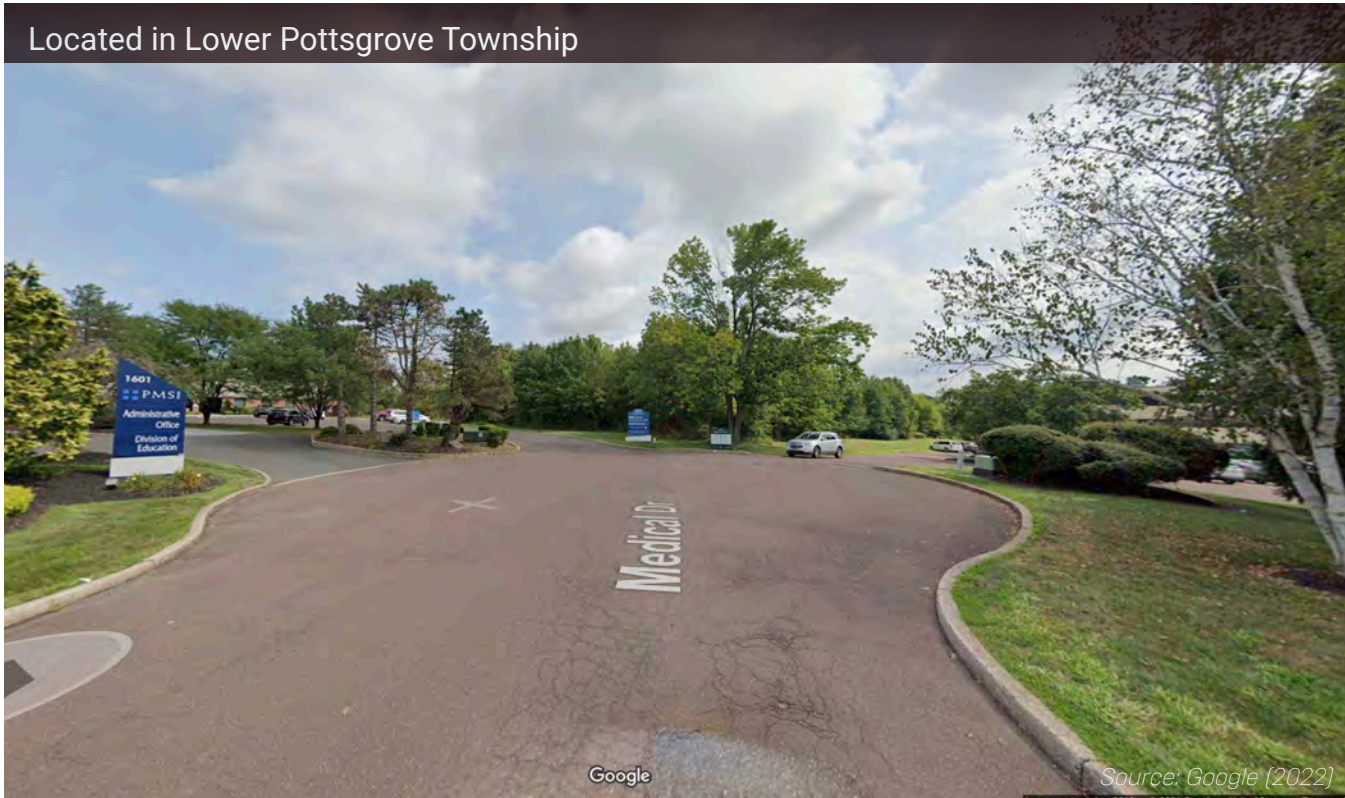
Located in Lower Pottsgrove Township

The Yellow Line serves the medical offices and services along Medical Drive. Currently, there is no designated stop at this location, making it difficult for passengers to know where to get on or off the bus. This stop could benefit from a variety of improvements. First, a stop area should be designated and marked with signs. According to PART, the medical offices towards the end of Medical Drive (near the cul-de-sac) have the highest number of boards and alights in the area, so this would be an ideal location for a designated stop.

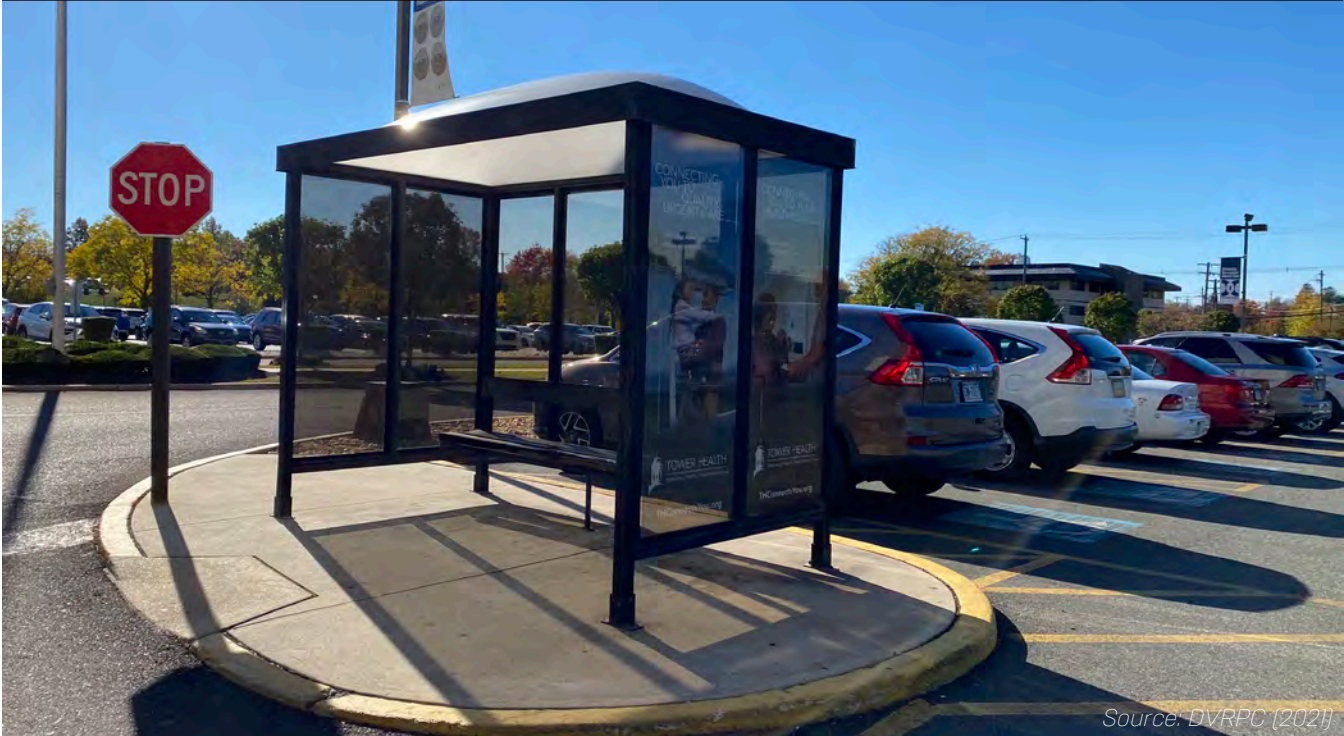
Pottstown Hospital – Tower Health

The Yellow, Blue, and Purple Lines stop in the parking lot in front of the Pottstown Hospital. This stop has a well-maintained shelter with seating, which can be accessed via a curb ramp directly in front of it. It is near the High Street corridor with abundant sidewalks, even though pedestrians need to navigate the parking lot to access them. The concrete pad which houses the shelter is small and does not have enough space for safe ramp deployment for passenger loading. Increasing the size of the concrete pad by taking over the adjacent parking space would provide ample space for waiting and loading.

Currently, the bus stops in the main travel lane in front of the hospital, which could cause delays during peak hours. However, the proximity of the stop to the hospital's main entrance is justification for keeping the stop where it is. PART branding and route information is a priority for this stop. Since it is a relatively high ridership stop on Saturdays and is served by multiple routes, it could benefit from transfer information and a full system map, which can increase passenger awareness of the useful connections that can be made using the PART system.

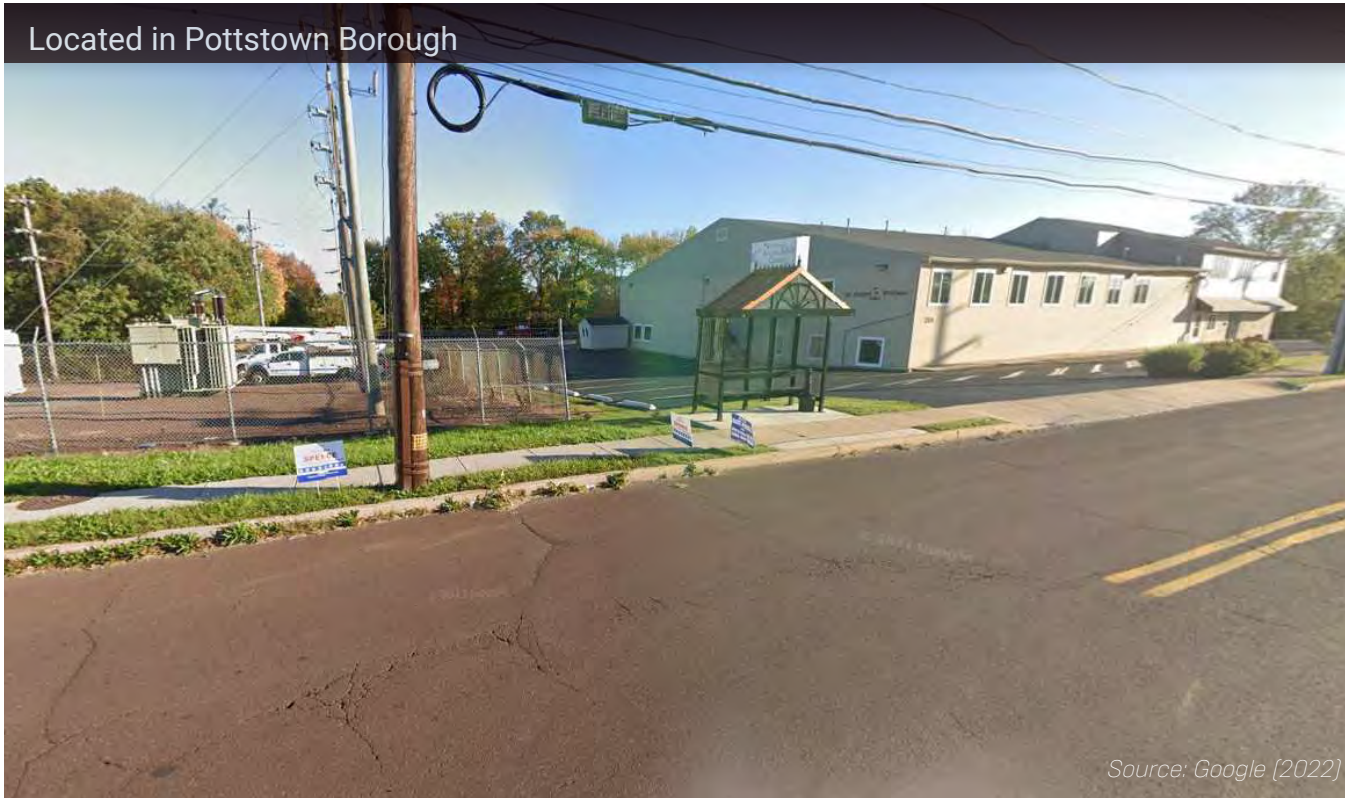
Tri-County Adult Activity Center (Seniors' Center)

The southbound-turning-westbound Yellow Line stops at the shelter on Moser Road, next to the parking lot for the Seniors' Center. This is a stop that serves older populations who are more likely to have mobility challenges, so it is necessary for it to be as complete with amenities and accessibility features as possible. This stop currently has a shelter and a bench. To complete the stop, trash cans and signage with PART branding and route information need to be implemented. Furthermore, the existing bench does not have any arm rests, which are required by the ADA, so seating should be improved.

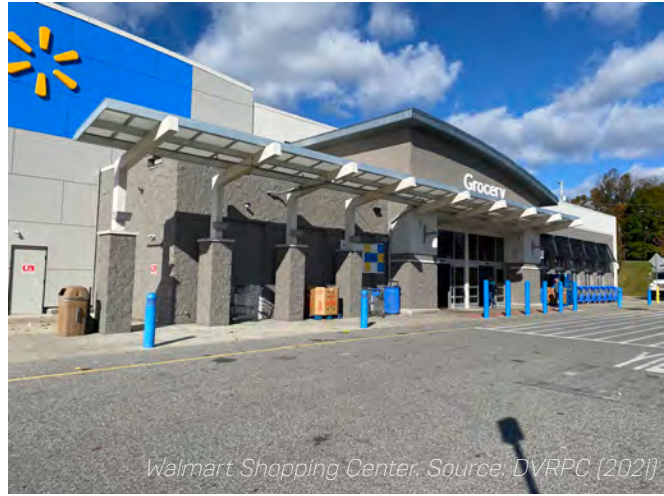
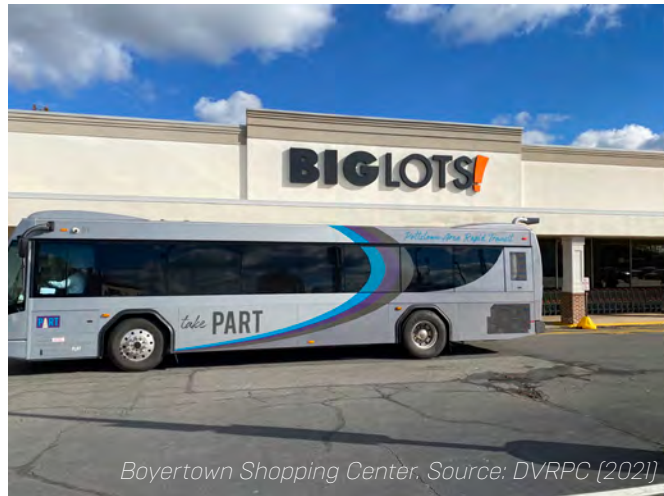
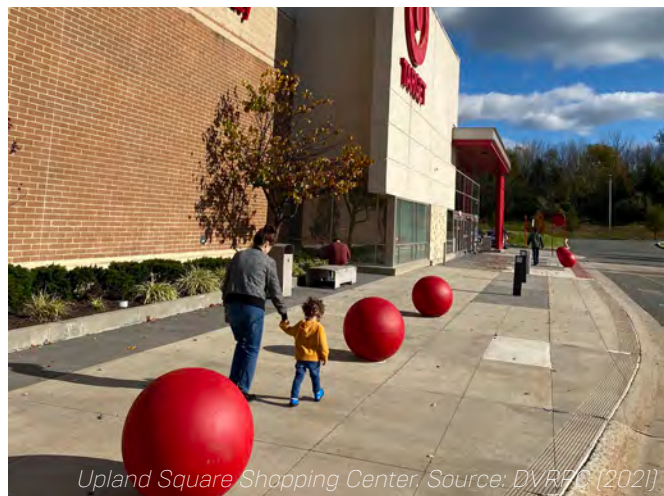
Figure 78: PART Stops at Shopping Centers

A number of PART stops are located in shopping centers throughout the PART service area. Many shopping centers have large overhangs at or near the entrances to stores which can serve as a shelter, protecting waiting passengers from the sun, rain, or snow. Adequate space and seating should be provided for passengers carrying bags from shopping trips. Given that waiting passengers may be consuming food or using products from the adjacent stores, trash cans should be provided to keep the area clean.

Most of these stops do not include PART signage or route information, making them difficult to find. While some shopping centers welcome PART service and would be amenable to adding passenger amenities on their properties, others are not as welcoming. In some instances, recommendations were made to add amenities adjacent to the shopping center instead of at the current stop location.

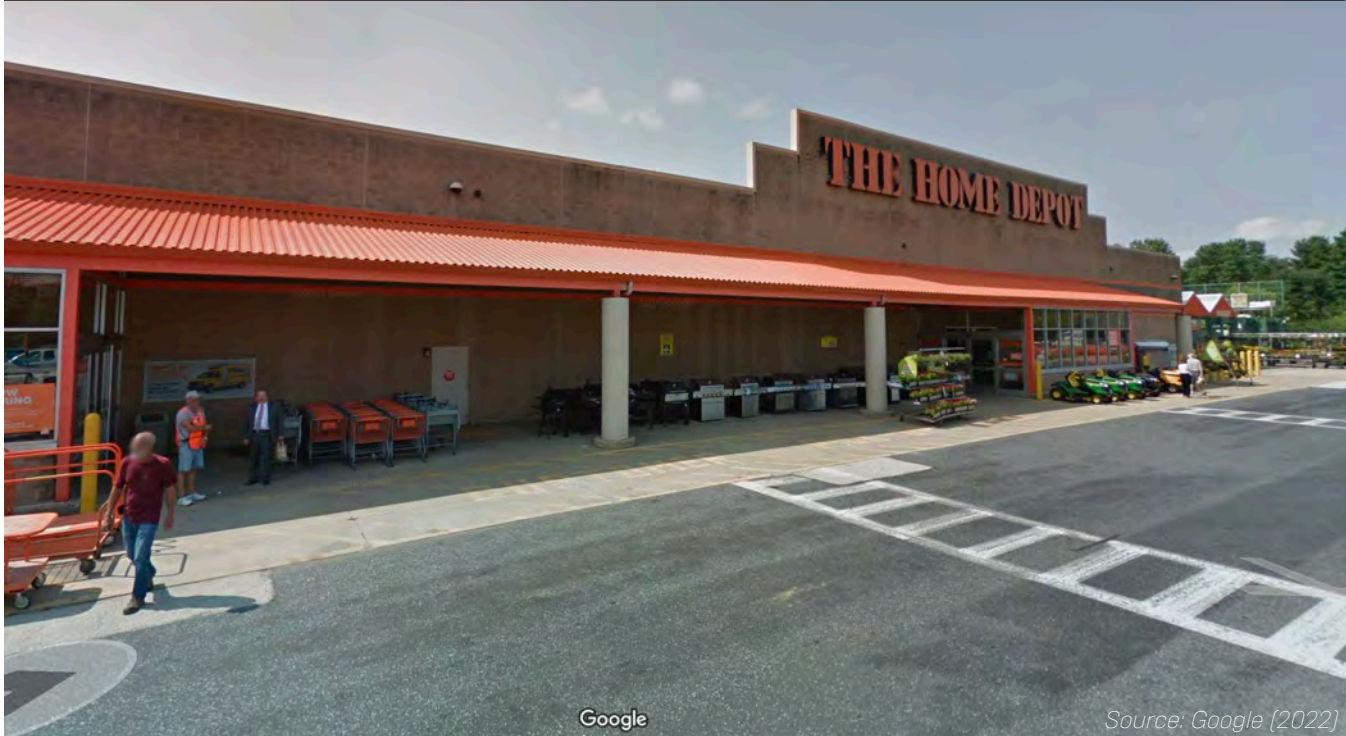
Aldi – Home Depot

The Yellow Line serves the Aldi and Home Depot shopping center. The actual location of the bus stops is difficult to find. Signs with PART branding and route information are necessary to identify the stop location. If approved by the shopping center, the signs could be placed in a location that encourages waiting passengers to wait under the awnings in front of the store.

The sidewalk and parking lot pavement are at the same grade, which allows for easy stop access. The stop should be placed in an area with ample space for ramp deployment. Bus zone markings are recommended to ensure that vehicles dropping off passengers or loading goods do not block the stop area.

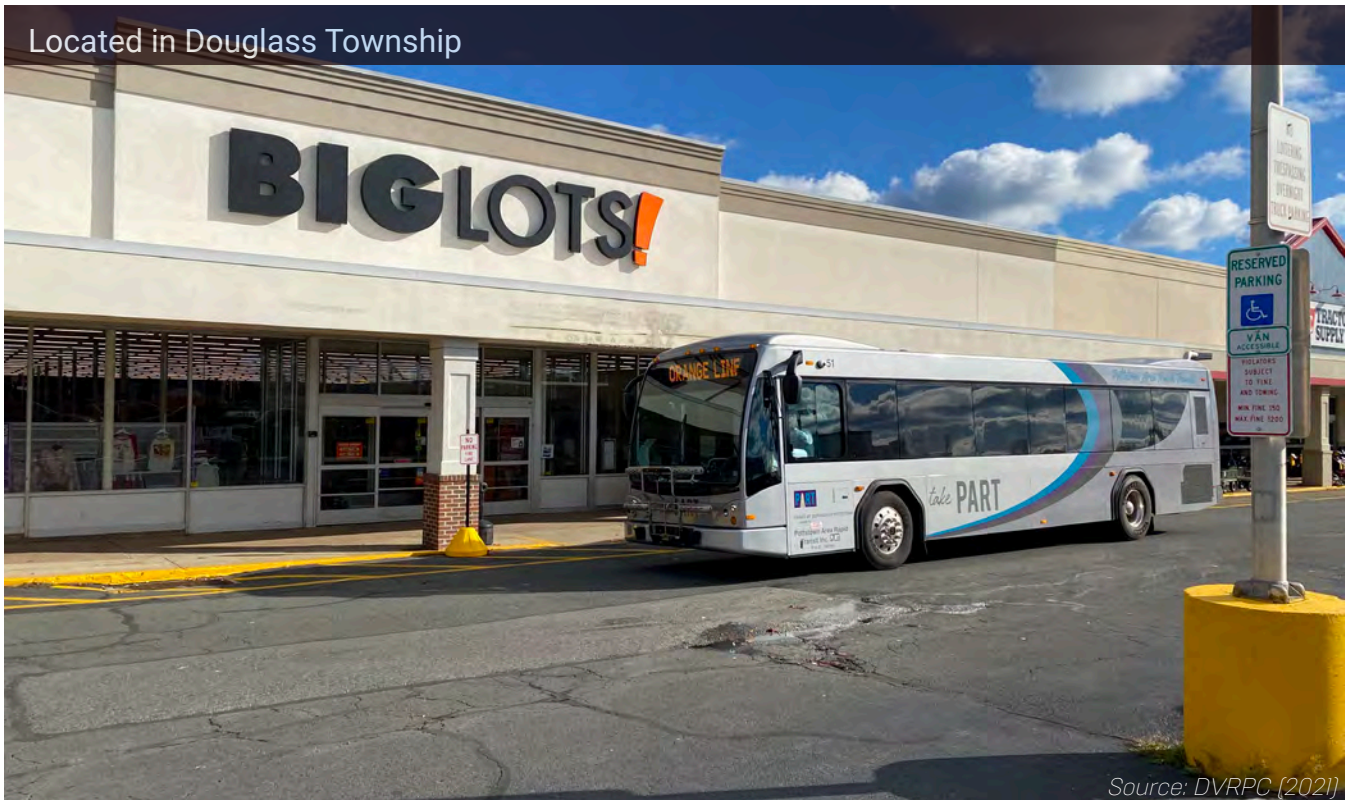
Located in Douglass Township

The Orange Line stops at the Boyertown Shopping Center in front of Big Lots. While the overhang and sidewalk in front of the stores provide ample sheltered space for waiting and loading, there is no indication that a bus stops there. Signage including PART branding, route, schedule, and fare information are a priority. The placement of this information would serve to designate the waiting area for passengers.

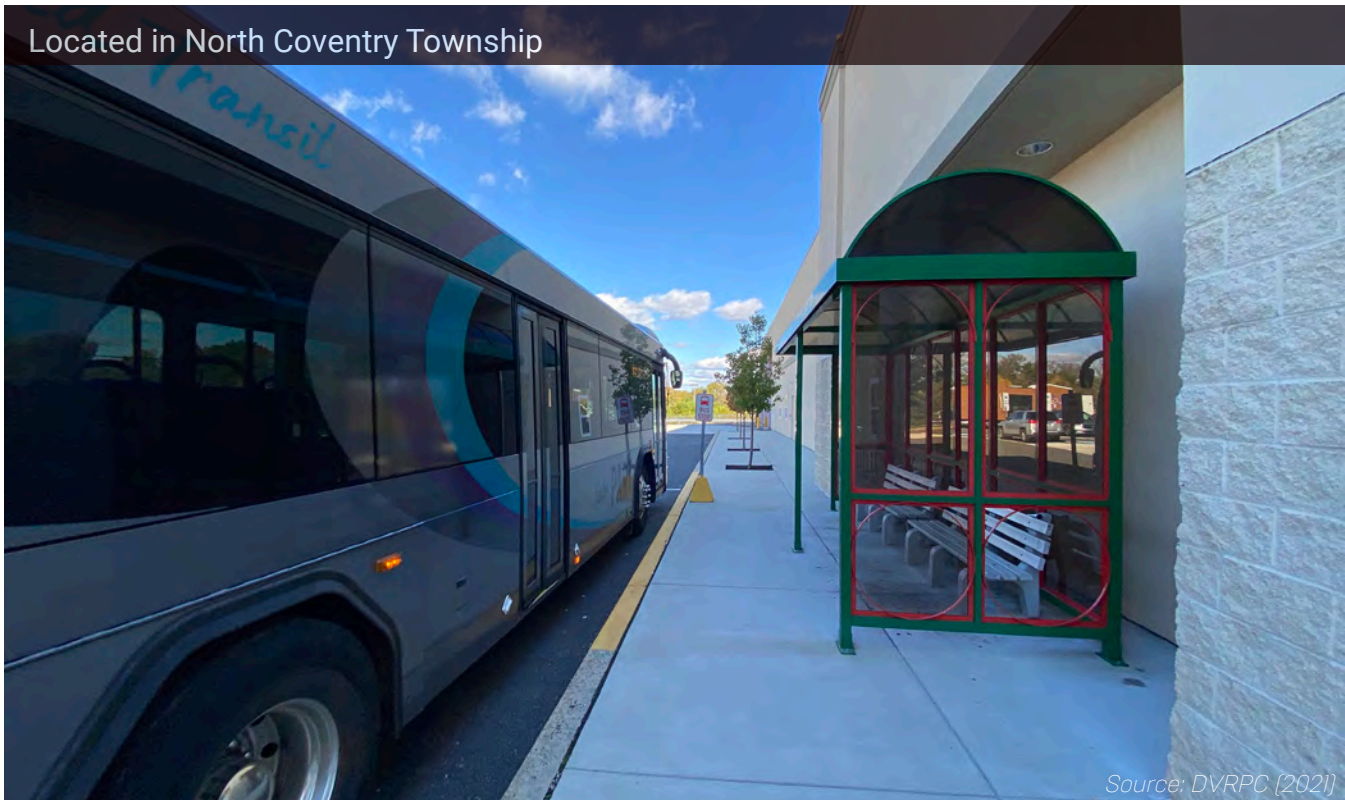
Coventry Mall

The Orange and Green Lines travel south across the Schuylkill River into North Coventry Township in Chester County. Ample seating and a shelter are provided at the stop behind Coventry Mall. There is plenty of space to wait for the bus, along with sidewalk access and a nearby curb ramp. The shelter blocks part of the sidewalk, reducing the space available for ramp deployment, so bus drivers should stop with the loading door just past the shelter.
