Enhancing PART Bus Stops in the Pottstown Area

July 2023

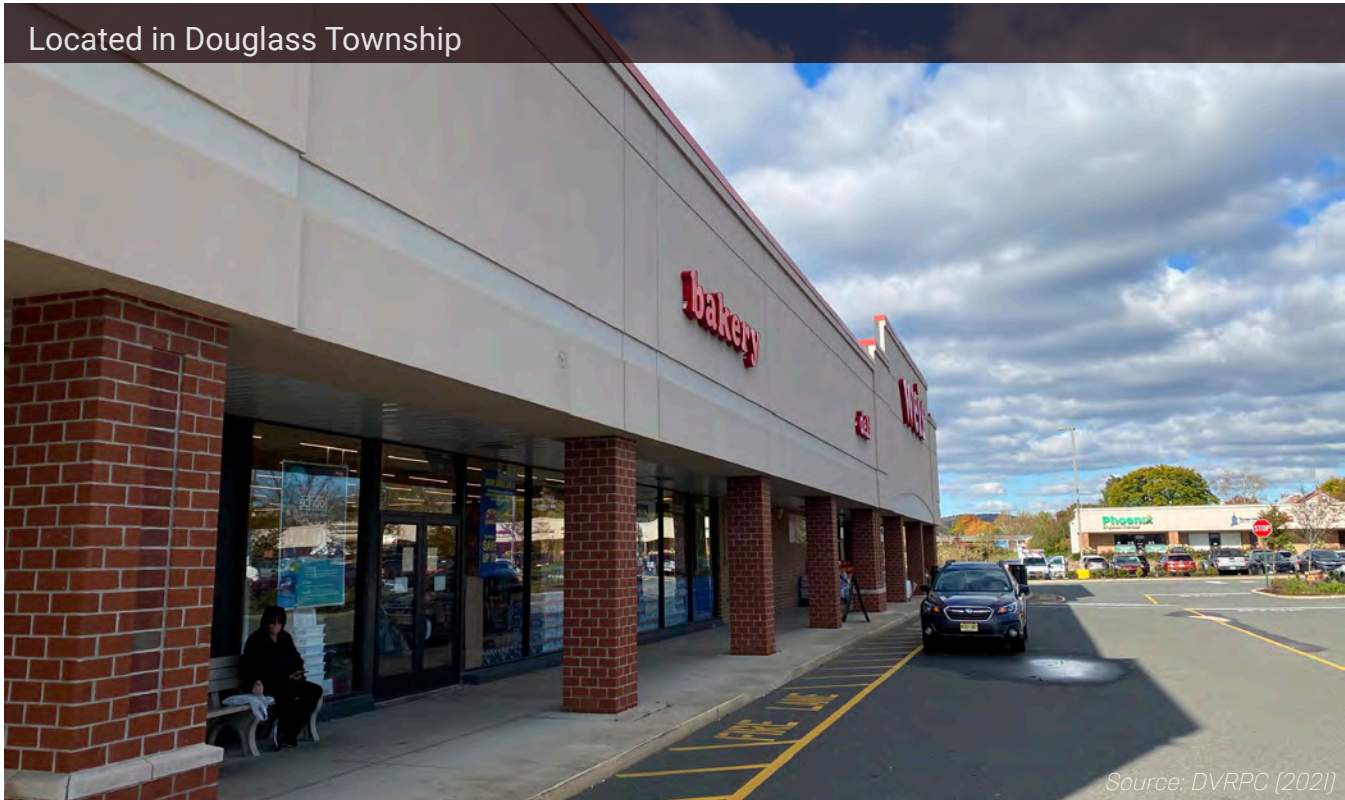
Located in Douglass Township

The Orange Line serves the Gilbertsville Shopping Center. The bus stops near the entrance to the Weis supermarket, but there is no designated waiting area or signage, making it difficult for riders to know where the bus will stop. The addition of signs with PART branding and route information, with approval from the supermarket, would improve the visibility of PART service in this area.

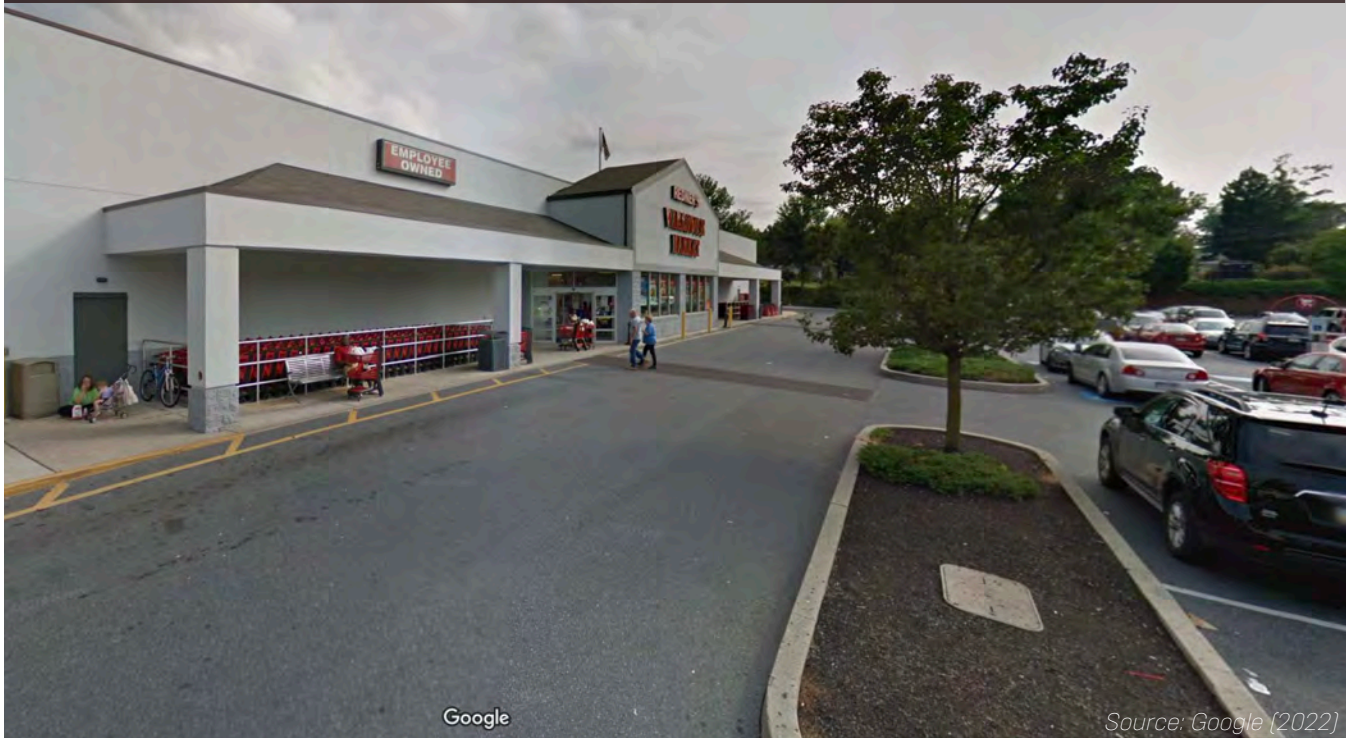
Located in Lower Pottsgrove Township

The Purple Line serves the North End Redner's supermarket. The actual location that the bus stops is difficult to find. Signs with PART branding and route information are necessary to identify the stop location and improve the visibility of the service. If approved by the shopping center, the signs could be placed in a location that encourages waiting passengers to take advantage of the existing shelter provided by the awnings in front of the store.

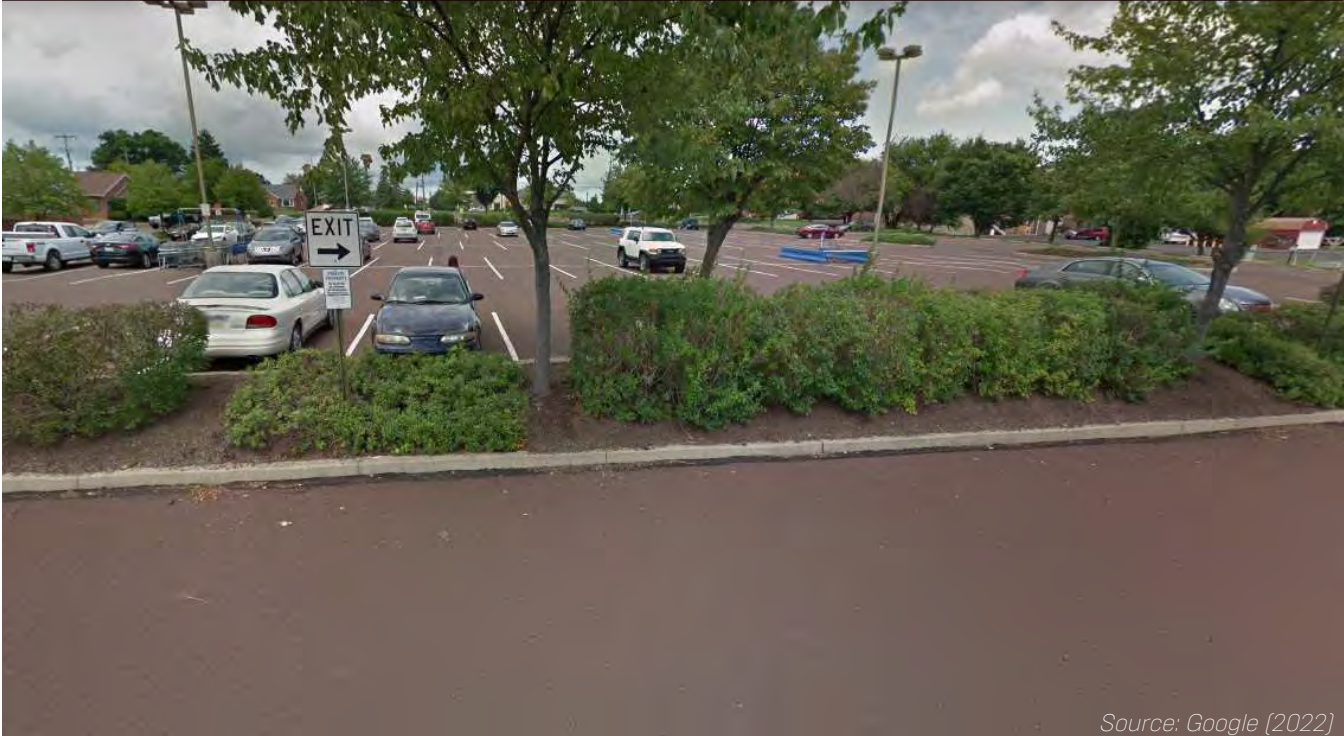
Sanatoga Village Shopping Center

Both the Blue and Purple Line stop in front of the landscaped area in the southern portion of the parking lot of the Sanatoga Village Shopping Center. This stop is in a shopping center, which will likely be used by shoppers with their groceries as well as employees, so it is necessary for this stop to be as complete with amenities and accessibility features as possible. There is no indication that a bus stops here. To solve this, signage with PART branding and route information should be added. Amenities such as shelter, seating, trash cans, and lighting are needed, but are infeasible at this location.

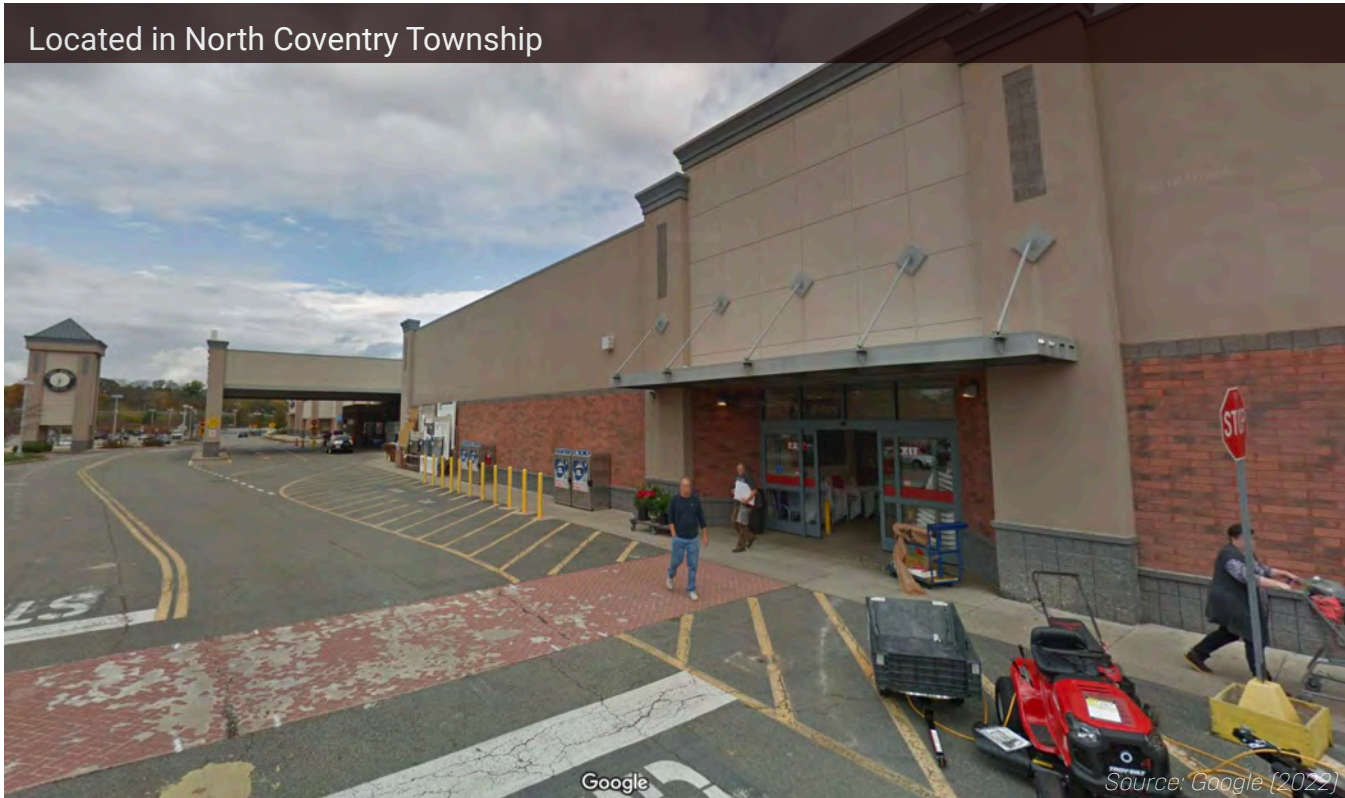
Located in North Coventry Township

The Orange Line serves the Town Square shopping center. The actual location of the bus stop is unclear. Signs with PART branding and route information are necessary to identify the stop location. If approved by the shopping center, the signs could be placed in a location that encourages waiting passengers to take advantage of the existing shelter under the awnings in front of the store.
