CR 534 (Blackwood-Clementon Road) Pedestrian and Bicyclist Road Safety Audit

Boroughs of Lindenwold, Pine Hill, and Clementon, NJ

May 2018

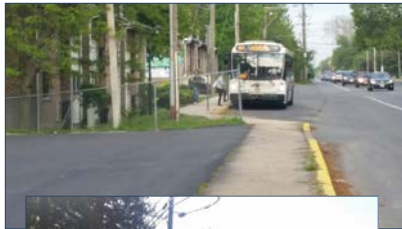
- ⌘ NJ Transit Bus 403
 - No service between CR 673 to CR 687
 - Follows CR 687 N/S and CR 534 E/W for less than ½ our study limits
 - 11 posted bus stops
 - Headways: 20 mins – 2 hours on weekdays; 50 mins – 2 ½ hours on weekends
 - Hours of operations: 5AM to 12:30AM on weekdays; 6AM to 12:30AM on weekends
 - Single day ridership at bus stops: 100+ weekday boardings; 80+ weekend boardings
 - Higher ridership numbers at CR 687 bus stops

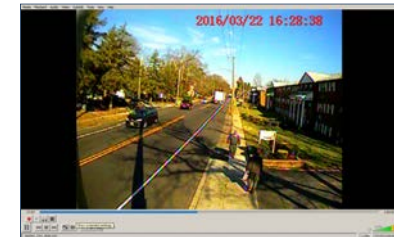
Pedestrian and Bicyclist Counts

- ☞ March 22, 2016
 - Clear, dry, conditions
- ☞ 24-Hour Counts
 - Post mounted cameras
- ☞ 7 Count Locations
 - 4 facing east
 - 3 facing west
- ☞ Study Area Tally
 - 1,240 pedestrians
 - 179 bicyclists
