LOCAL CONCEPT DEVELOPMENT REPORT

HUNTER STREET BRIDGE OVER CONRAIL

JUNE 2019
WOODBURY CITY,
GLOUCESTER COUNTY, NJ

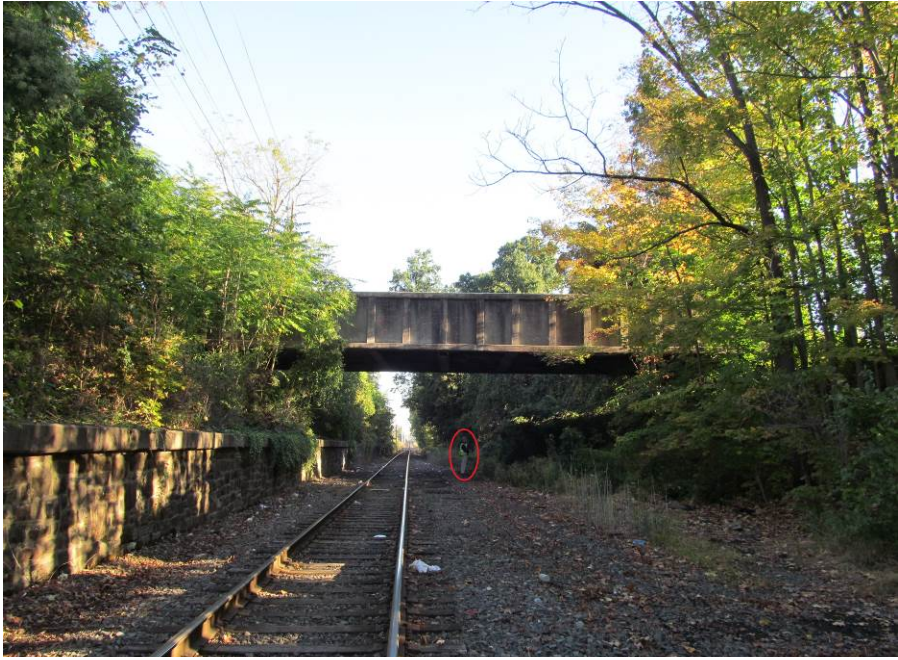
Photo No: 01
Location:	South elevation, looking north.	
Description:	General view. Note: Flagman was present during inspection.

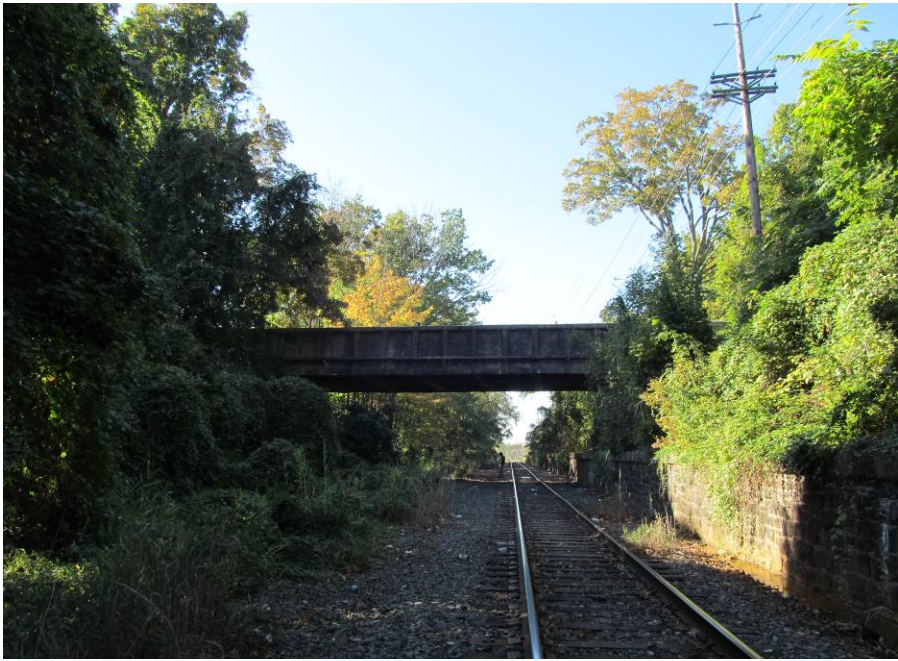
Photo No: 02
Location:	North elevation, looking south.	
Description:	General View.

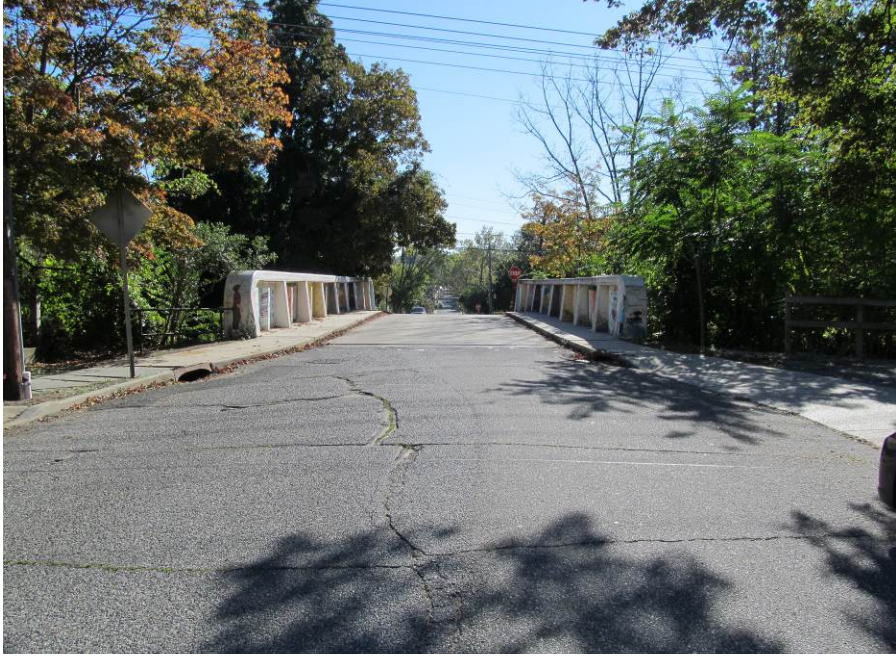
Photo No: 03
Location:	West approach, looking east.	
Description:	General roadway view. Note the settlement and wide cracks in the slabs and reflected in asphalt overlay.

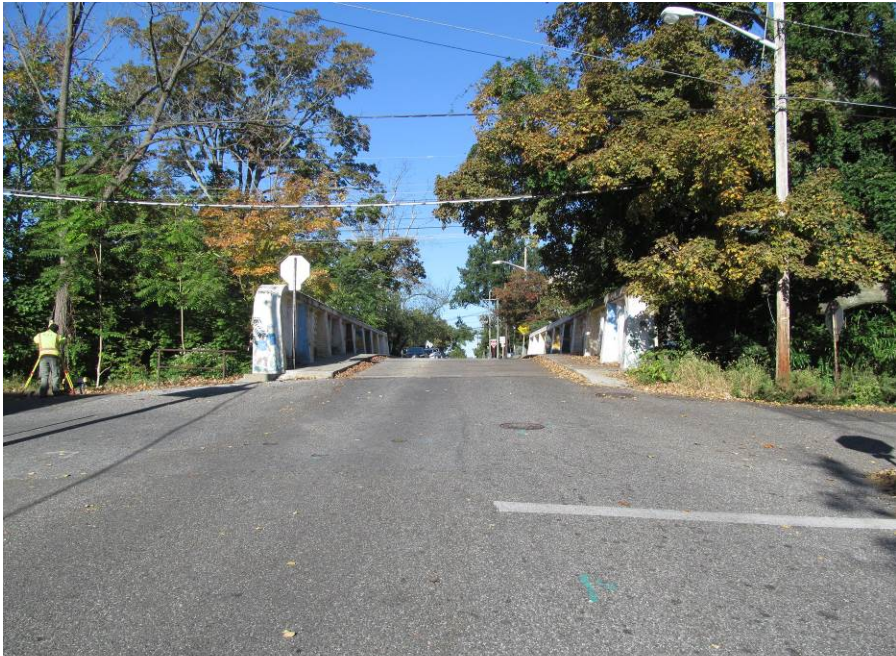
Photo No: 04
Location:	East approach, looking west.	
Description:	General roadway view.

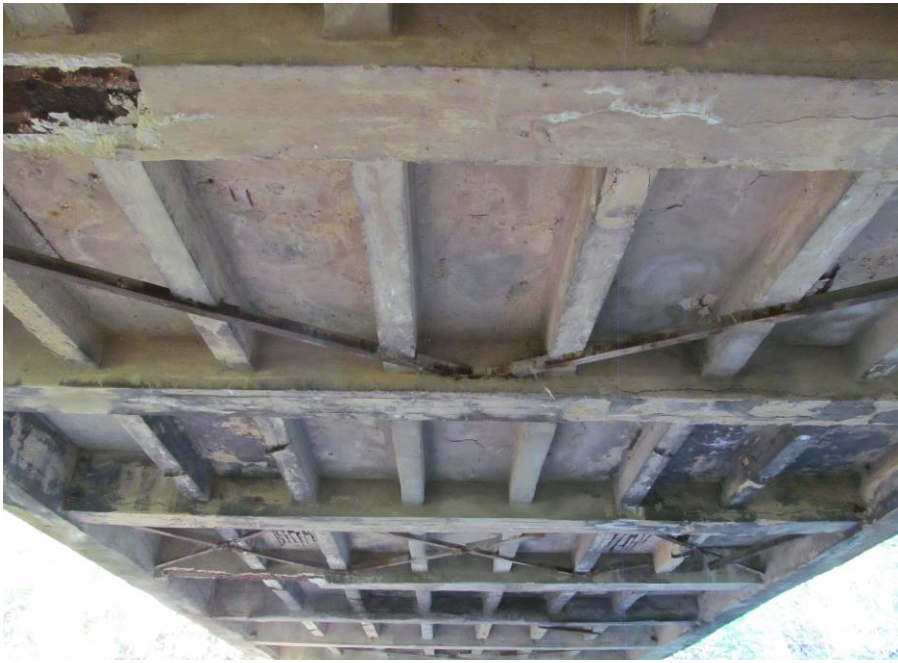
Photo No: 05
Location:	Superstructure and underside of deck, looking west.	
Description:	General view. Note the exposed rusted floor beam bottom flange and lateral bracings. Also note wide cracks with efflorescence on the concrete encasement.

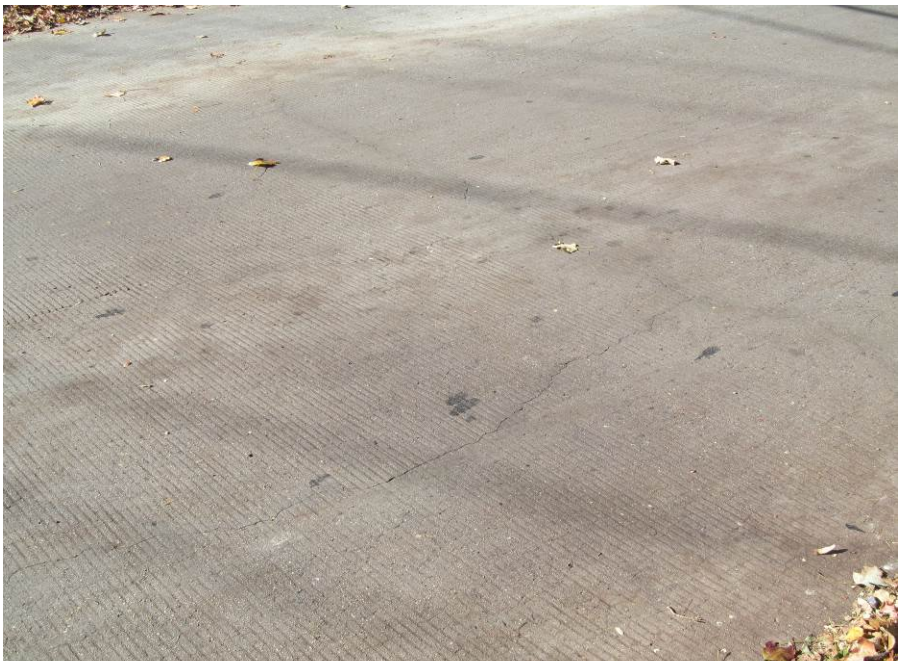
Photo No: 06
Location:	Top of the deck, looking southwest.	
Description:	Wide intermittent transverse and longitudinal cracks. Note fine and medium random cracks throughout.

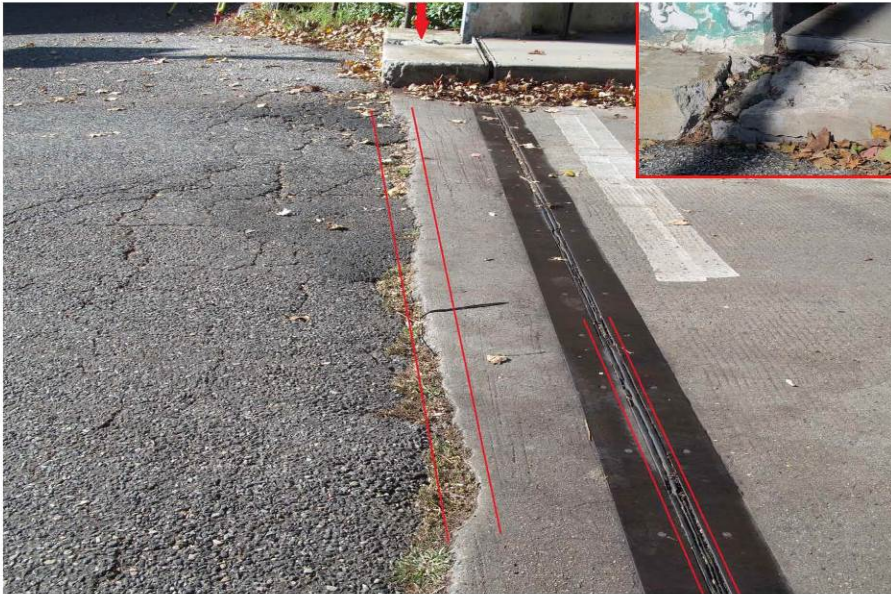
Photo No: 07

Location:	East abutment deck joint, looking south.
Description:	Large edge spall on concrete header in eastbound lane. Note deteriorated sealer material throughout. Also note a large spall at the east end of the south sidewalk near thru girder.

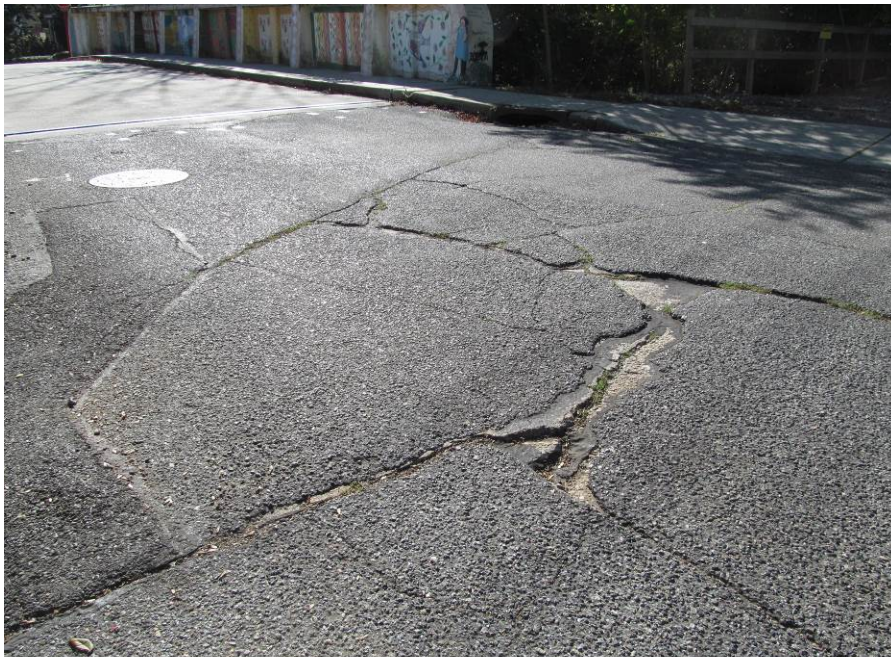
Photo No: 08

Location:	West approach roadway, looking southeast.
Description:	Settlement (up to 1/2") and potholes. Note wide random cracks and moderate raveling throughout in bituminous overlay.

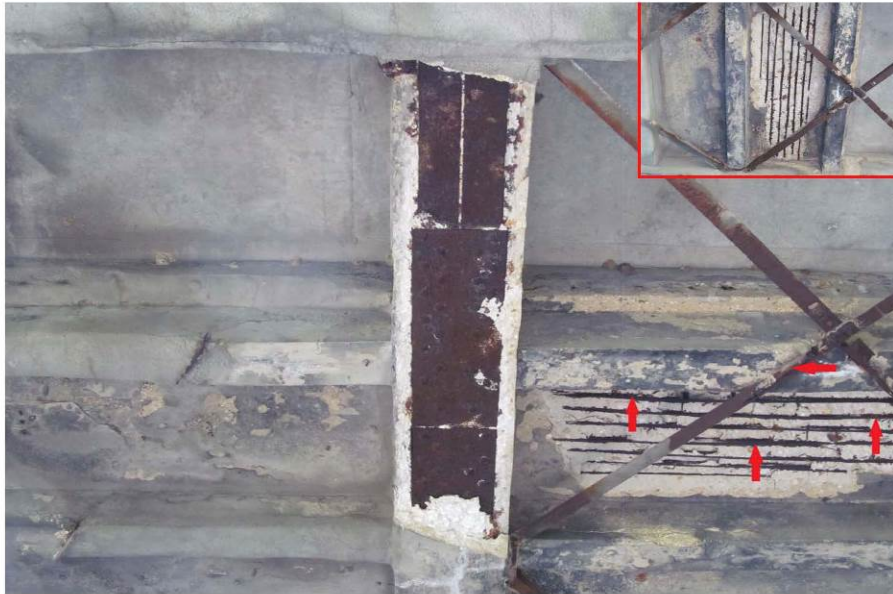
Photo No: 09

Location:	Underside of the deck slab, floorbeam Bay 4 from the west, looking north and up.
Description:	A large spall (27 SF x 4"D) with exposed corroded rebar on underside of deck. Note the corroded and broken lateral bracing. Also note spalled encasement of floorbeam with exposed rusted bottom flange.

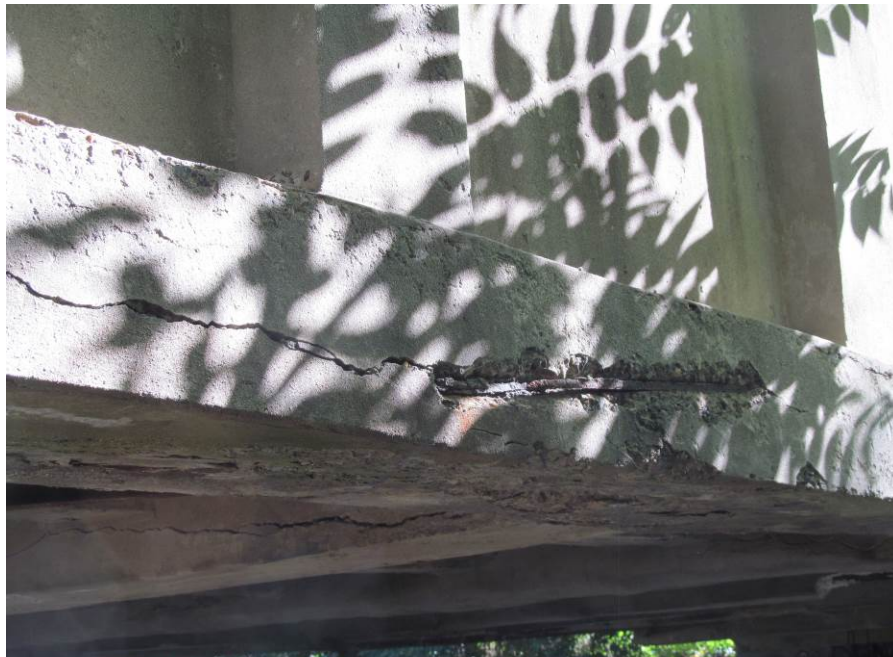
Photo No: 10

Location:	South fascia thru girder, looking northeast.
Description:	Spall (3 SF x 1.5"D) with exposed rusted bottom flange and adjacent wide crack.

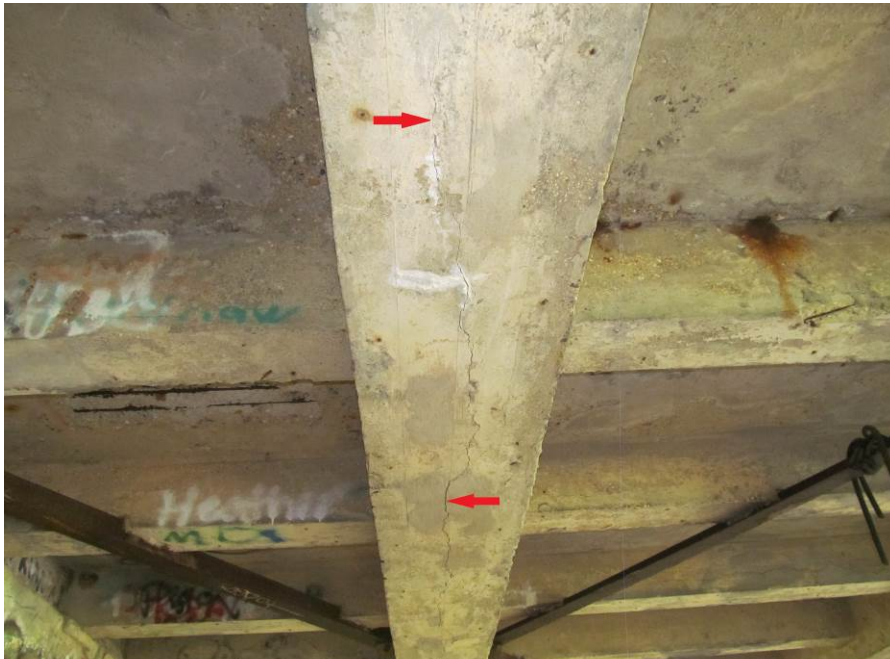
Photo No: 11

Location: Underside of superstructure, floor beam FB8, looking south.

Description: Typical medium to wide longitudinal crack on bottom side of concrete encasement.

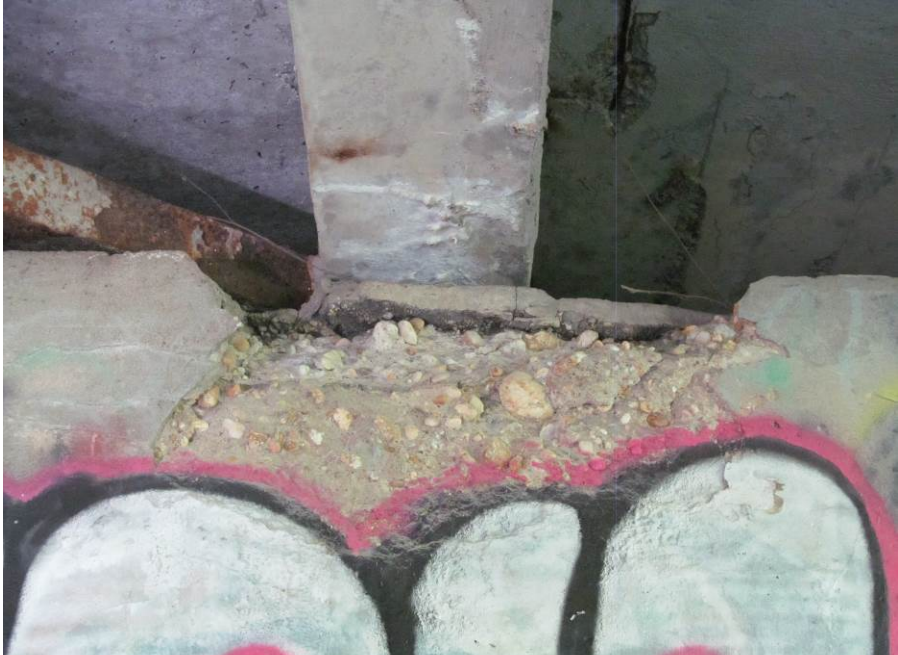
Photo No: 13
Location:	West abutment, south end, looking west.	
Description:	A large spall (8 SF x up to 6" D) at top of the breastwall below Stringer 6.

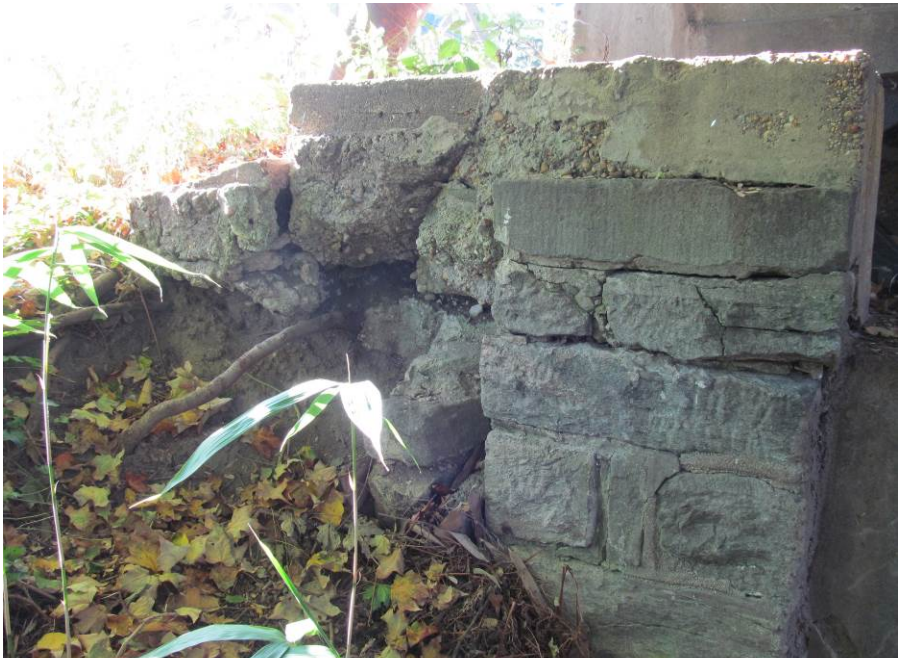
Photo No: 14
Location:	Northeast approach roadway embankment, wingwall/retaining wall, looking southeast.	
Description:	Missing stones and cracked/deteriorated pointing with moderate erosion adjacent to wingwall.

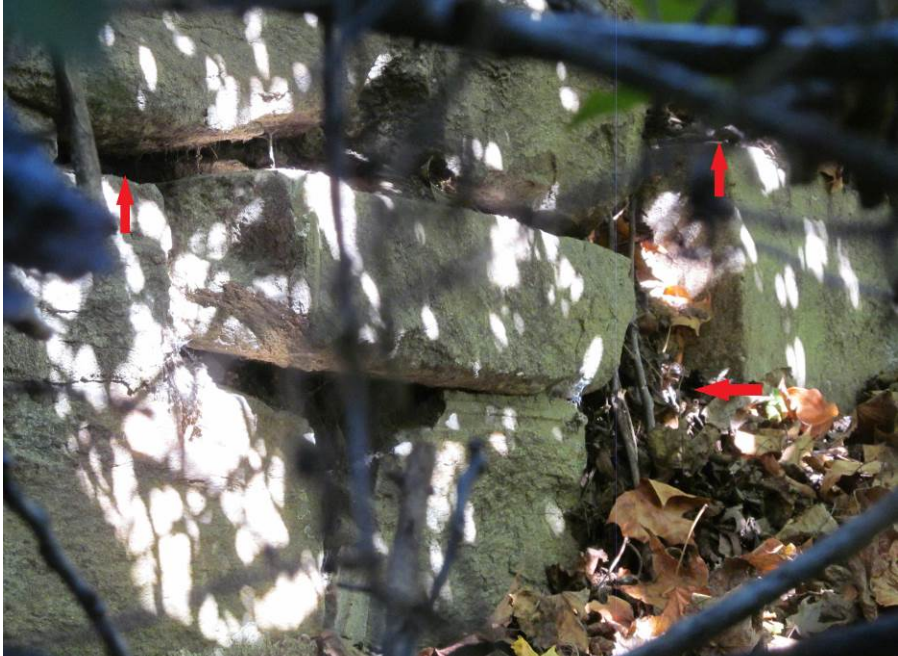
Photo No: 15
Location:	Northwest retaining wall, looking northwest.	
Description:	Loose, missing and displaced stones with a broken and missing cap stone.

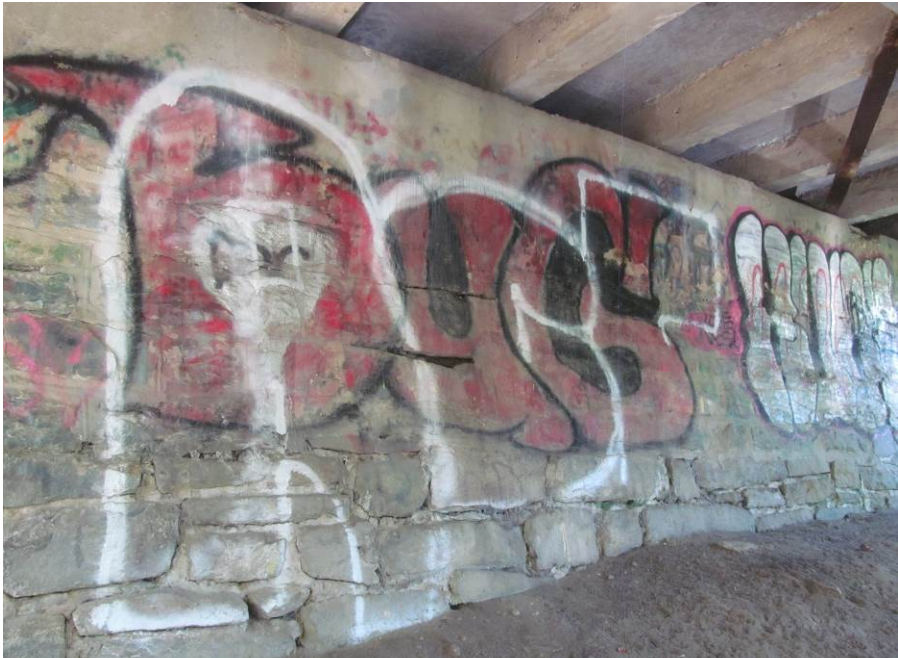
Photo No: 16
Location:	West abutment, looking northwest.	
Description:	Typical paint vandalism throughout the wall (typical at east abutment). Note deteriorated and missing mortar on bottom half of the wall throughout.

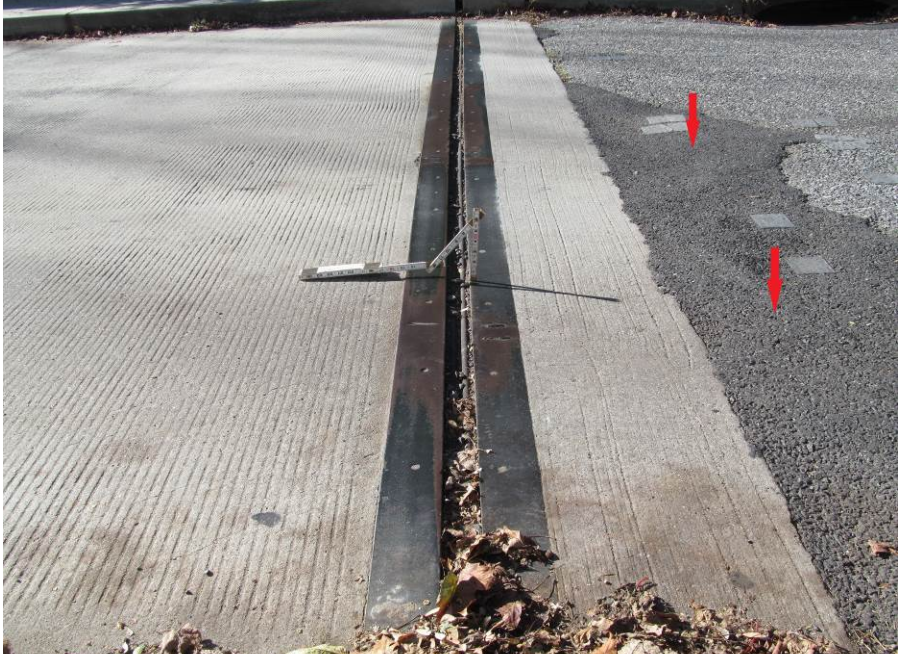
<p>Photo No: 17</p>
<p>Location:</p>	<p>West abutment deck joint, looking south.</p>
<p>Description:</p>	<p>Work Done: Bituminous concrete patch placed adjacent to header on west approach. Note up to ½” vertical misalignment of steel armor angles.</p>

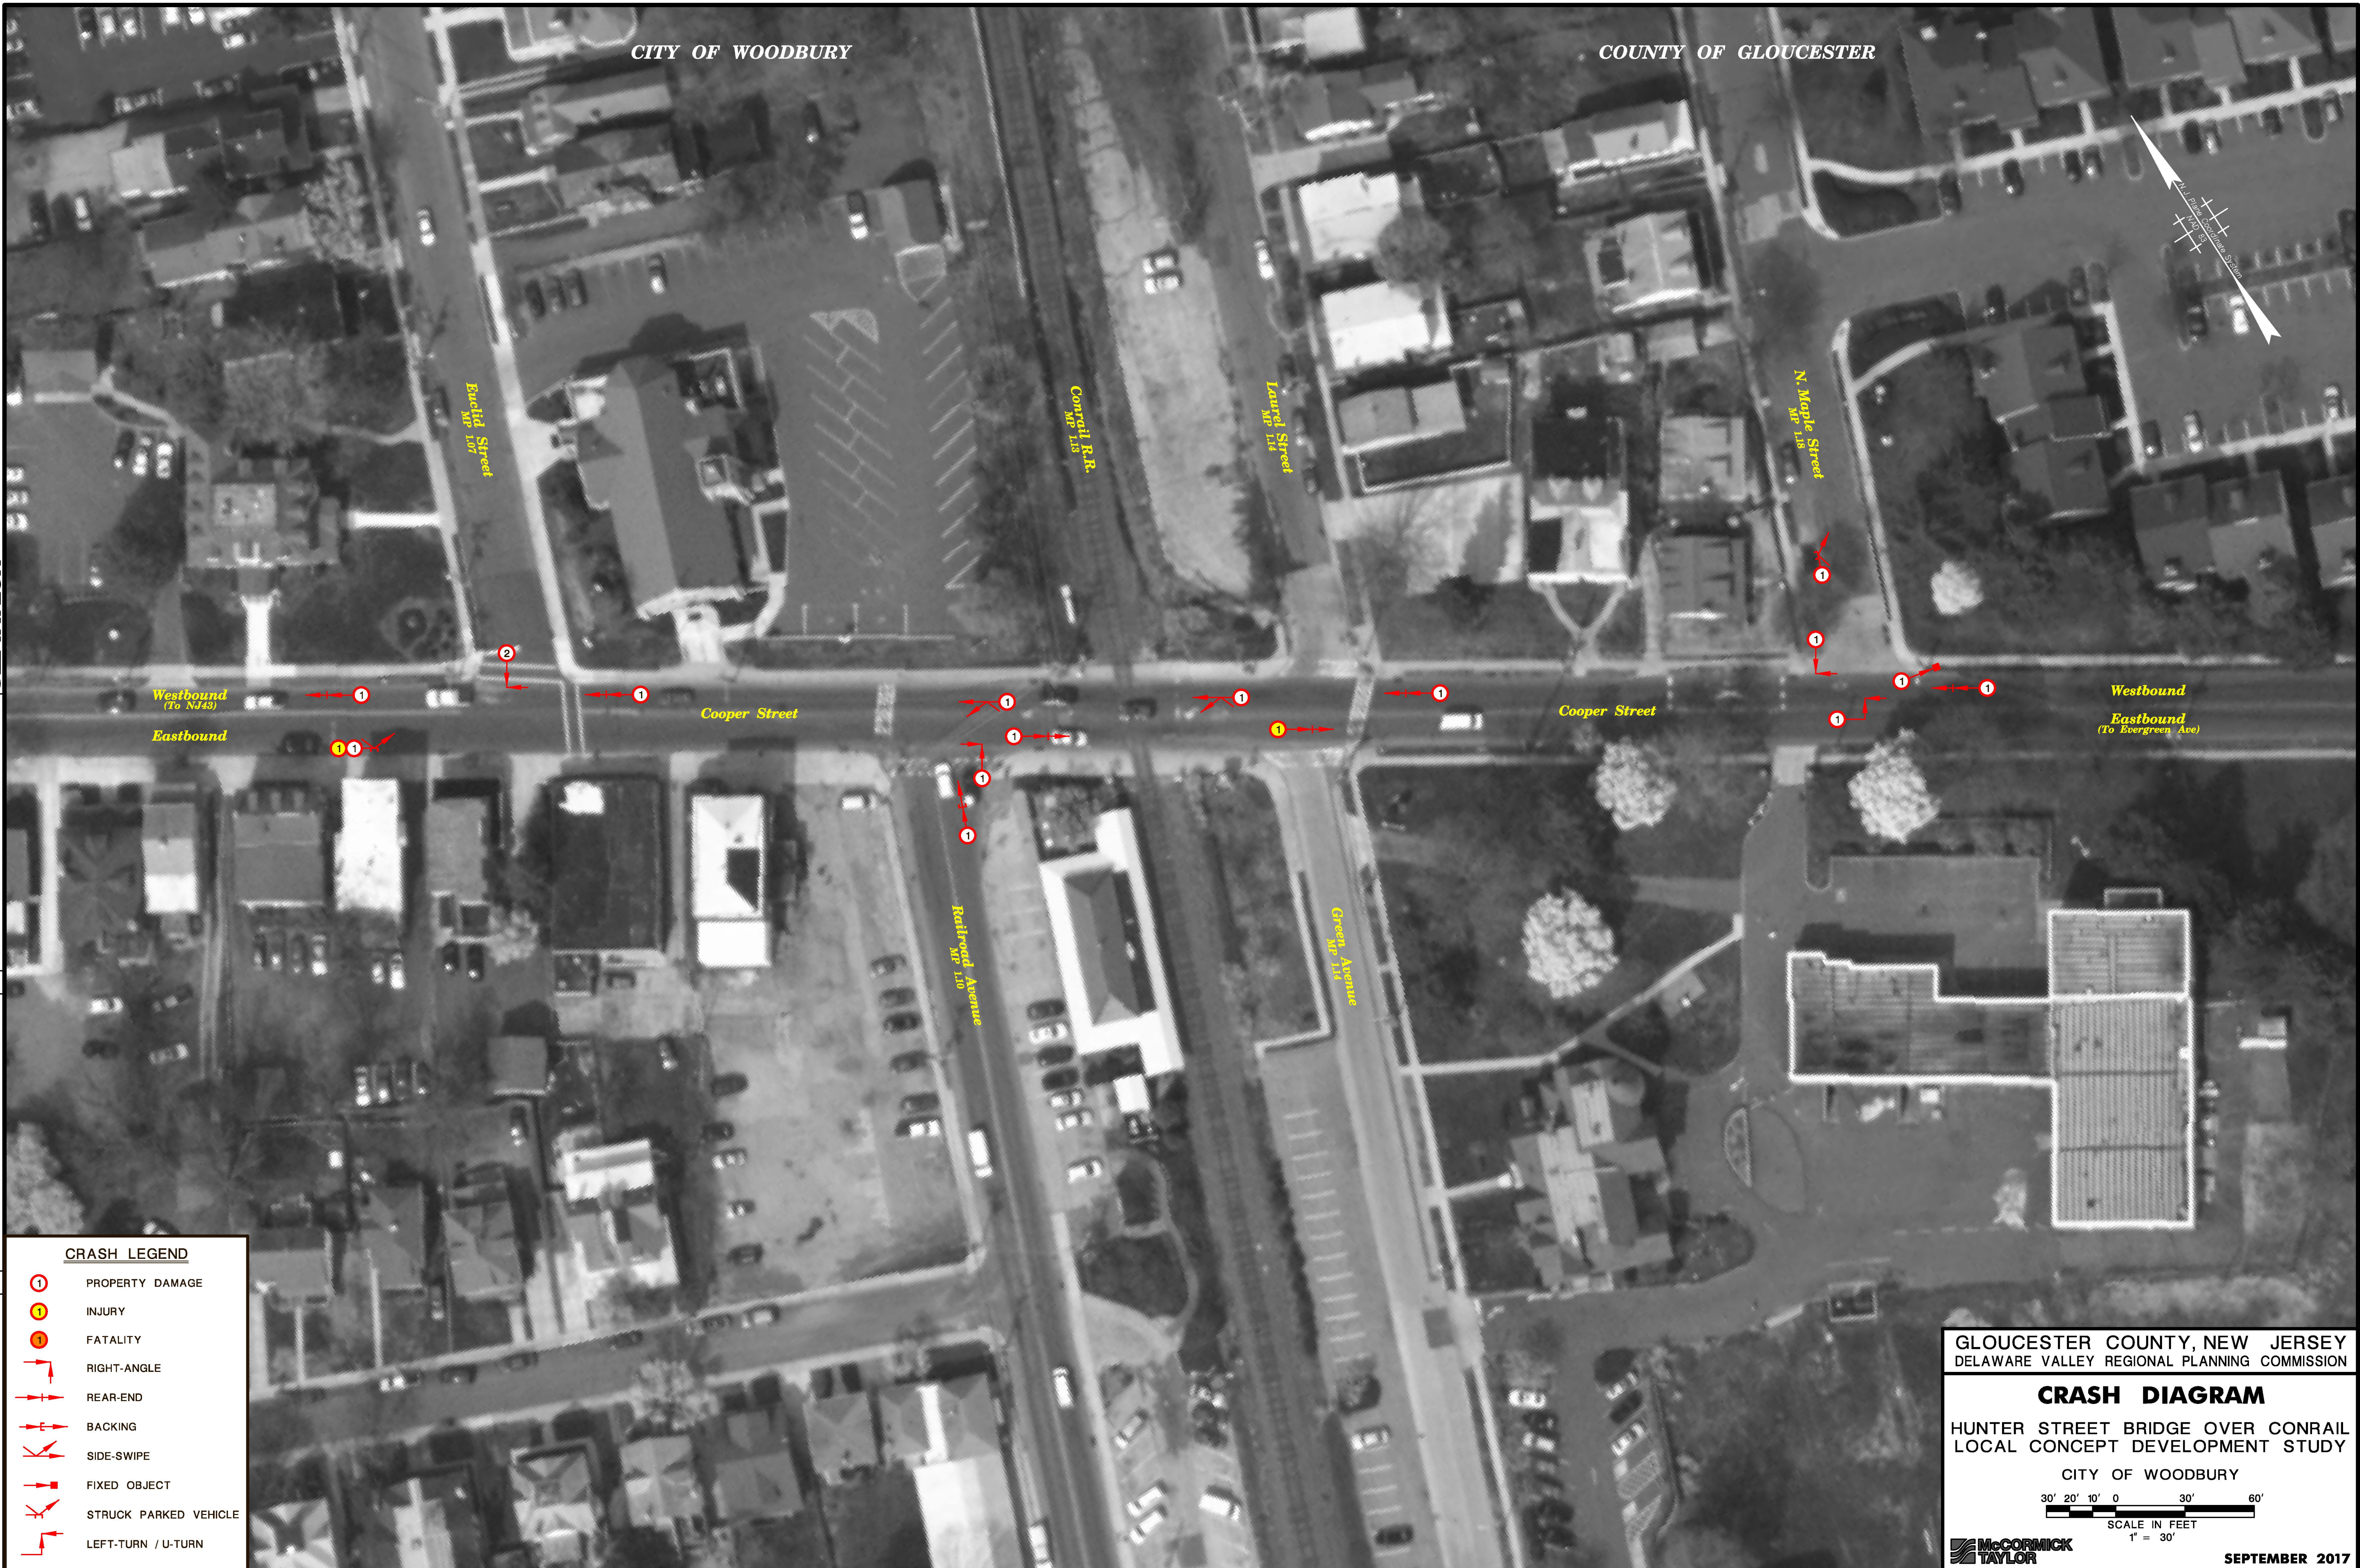
CRASH LEGEND

- ① PROPERTY DAMAGE
- ② INJURY
- ③ FATALITY
- ↗ RIGHT-ANGLE
- ↖ REAR-END
- ↔ BACKING
- ↘ SIDE-SWIPE
- ⊥ FIXED OBJECT
- ⊥ STRUCK PARKED VEHICLE
- ↶ LEFT-TURN / U-TURN

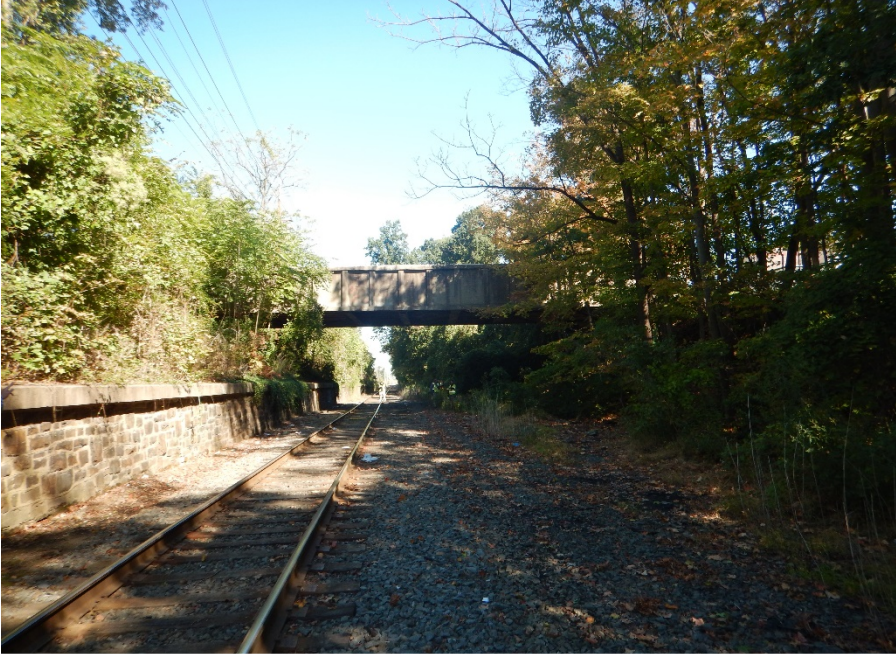
Photo No: 1
Location:	South elevation, looking north.	
Description:	General view. Note: Stone masonry retaining wall along west side of railroad track.

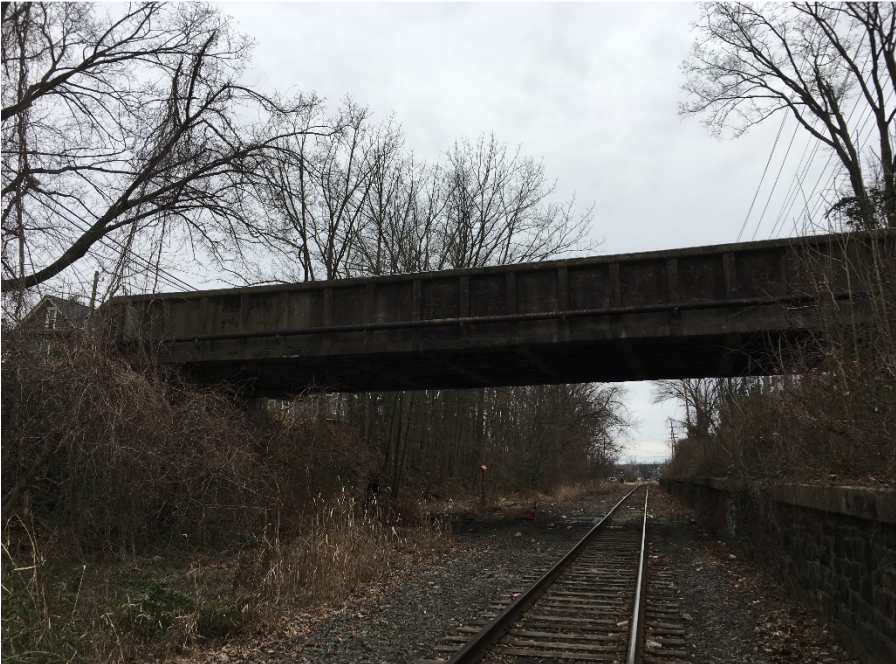
Photo No: 2
Location:	North elevation, looking south.	
Description:	General view. Note: Gas line attached to bridge fascia.

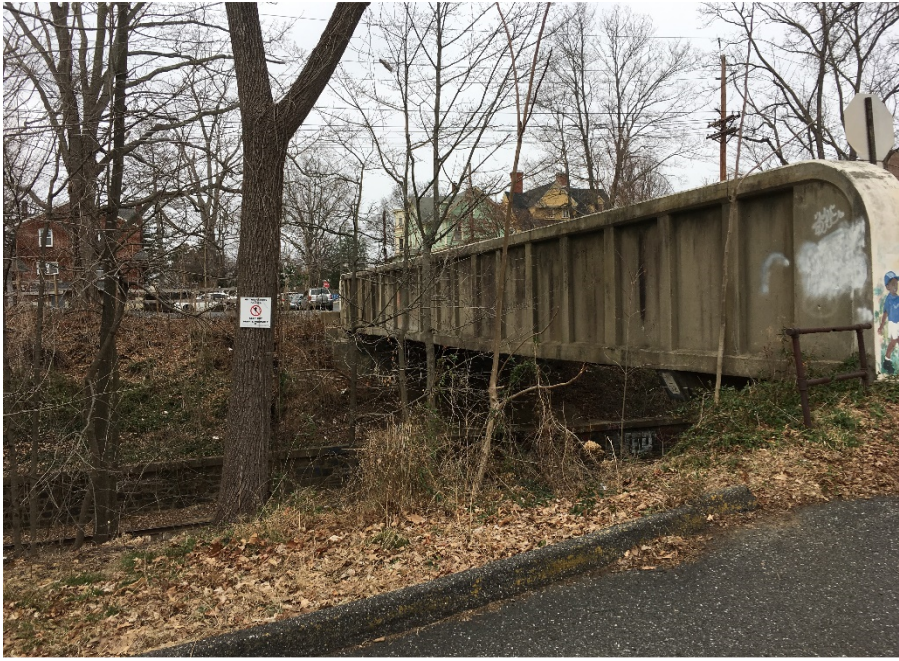
<p>Photo No: 3</p>
<p>Location:</p>	<p>South fascia, looking northwest from Laurel Street.</p>	
<p>Description:</p>	<p>General view.</p>

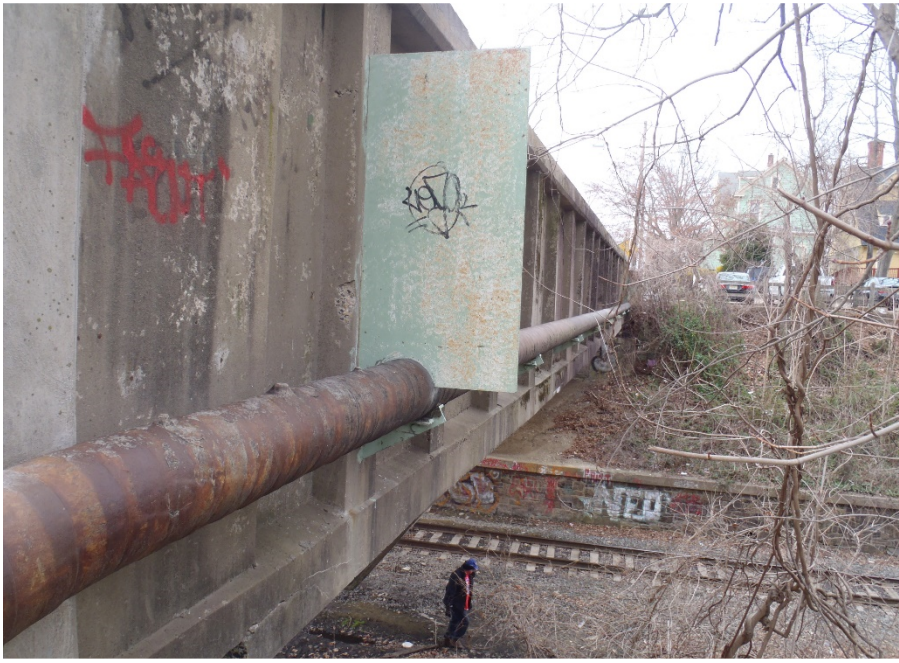
<p>Photo No: 4</p>
<p>Location:</p>	<p>North fascia, looking southwest.</p>	
<p>Description:</p>	<p>General view. Note: Gas line attached to bridge fascia.</p>

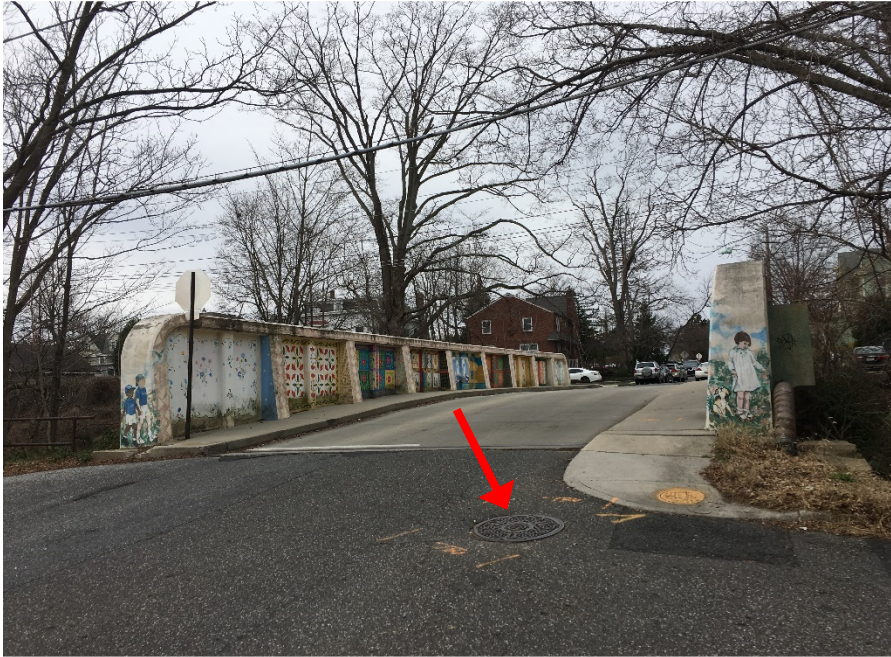
Photo No: 5

Location:	Hunter Street east approach roadway, looking west from Laurel Street.
------------------	---

Description:	General view. Note: Utility manhole in street and murals painted on bridge girders.
---------------------	---

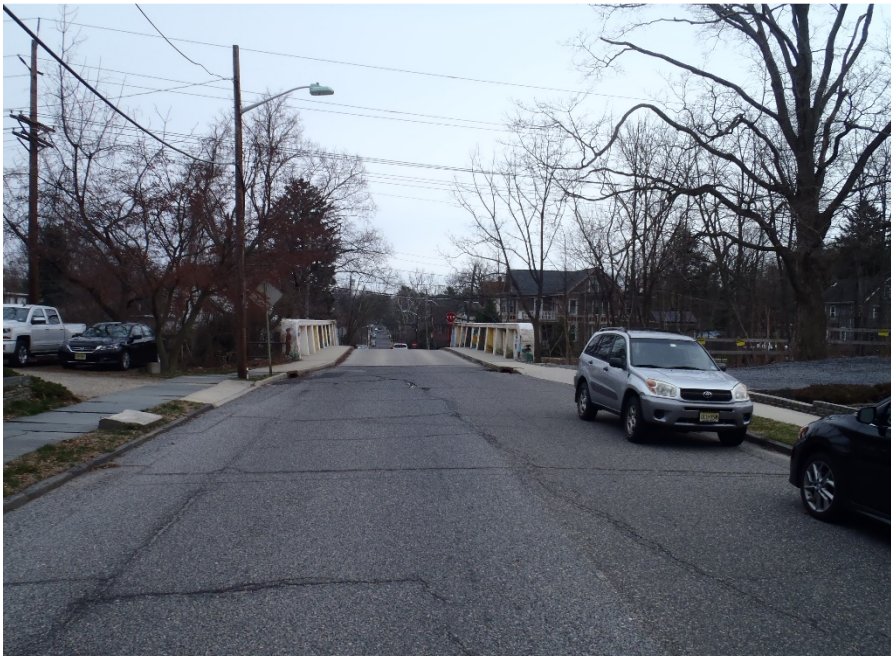
Photo No: 6

Location:	Hunter Street west approach roadway, looking east.
------------------	--

Description:	General view.
---------------------	---------------

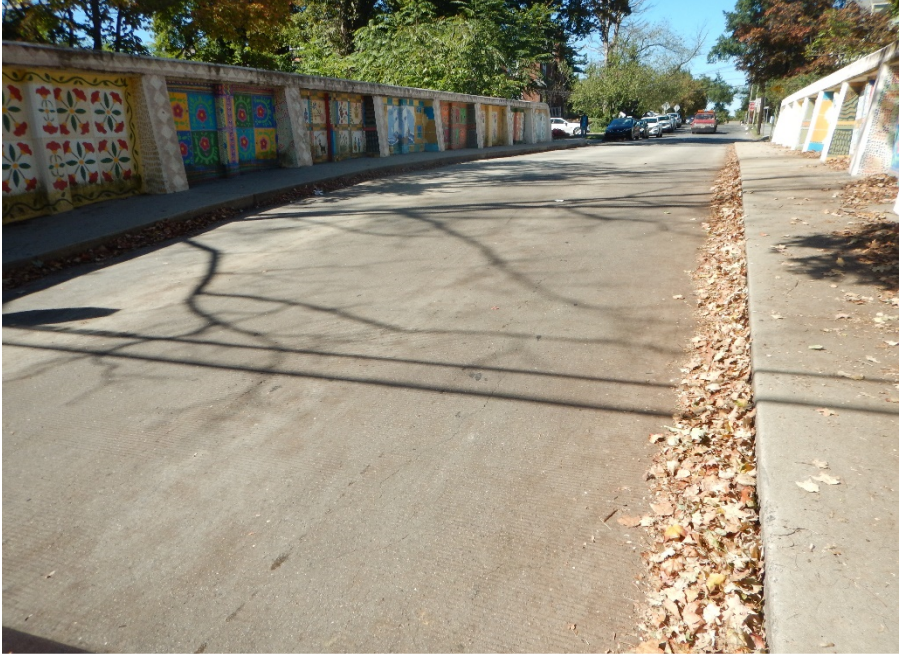
<p>Photo No: 7</p>
Location:	Top of deck, looking west.	
Description:	General view.

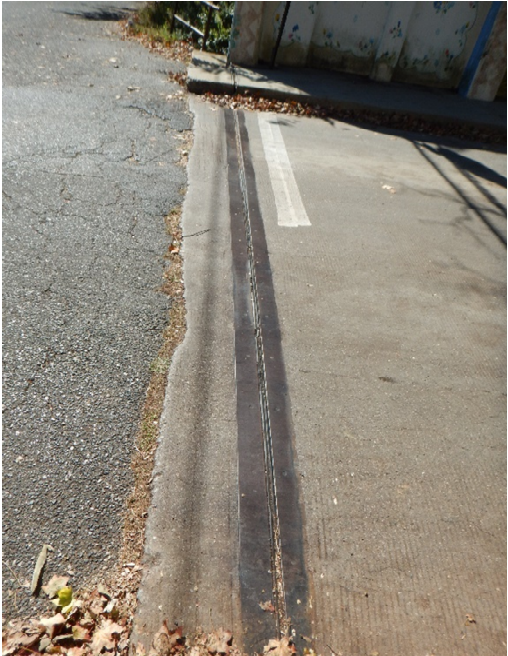
<p>Photo No: 8</p>
Location:	East abutment deck joint, looking south.	
Description:	General view.

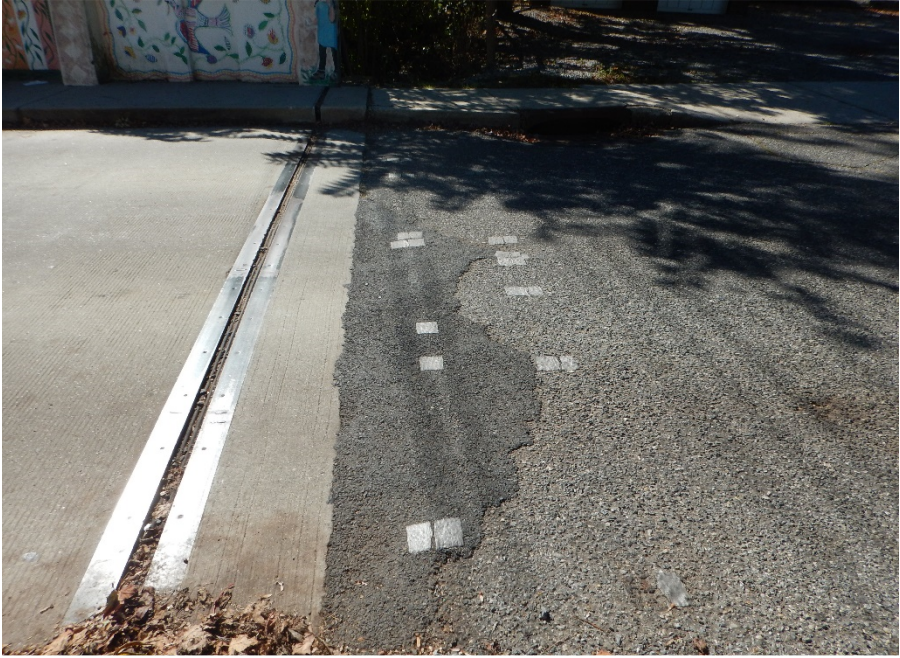
<p>Photo No: 9</p>
<p>Location:</p>	<p>West abutment deck joint, looking south.</p>	
<p>Description:</p>	<p>General view. Note: Asphalt patching adjacent to abutment backwall.</p>

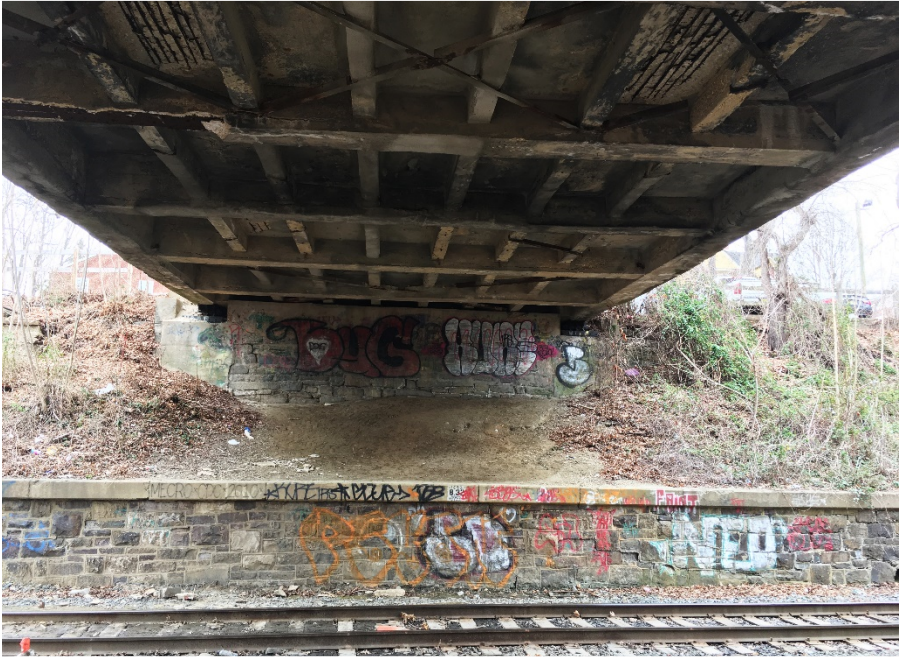
<p>Photo No: 10</p>
<p>Location:</p>	<p>Underside of bridge, looking west.</p>	
<p>Description:</p>	<p>General view. Note: Large spalls with exposed corroded rebars on underside of deck, spalled encasement of floor beam with exposed rusted bottom flange, corroded and broken lateral bracing.</p>

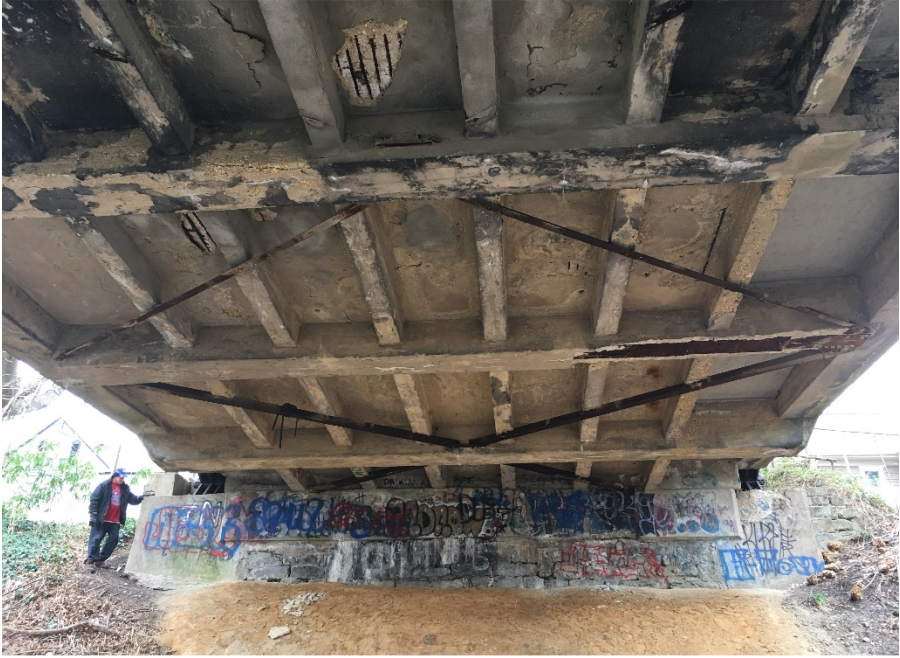
Photo No: 11
Location:	Underside of bridge, looking east.	
Description:	General view. Note: Large spalls with exposed corroded rebar on underside of deck, spalled encasement of floor beam with exposed rusted bottom flange, and corroded lateral bracing.

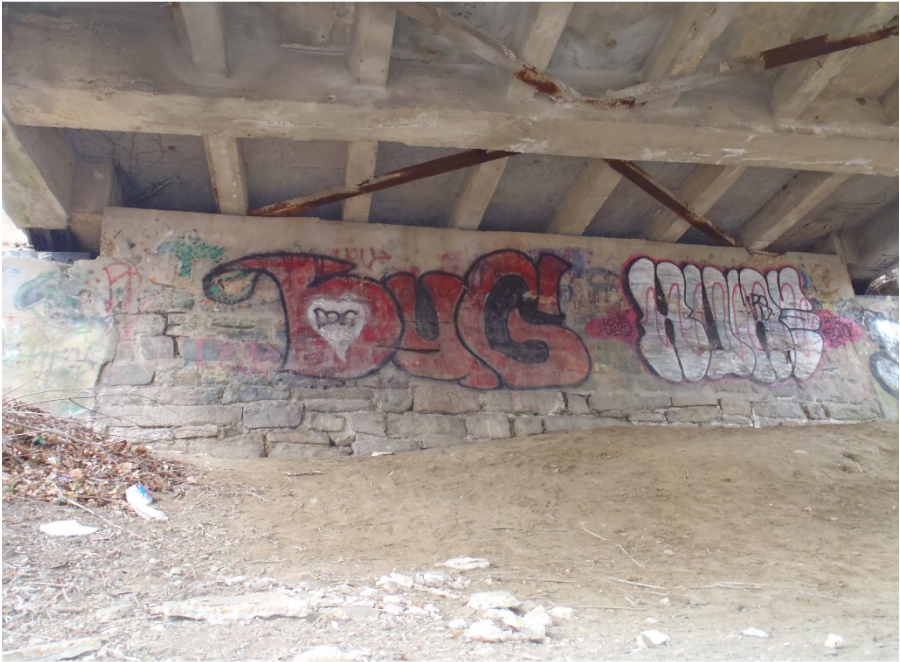
Photo No: 12
Location:	West abutment, looking west.	
Description:	General view. Note: Graffiti and areas of missing mortar in stone masonry.

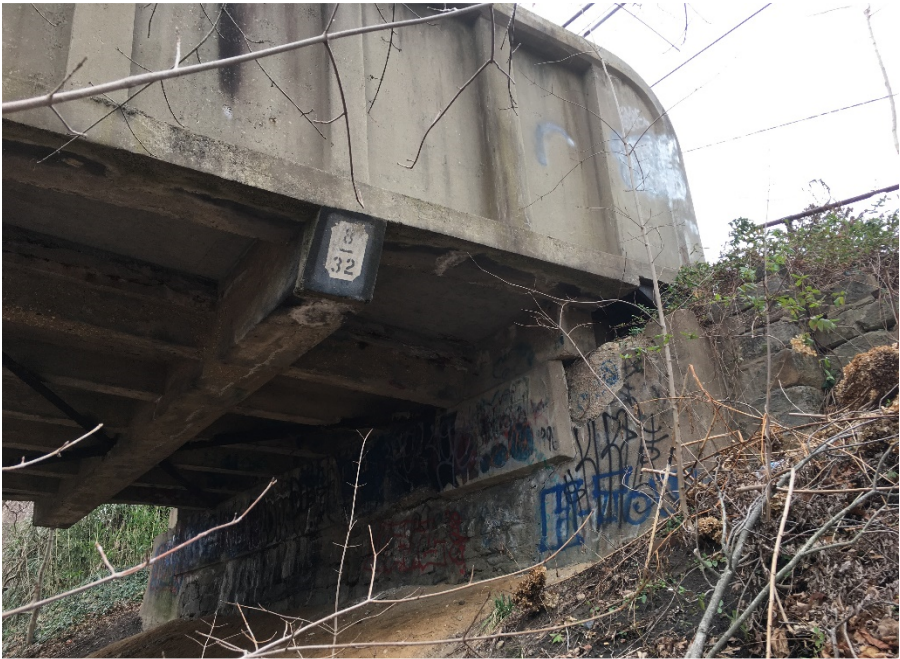
Photo No: 13
Location:	East abutment, looking northeast.	
Description:	General view. Note: Graffiti and areas of missing mortar in stone masonry.

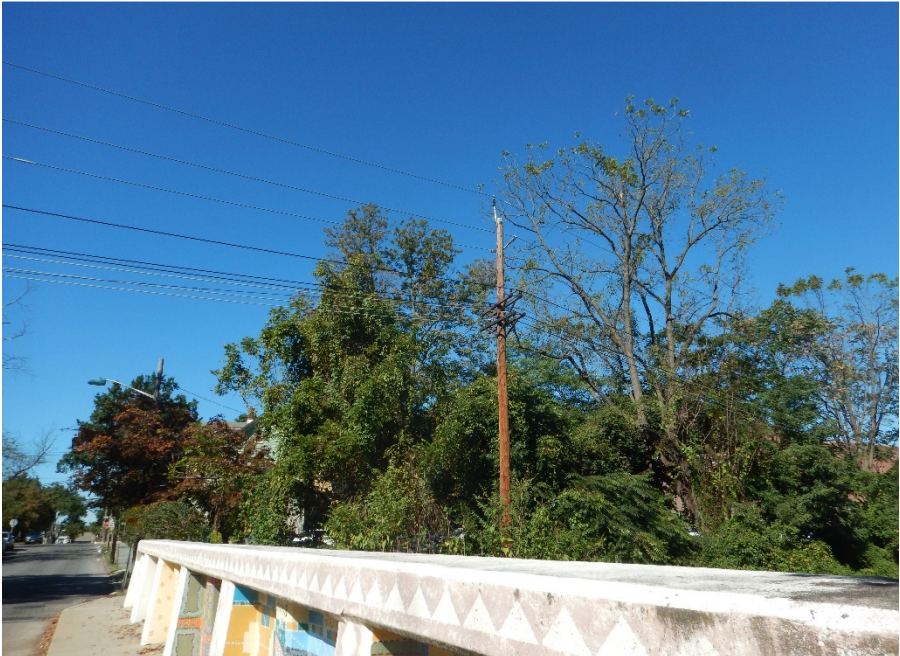
Photo No: 14
Location:	Hunter Street bridge, looking northwest.	
Description:	Aerial utilities running parallel to railroad on west side of track.
