# PHASE I

MAY 2013

# DARBY BOROUGH

## GRADE CROSSING STUDY

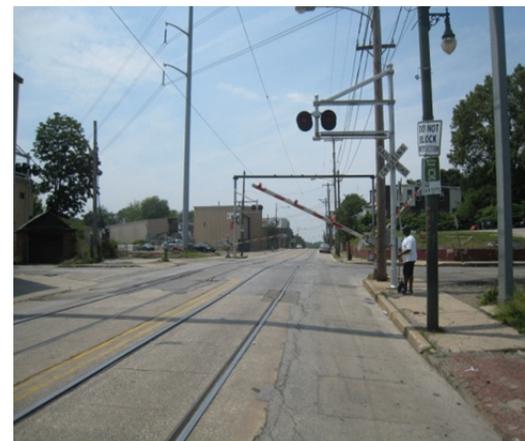
*The gates closing for an oncoming train at the Main Street grade crossing (facing west). (Source: DVRPC)*

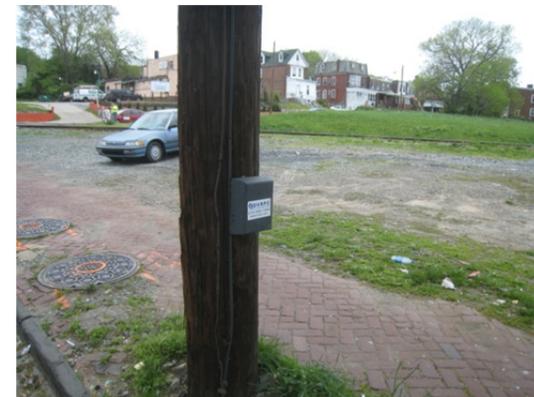
An automated pedestrian counter on the north side of Main Street.  
(Source: DVRPC)

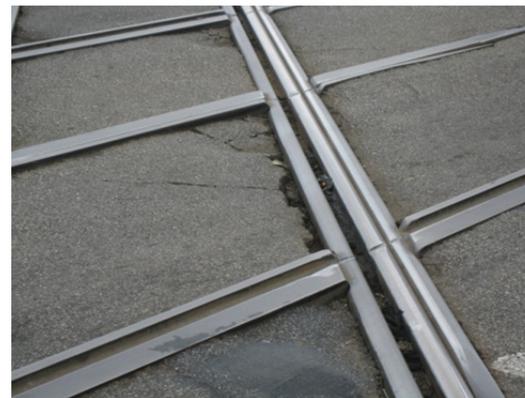
Recently, double-frogged flange, was installed at the Main Street grade crossing. The trolley tracks are situated at a slightly higher elevation than the railroad tracks. This allows the trolley to virtually pass over the rail line without making as much contact and without creating as much wear and tear on the surrounding pavement. While the double-frogged flange has

*A close-up of the grade crossing surface on Main Street in Darby Borough.  
(Source: DVRPC)*

provided some improvements, the surrounding pavement is still deteriorating and will still need regular maintenance in the future. This regular maintenance is expensive, and any major project at the crossing should seek to continue to improve the surface conditions.

At Main Street, frequent resurfacing of the crossing has been necessary due to the additional wear and tear caused by trolley traffic. While the new double-frogged flange has been a major upgrade over the previous crossing mechanism, new technologies may be discovered that provide an even better solution. Additionally, a new water drainage system for the crossing and the surrounding roadway and railroad bed has the possibility of lessening future maintenance needs and making the area around the crossing more visually appealing. At Fifth Street, the resurfacing could focus on the roadway leading up to and proceeding away from the crossing to create a smoother change of grade instead of the severe ramp that currently exists on either side.

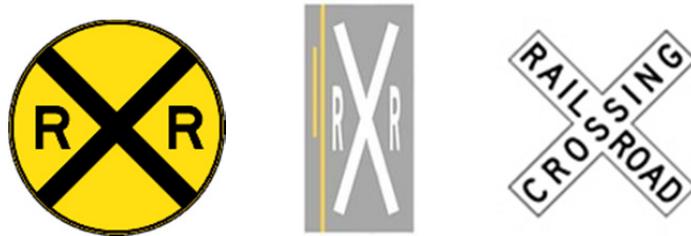
Figure 10: Examples of Popular Passive Warning Devices

Left: An Advanced grade crossing warning sign.  
Center: Advanced grade crossing warning striping in pavement.  
Right: Grade crossing cross bucks.  
(Source: Operation Lifesaver)

Passive Devices refer to the signage and striping at a grade crossing and the advanced signage and striping leading up to a grade crossing. In many rural areas or on seldom-used rail lines, passive devices are the only safety measure present at a grade crossing. Advanced passive devices play an important role in warning vehicular traffic, which is especially important for drivers unfamiliar with the area. Passive devices at a crossing usually consist of a cross buck railroad sign and striping to let motorists know exactly where the train crosses.

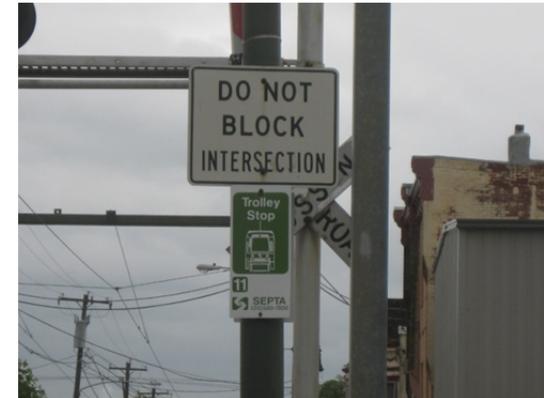
Above: A cross buck sign is obscured by a “Trolley Stop” sign and “Do Not Block Intersection” sign on the eastbound approach to the grade crossing on Main Street. (Source DVRPC)

All signage at the Main Street grade crossing and advanced signage leading up to the Main Street crossing could be replaced with new passive devices. When placing the signs, it is important to have sufficient sight distance and visibility so that the signs can be easily seen. Striping could be improved at the crossing by providing advanced warning signs. Stop bars should be

refreshed well before the crossing gate on Main Street. Currently, the stop bars on eastbound Main Street bisect the train tracks. At Fifth Street, the posted cross bucks are clearly visible, but there are no advanced warning signs or striping in the pavement to warn drivers.

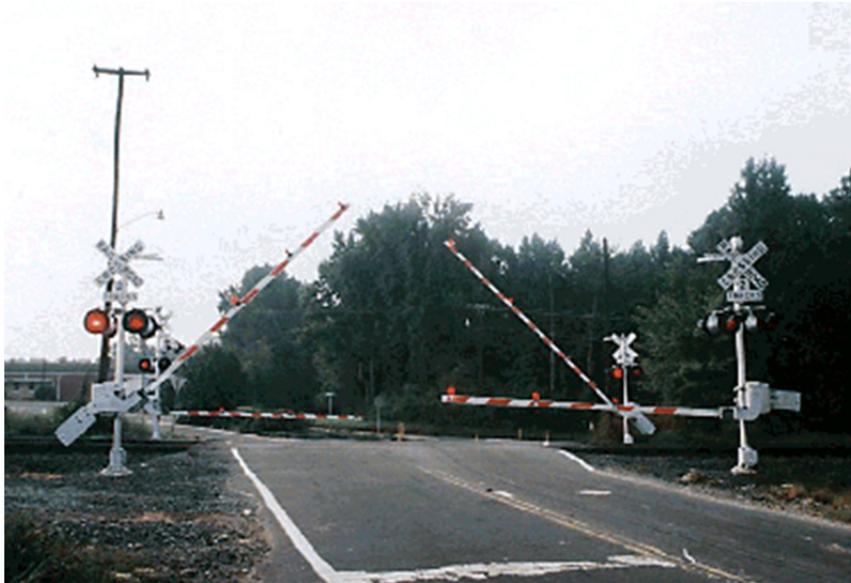
Figure 11: Example of Four-Quadrant Gate System

*Left: A four-quadrant gate in North Carolina (note: the gates to the entrances are already closed, but the gates for the exits are in the process of closing). (Source: North Carolina Department of Transportation)*

Typical grade crossings involve just a single intersecting highway. If installing a four-quadrant gate system at the Main Street crossing, at least seven gates would be needed to reach the desired effect. In general, four-quadrant gates have a price range of \$150,000 to \$500,000, but this is likely a low cost estimate considering the amount of gates needed for Main Street.

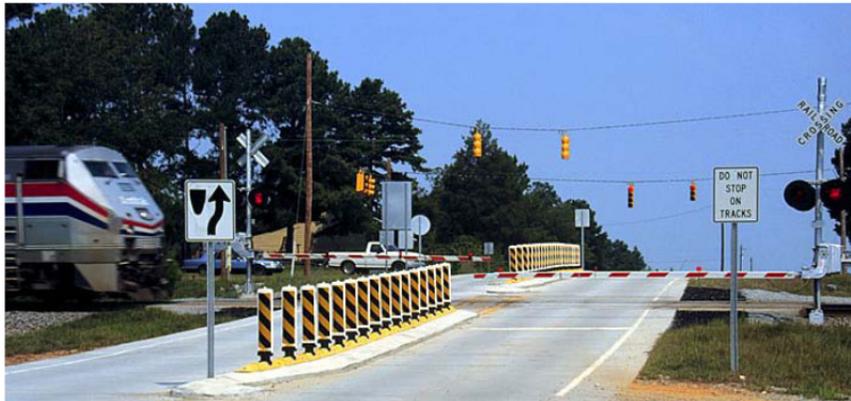
Figure 12: Example of Mountable Raised Curb Channelization Device

*Left: A mountable raised curb with vertical panels in North Carolina. (Source: North Carolina Department of Transportation)*

Both Main Street and Fifth Street could be viable candidates for medians or channelization devices. Typically, these improvements cost a total of \$10,000 to \$15,000 per crossing. While this SSM does not provide any direct pedestrian safety benefit, the raised vertical panels bring additional visible attention to the crossing, which may improve driver awareness of pedestrians at the crossing.

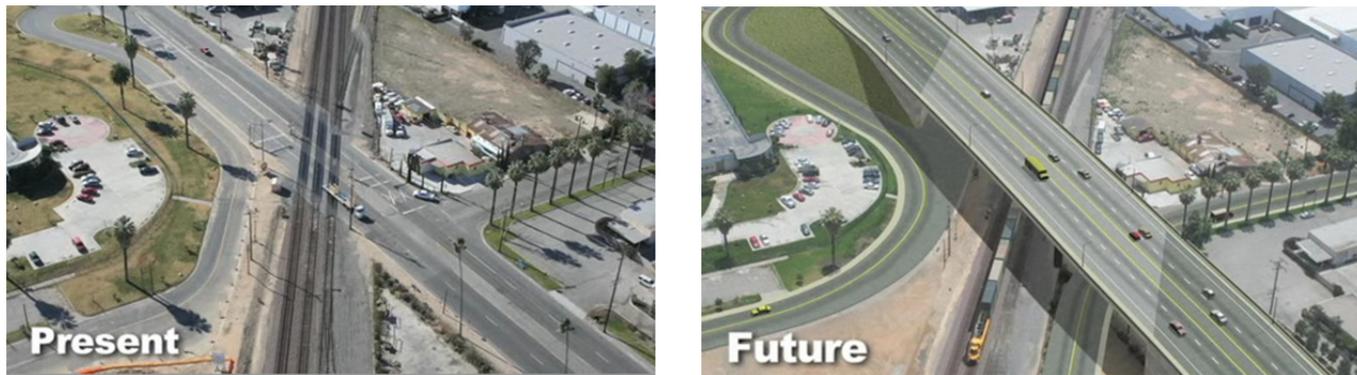
Figure 13: Example of Road over Rail Grade Separation Project

Left: Present conditions at Iowa Avenue in Riverside, CA. Right: A rendering of a planned roadway bridge over the railroad tracks. (Source: Riverside California, Public Works Department)

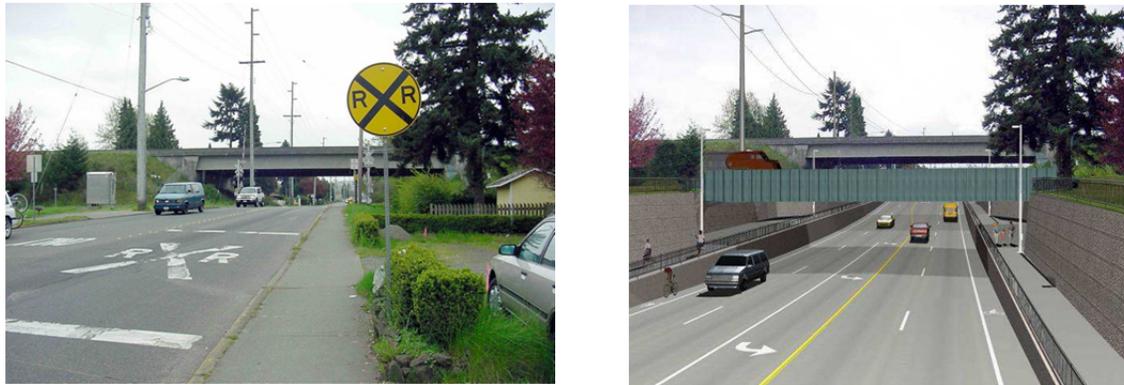
Figure 14: Example of Road under Rail Grade Separation Project

Left: Present at-grade conditions at M Street in Auburn, WA. Right: A rendering of a planned roadway tunnel under the rail line in Auburn, WA. (Source: Puget Sound Regional Council)

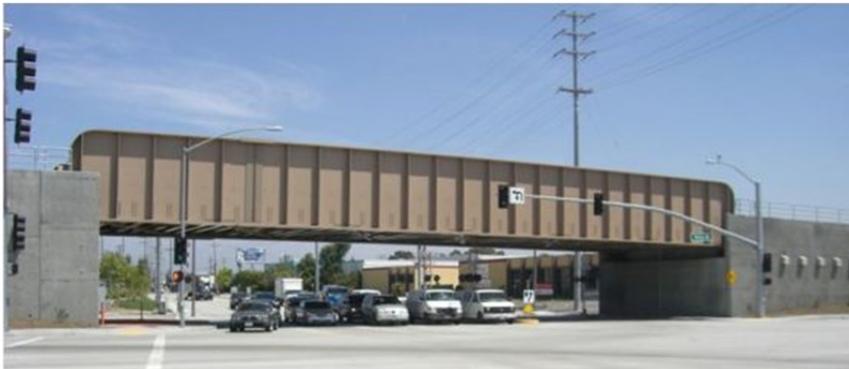
Figure 15: Example of a Rail over Road Grade Separation Project

*A railroad bridge over Sunset Avenue  
in the City of Industry, CA.  
(Source: Alameda Corridor-East  
Construction Authority)*
