North Maple Avenue (CR 607) Road Safety Audit

Evesham Township, NJ

March, 2015

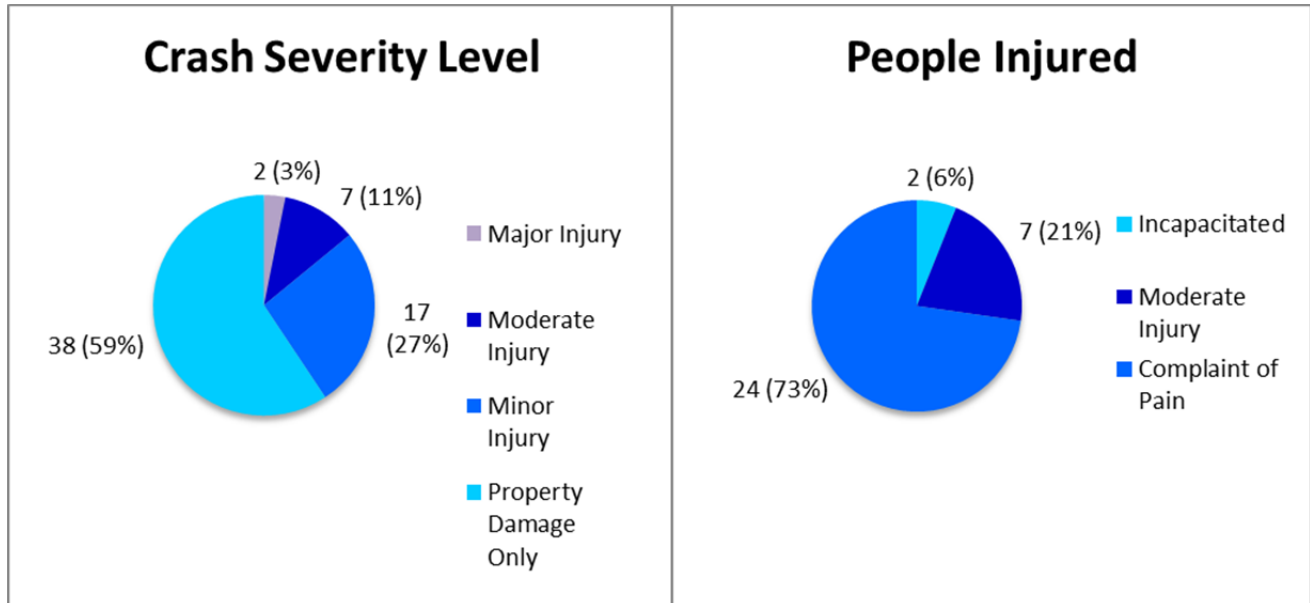
Figure 5: Crash Severity

Injury severity was relatively low along the corridor during the study period. There were no fatal crashes reported during the study period. Only three percent of reported crashes involved major injury, and a quarter involved minor injuries. The majority (over half) were property damage only (see Figure 5 below).

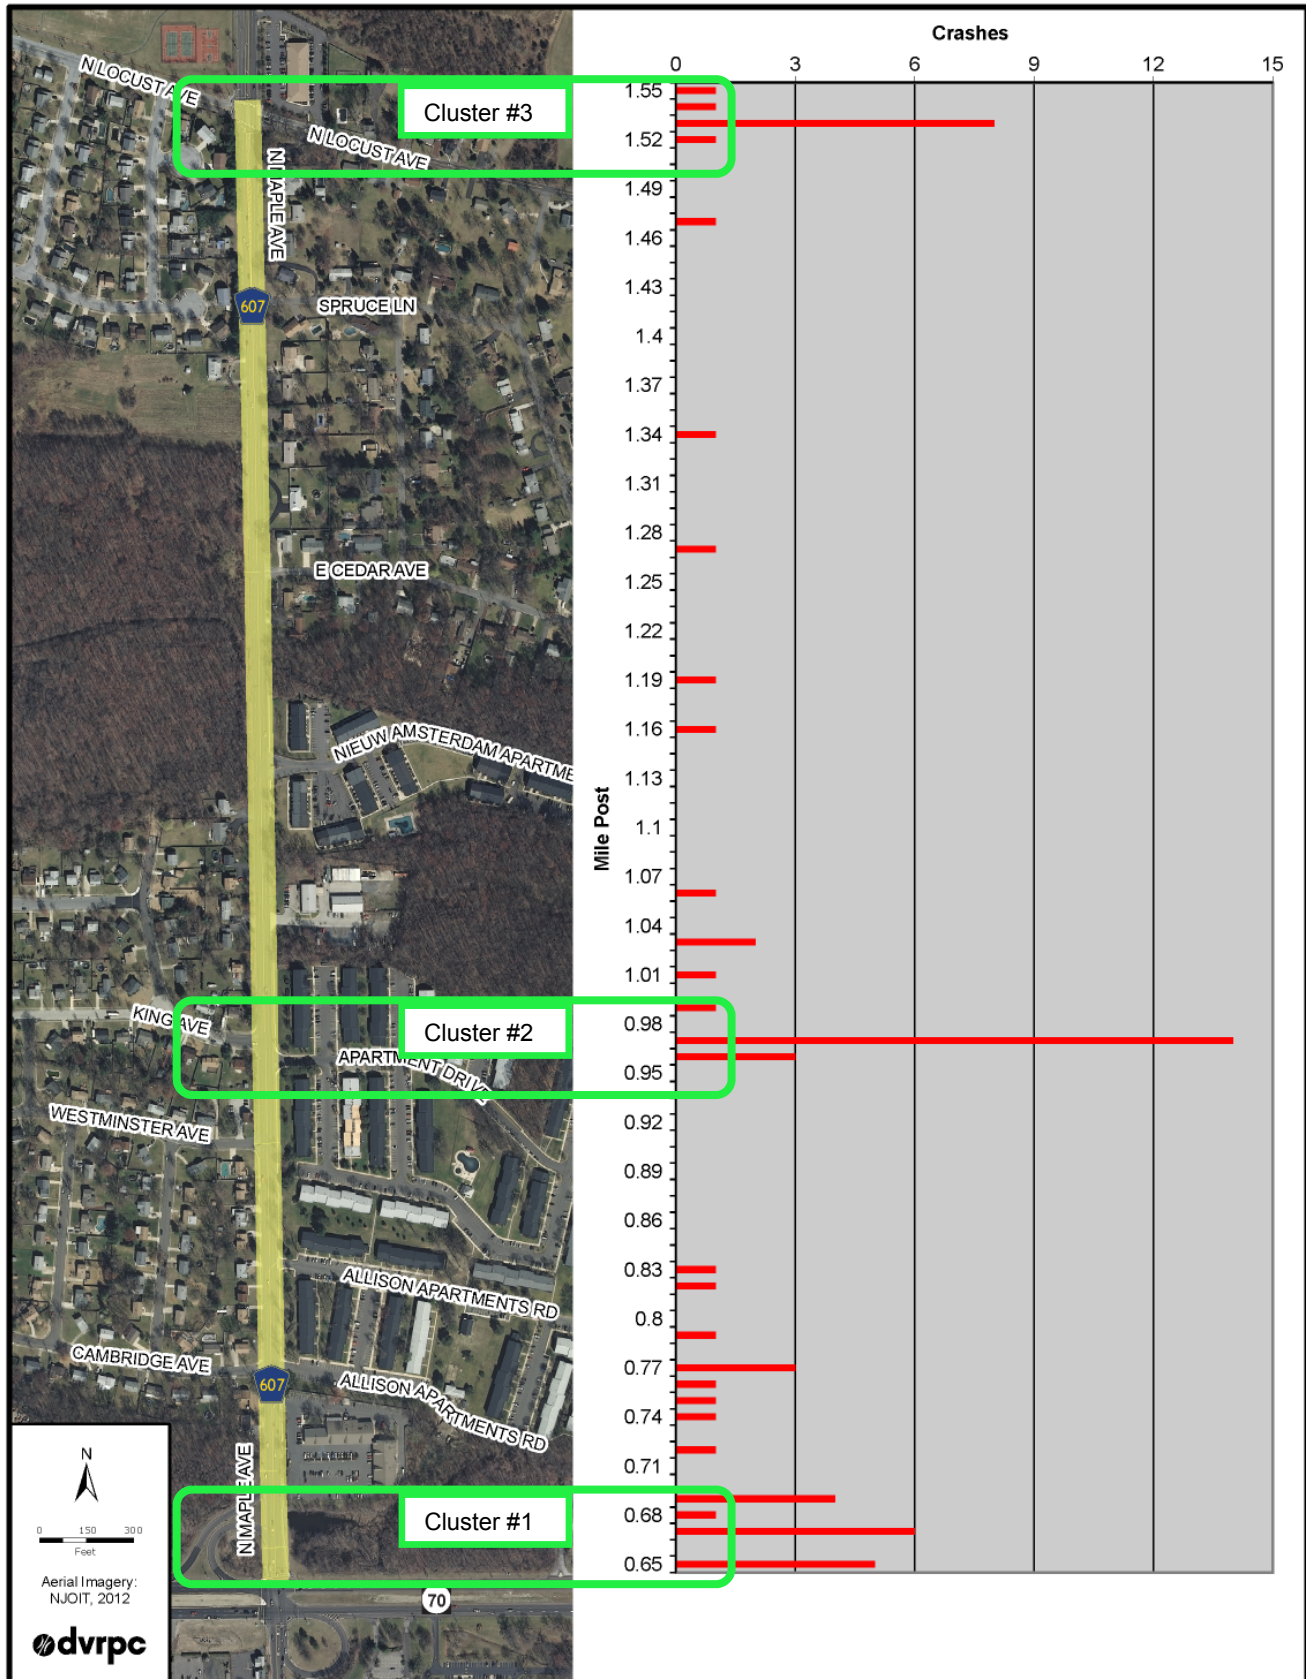
Figure 6: Crash Frequency by Milepost

The crash frequency by milepost map (Figure 6) depicts a bar graph representing crash concentrations by mile post aligned with an aerial view map of the corridor. Crashes are coded to a two-decimal place tolerance, which allows for locating crashes within approximately 50 feet of one another. The map revealed three crash cluster locations which became the focus of the audit analysis and field visit. Although the catchment area for each of these clusters differs, they are relatively similar in size, and each centers on an important intersection along the study corridor. The map in Figure 6 was used during the audit to demonstrate to the RSA team where there were crash trends.

Corridor-wide, crashes occurred in a total of 27 unique locations, of which 19 locations had only one crash during the study period. The highest single concentration of crashes—14 crashes—occurred at milepost 0.97 where North Maple Avenue intersects with King Avenue and Apartment Drive; the focus of a cluster location. Another cluster was identified where North Maple Avenue intersects NJ 70, and a third at the intersection of North Locust Avenue. These three cluster locations were the focus of further analyses and were examined closely during the field visit (see Figure 6 for the geographic limits of each cluster). The areas between these three locations had comparatively fewer crashes.
